Gills Creek Watershed: Assessment of Regulated Dams

February 15, 2016

PROJECT NAME: Gills Creek Watershed Assessment of Regulated Dams Report

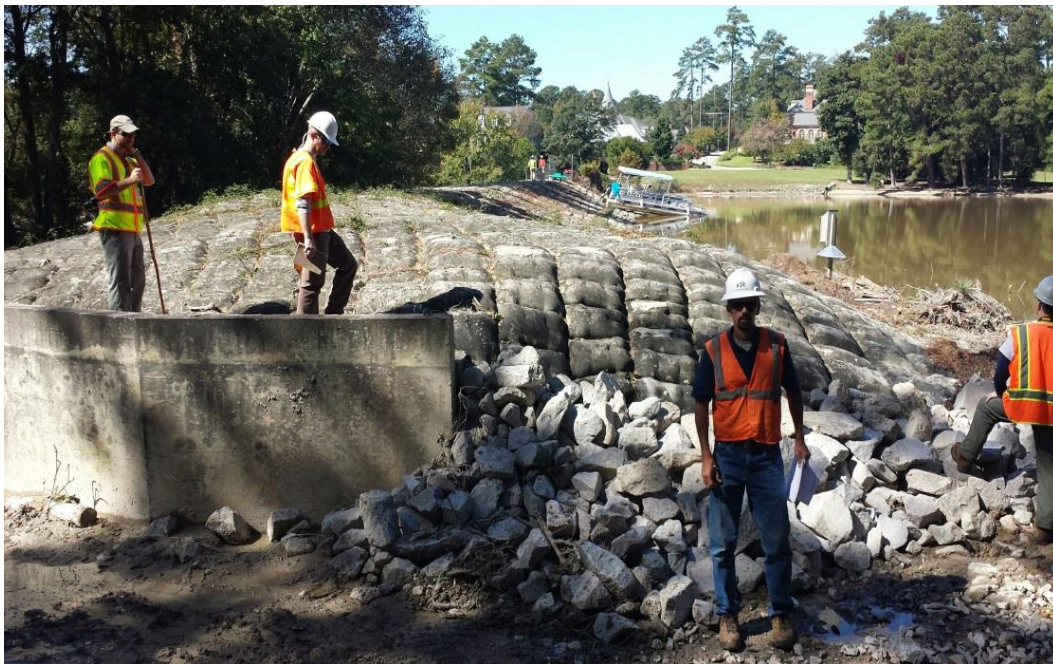
Photo 7: Approach to auxiliary concrete-chute spillway showing temporary rockfill repair of scour

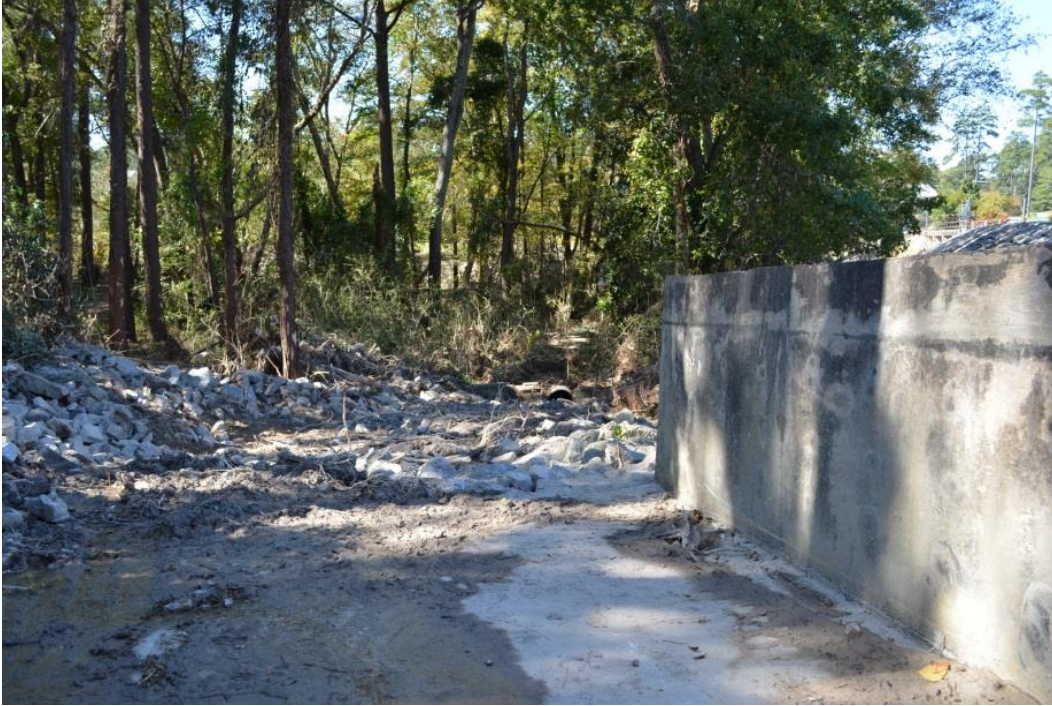
Photo 8: Temporary riprap repair upstream end of the auxiliary spillway concrete chute

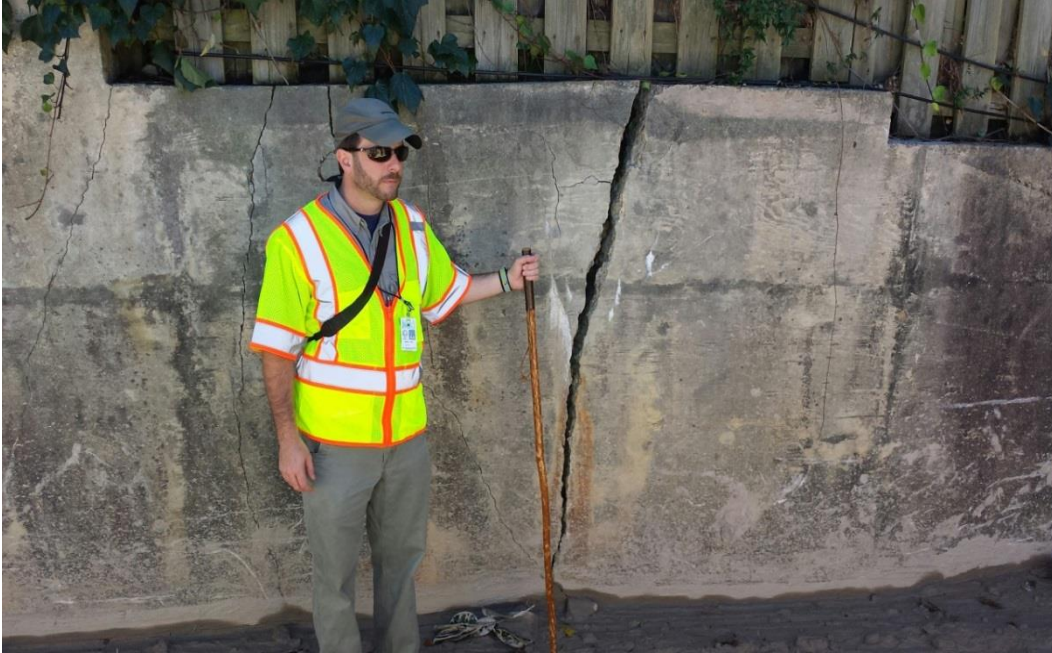
Photo 9: Downstream end of auxiliary spillway concrete chute with temporary rockfill of scour

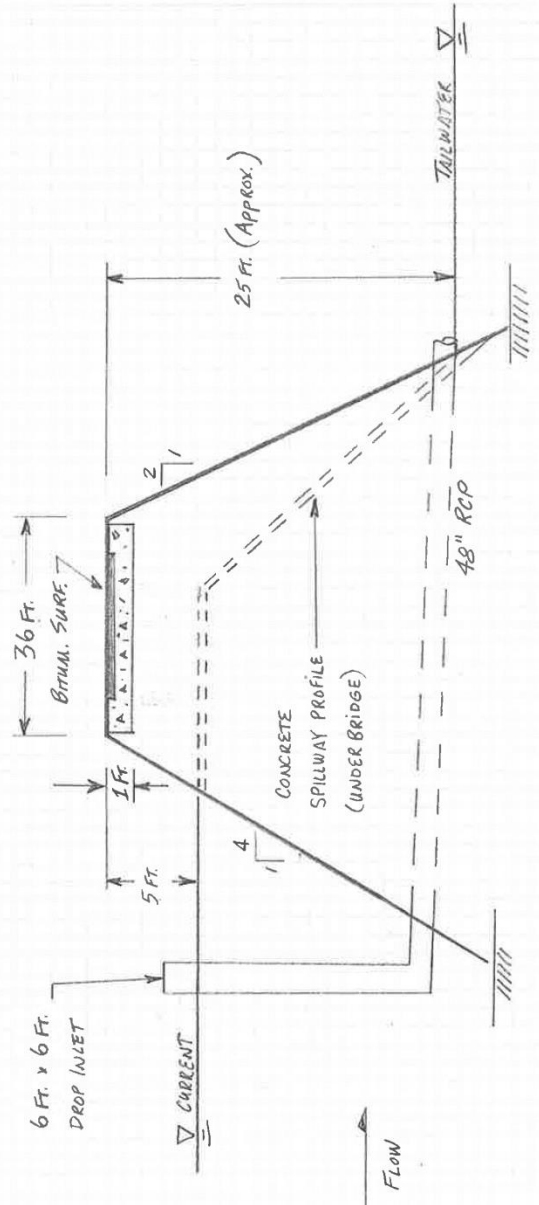
- NOTES:
- SPILLWAY LENGTH = 45 FT.
 - MINIMAL OVERTOPPING EVIDENCE OBSERVED
 - WATER FLOWING OVER SPILLWAY AT TIME OF INSPECTION
 - CURRENT WATER SURFACE = NORMAL WATER SURFACE
 - RISE & FALL DIMENSIONS & 48" RCP OUTLET PIPE SHOWN PER RECORDED DRAWINGS
 - ALL OTHER DATA SHOWN PER FIELD MEASUREMENTS / OBSERVATIONS / ESTIMATE

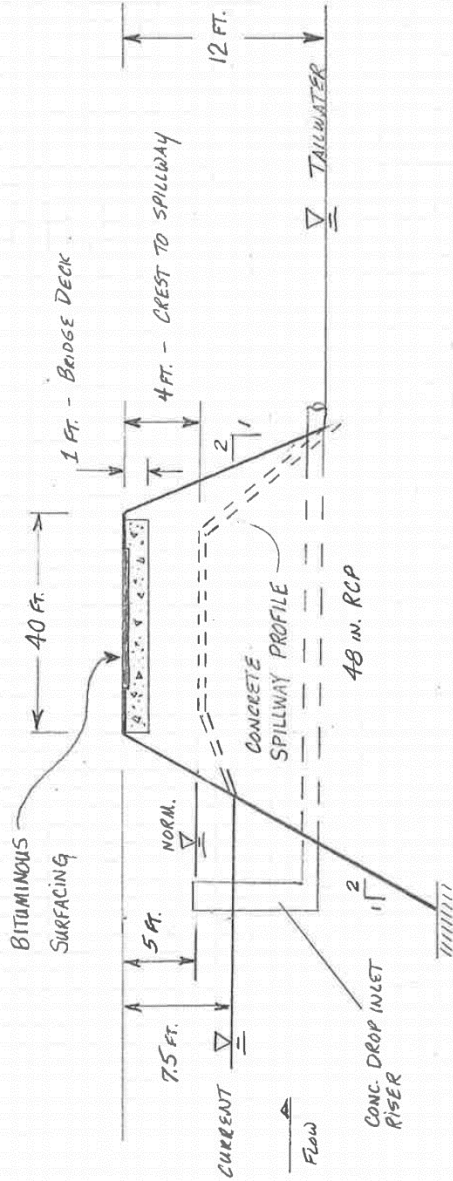
UPPER WINDSOR LAKE DAM

- NOTES:
- ROADWAY 1' BRIDGE OVER SPILLWAY ABANDONED
 - APPROX. 1-2 FT. OVERTOPPING EVIDENCE OBSERVED
 - SPILLWAY LENGTH = 44 FT.
 - OUTLET PIPE LOCATED BEYOND RIGHT ABUTMENT - OUTLET SUBMERGED
 - 48" RCP OUTLET SHOWN PER RECORDED DRAWINGS
 - ALL OTHER DATA SHOWN PER FIELD OBSERVATION / MEASUREMENTS / ESTIMATE

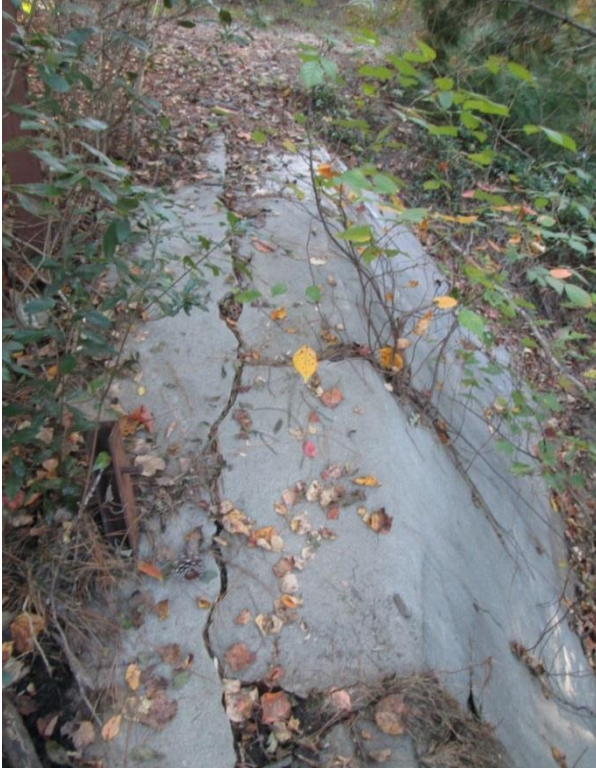
Photo 6: Auxiliary spillway lower masonry stone dam

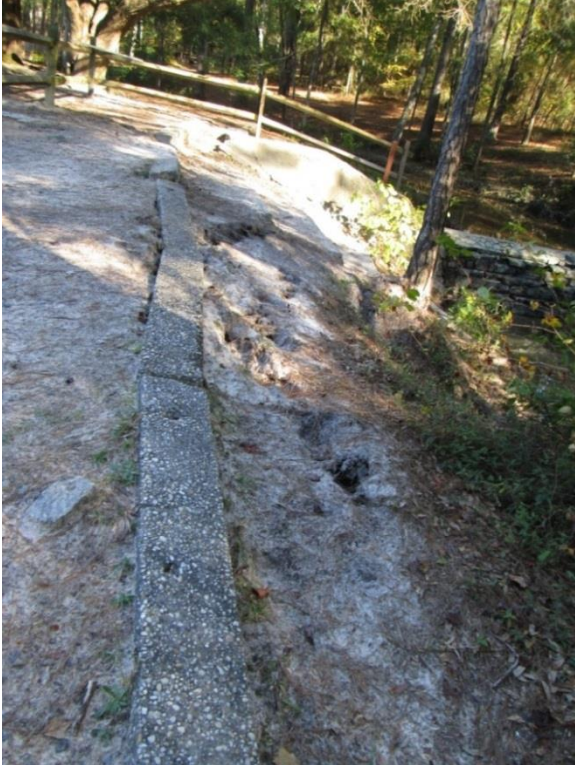
Photo 9: Vertical crack/slabbing in left abutment of lower stone dam

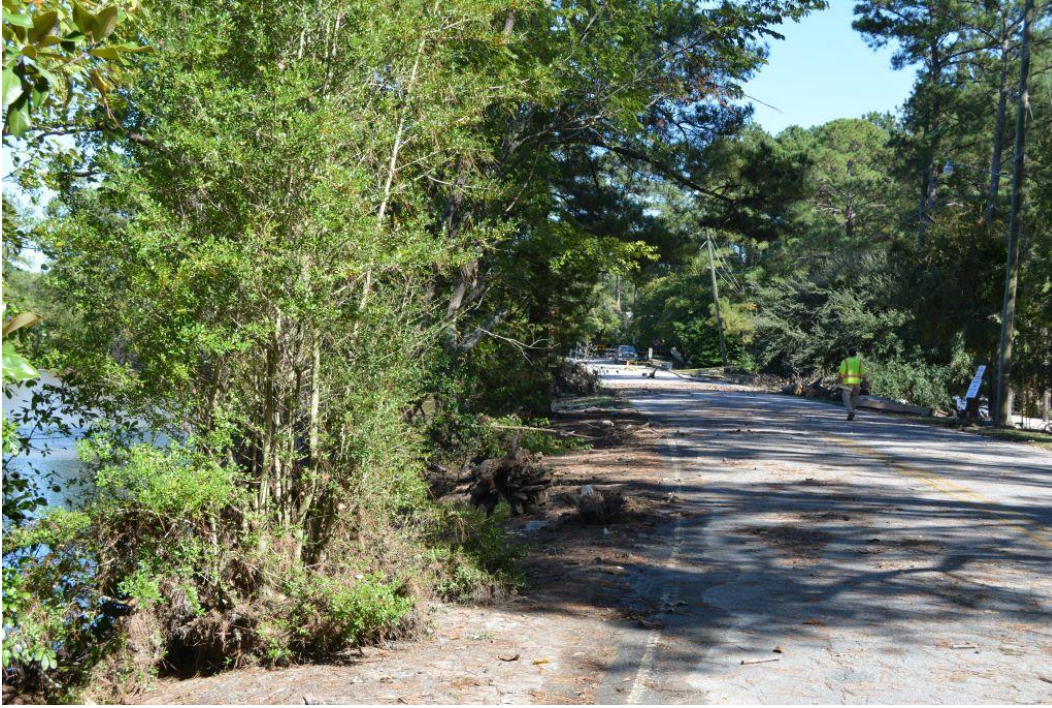
As discussed below in Section 3.3, the Spring Lake Dam is susceptible to further erosion if the flow is discharged through the auxiliary spillway before temporary repairs are completed. The auxiliary spillway activated by the 1-inch rain event at Wildewood Pond #1 Dam and Beaver Dam/Wildewood Pond #2 are excavated temporary emergency earth channels which may result in erosion and sedimentation downstream.

Photo 4: Auxiliary spillway damage

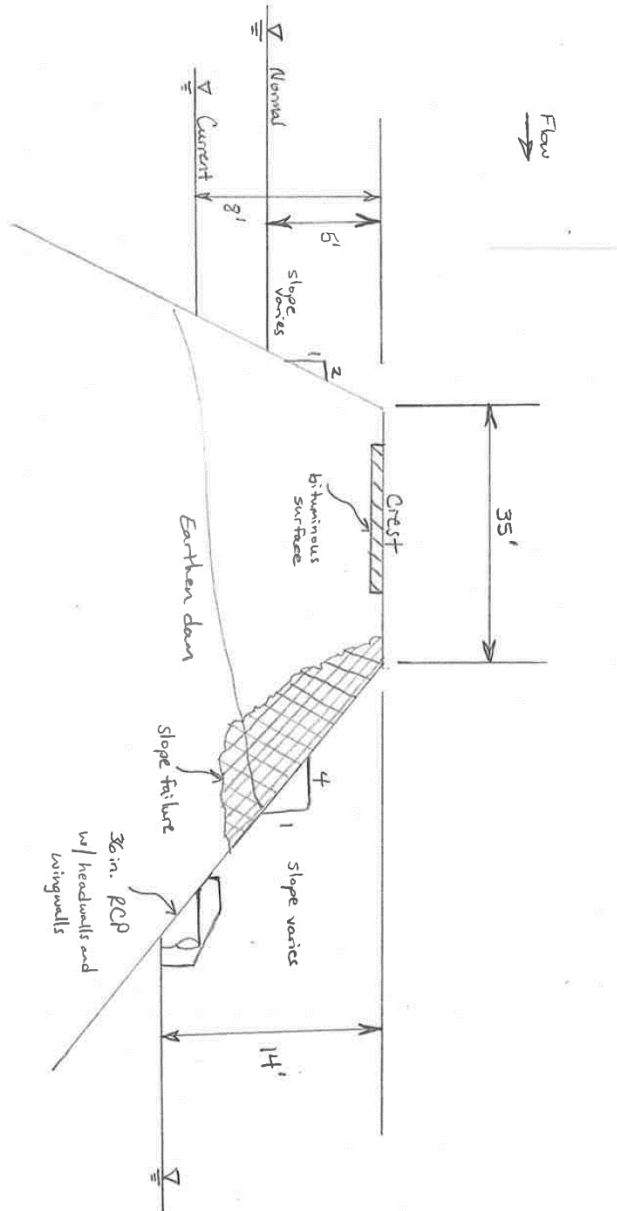
Project:	Spring Lake	Computed:	Date:
Subject:	Dam # 0025	Checked:	Date:
Task:		Page:	of:
Job #:		No:

- * Spillway is approximately 90' in length. (complete failure on DS end)
- * ALL DATA SHOWN PER FIELD OBSERVATION / MEASUREMENTS / ESTIMATE

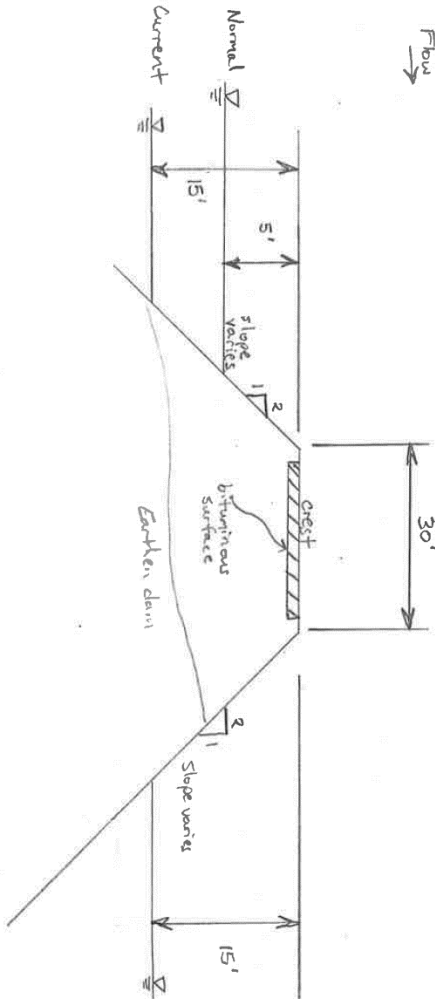
Project:	Rocky Ford Lake	Computed:	Date:
Subject:	Dam # 0028	Checked:	Date:
Task:		Page:	of:
Job #:		No:

Rocky Ford Lake (D 0028): The auxiliary spillway breached, and stream flow is conveyed through the resulting earth channel. Service spillway functionality is undetermined. The remaining earth channel, left earthen slope, and right embankment are susceptible to significant erosion from flow in the auxiliary spillway. This dam is considered to be of moderate concern due to susceptibility of erosion that could lead to further slope failure of the embankment. Runoff to Rocky Ford Lake Dam is from the large, unregulated, northeast portion of the Gills Creek Watershed, with only minimal attenuation of peak runoff flows from Upper Rocky Ford Lake located upstream.

- * Spillway is approximately 115' in length
 - * Dam, crest, and bridge failed
 - * Normal was measured from crest to a normal piece of spillway remaining
- * ALL DATA FROM PER FIELD OBSERVATION / MEASUREMENTS / ESTIMATE

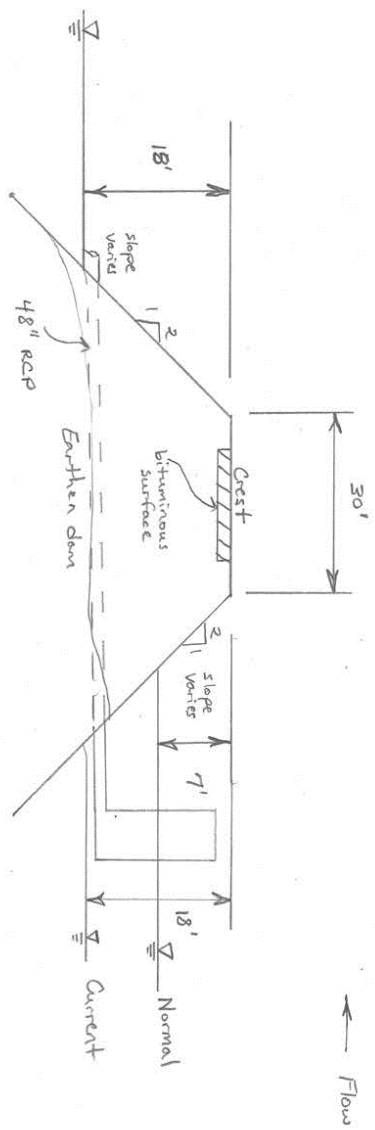
Project:	North Lake	Computed:	Date:
Subject:	Dam # 0029	Checked:	Date:
Task:		Page:	of:
Job #:		No:

Upper (North) Rocky Ford Lake (D 0029): The auxiliary spillway breached, and stream flow is conveyed through the resulting earth channel. Service spillway functionality is undetermined. The remaining earth channel and left and right embankment slopes are susceptible to significant erosion from river flow. This dam is considered to be of moderate concern due to susceptibility to erosion that could lead to further slope failure

- * Spillway is approximately 90' in length (failed)
- * Lake completely drained
- * Normal was measured from crest to existing piece of normal spillway remaining
- * ALL DATA SHOWN PER FIELD OBSERVATION / MEASUREMENTS / ESTIMATE

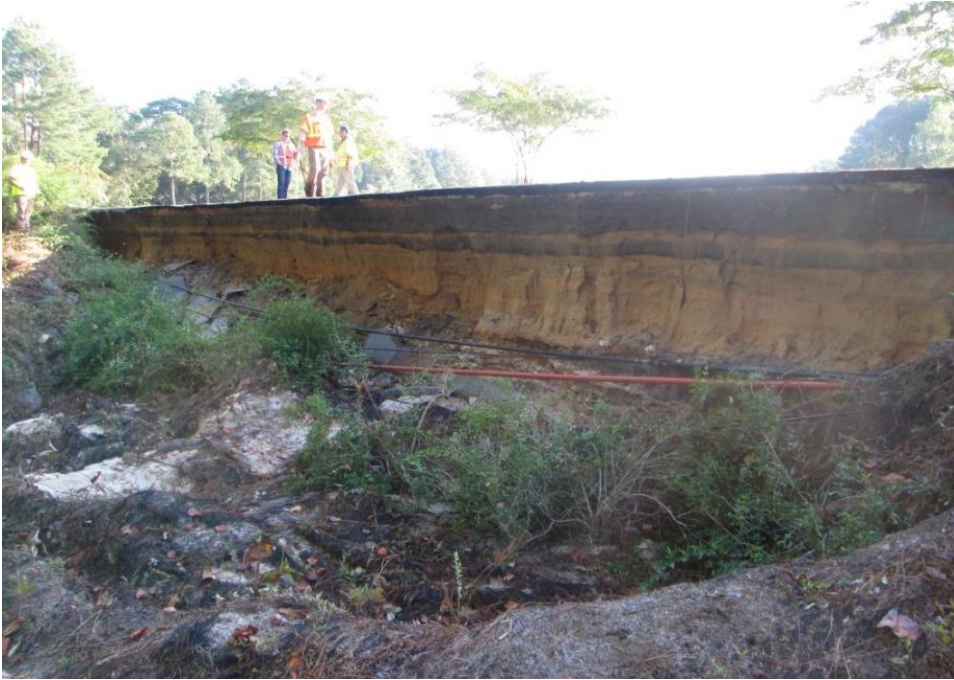
Photo 2: Upstream embankment slope slough

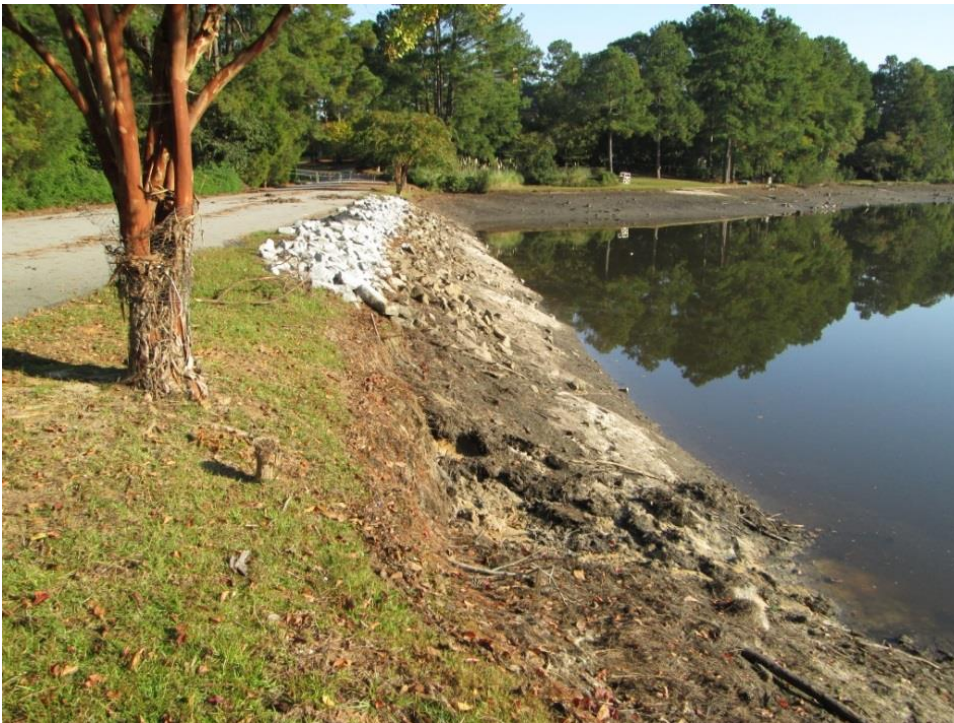
Photo 3: Downstream embankment slope failure along alignment of service spillway low-level outlet

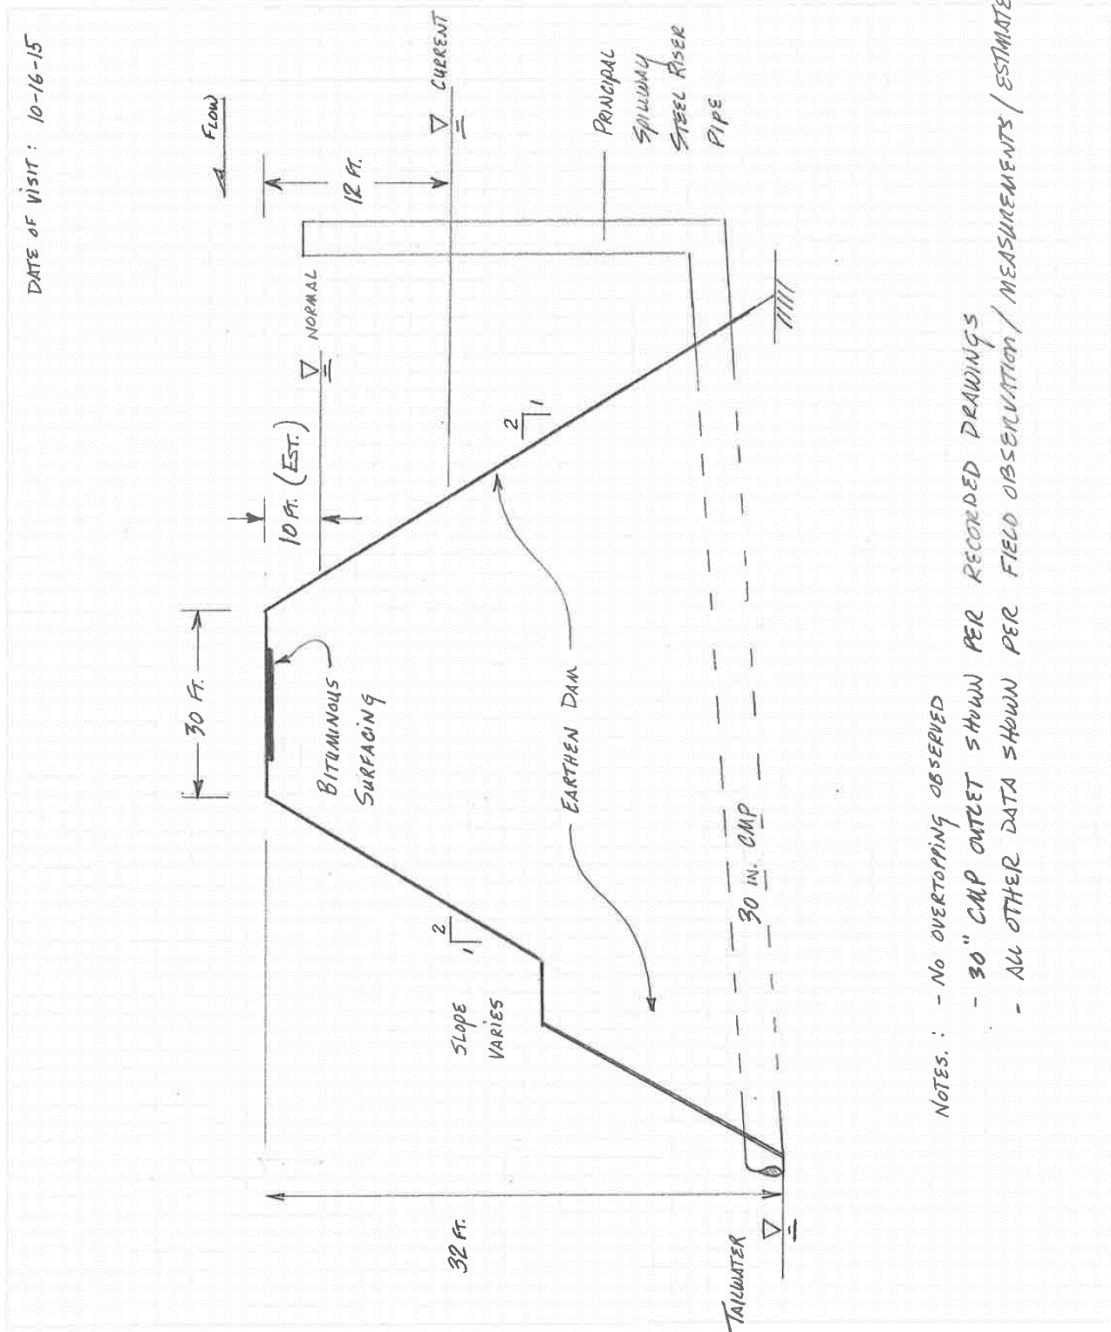
Project:	WILDEWOOD # 3	Computed:	BWL	Date:	10-19-15
Subject:	DAM # D0567	Checked:		Date:	
Task:		Page:		of:	
Job #:		No:

NOTES: - No OVERTOPPING OBSERVED
 - 30" CMP OUTLET SHOWN PER RECORDED DRAWINGS
 - ALL OTHER DATA SHOWN PER FIELD OBSERVATION / MEASUREMENTS / ESTIMATE

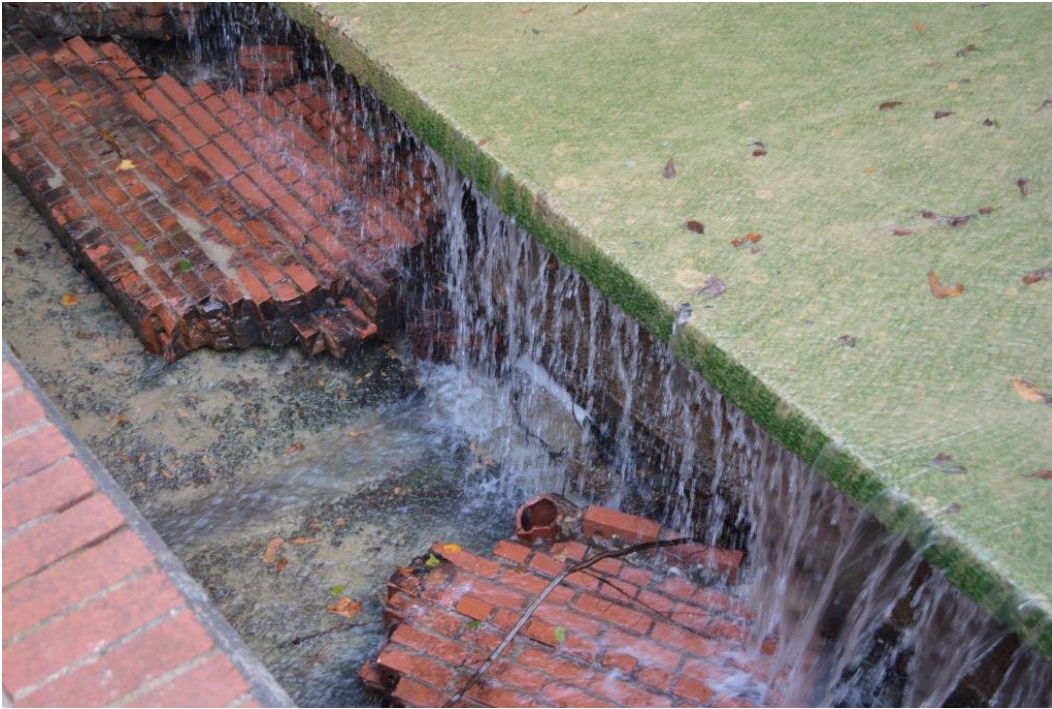
Photo 9: Auxiliary spillway with debris

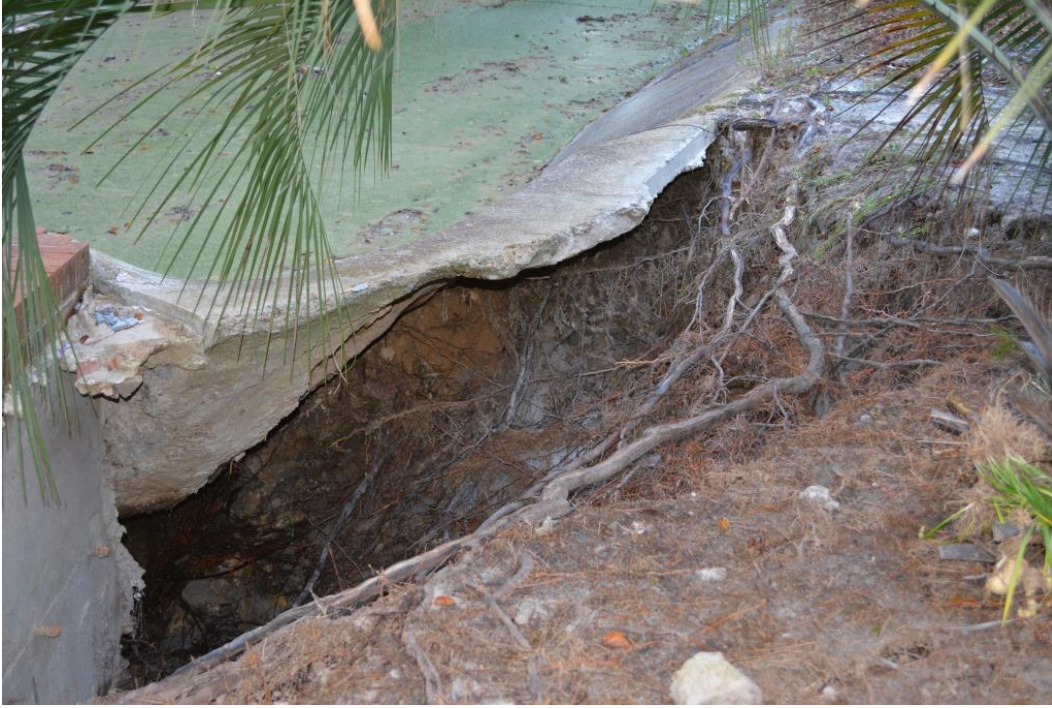
Photo 10: Damage at downstream end of auxiliary spillway

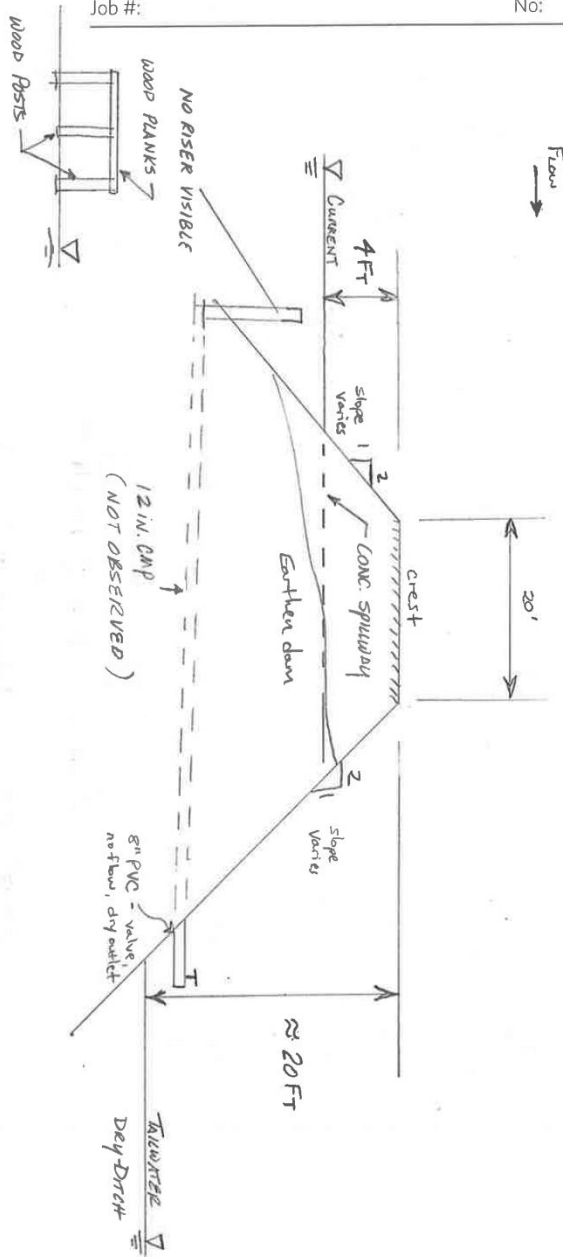
Project:	Entrance Lake	Computed:	Date:
Subject:	Dam # 0450	Checked:	Date:
Task:		Page:	of:
Job #:		No:

* OBSERVED 2" IRRIGATION PIPE OUTLET w/ SHUT-OFF VALVE
 * ALL DATA SHOWN PER FIELD OBSERVATION / MEASUREMENTS / ESTIMATE

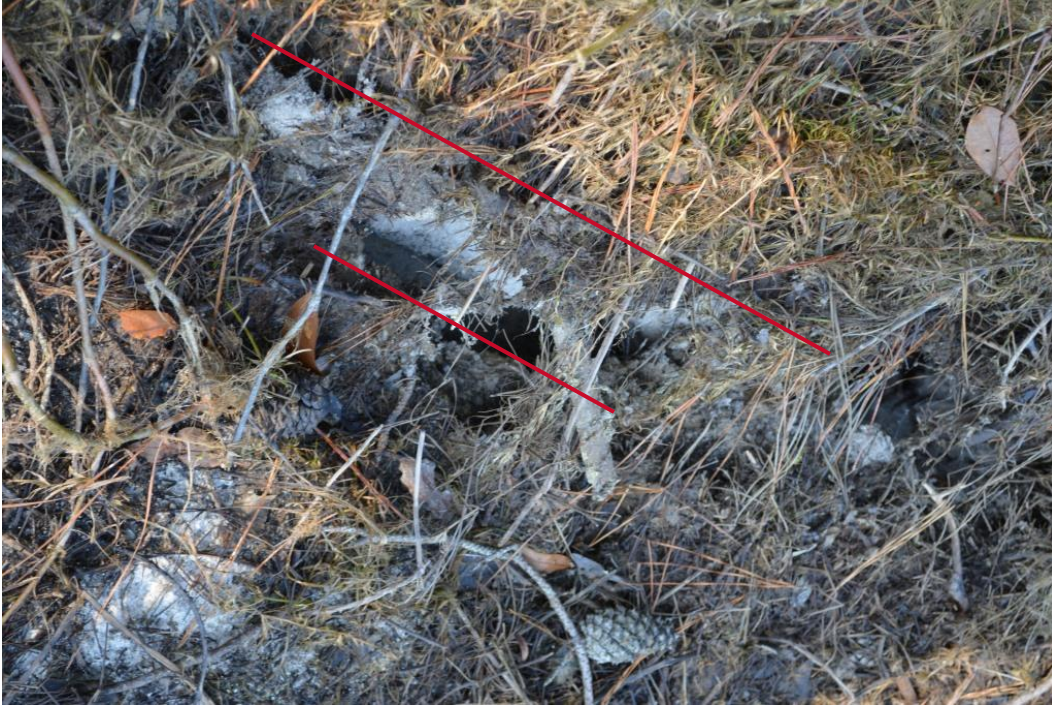
Pine Springs Lake Complex 2 (D 0561): The upstream slope of the embankment has significant sloughs and cracks above the service spillway outlet pipe alignment. Since

Photo 4: Upstream embankment slope failure

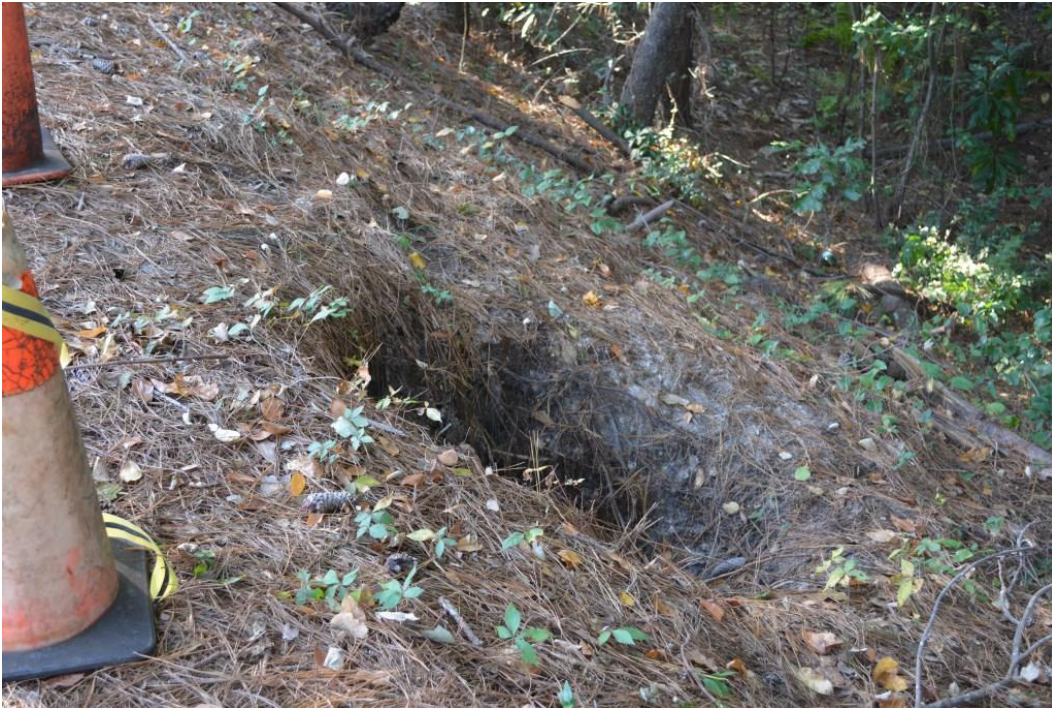
Photo 7: Upstream slope failure along service spillway alignment

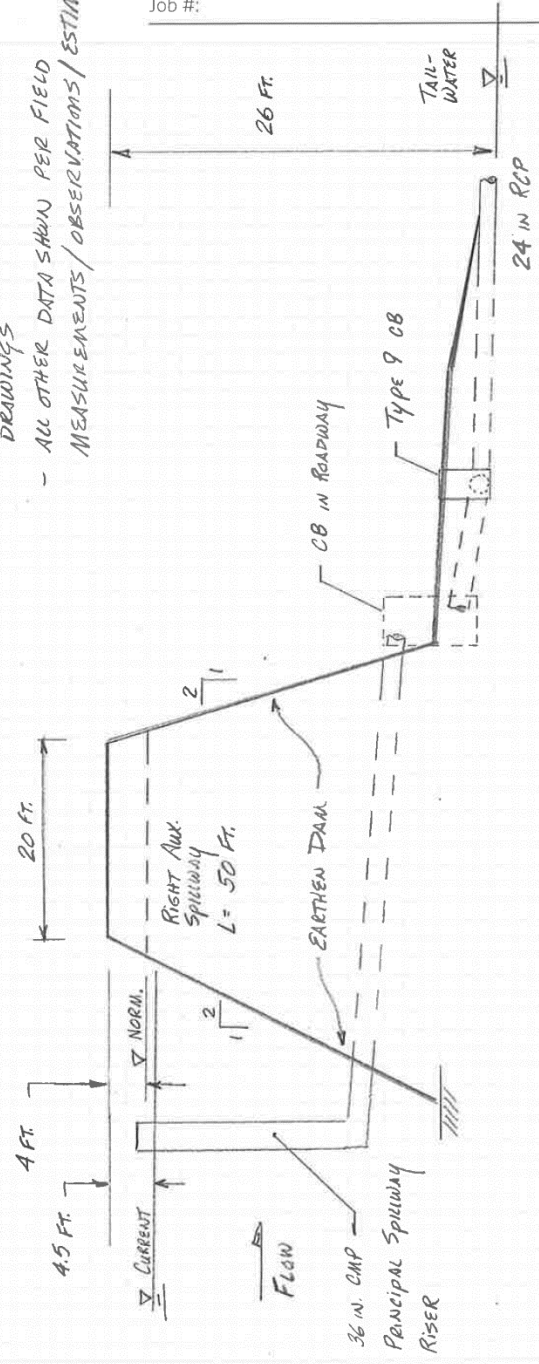
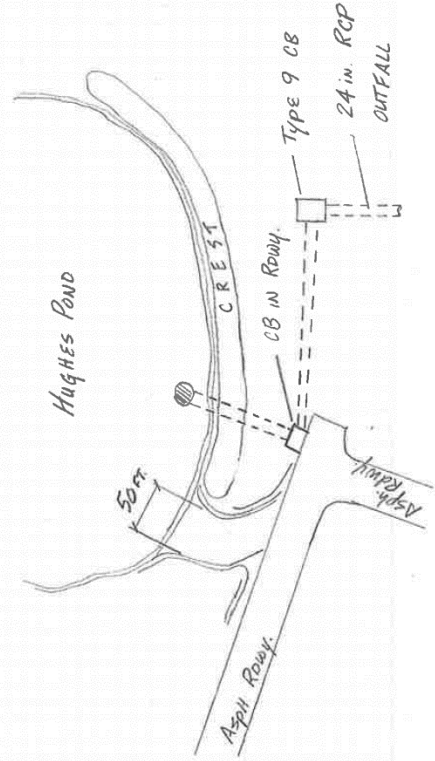
- NOTES: - NO OVERTOPPING OBSERVED
 - RISER DIMENSIONS PER RECORDED DRAWINGS
 - ALL OTHER DATA SHOWN PER FIELD MEASUREMENTS/OBSERVATIONS/ESTIMATE

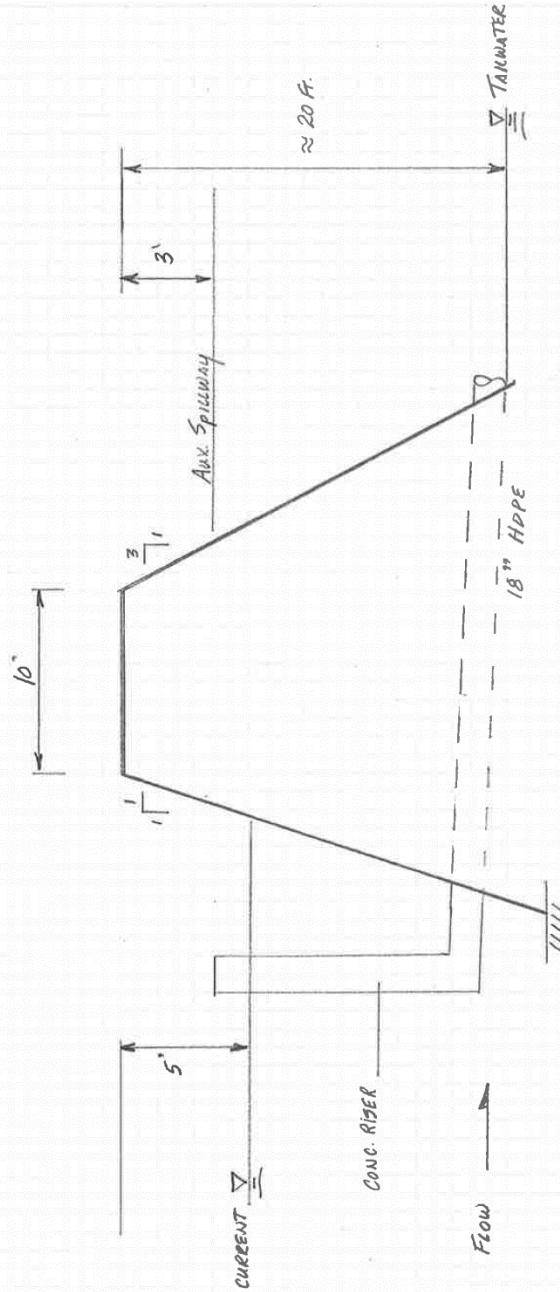
- NOTES :-
- NORMAL WATER LEVEL OBSERVED TO BE ABOUT 6 IN. ABOVE CURRENT LEVEL
 - Aux. Spillway L = 12 FT.
 - HIGH WATER MARK UP TO CREST, BUT NO OVERTOPPING
 - ALL DATA SHOWN PER FIELD OBSERVATION / MEASUREMENTS / ESTIMATE

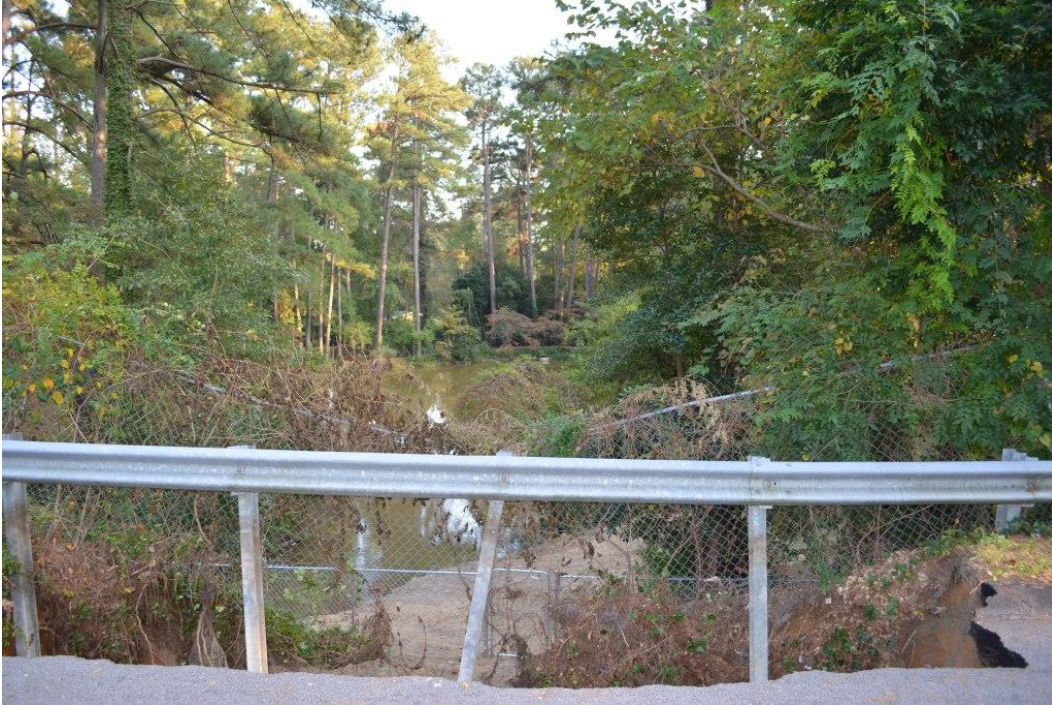
Photo 4: Slope failure on downstream slope of embankment

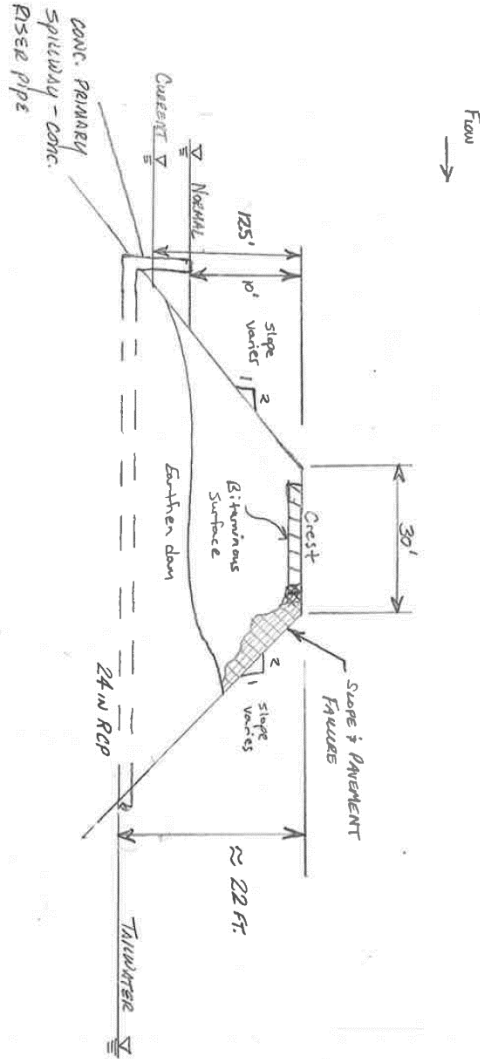
Project:	Arcadia Woods Lake	Computed:	Date:
Subject:	Dam # 0557	Checked:	Date:
Task:		Page:	of:
Job #:		No:

* HIGH WATER MARKS INDICATE Dam overtopped but owner reported no overtopping (downstream)

* Evidence of failed section of the crest
