Gills Creek Watershed: Assessment of Regulated Dams

February 15, 2016

PROJECT NAME: Gills Creek Watershed Assessment of Regulated Dams Report

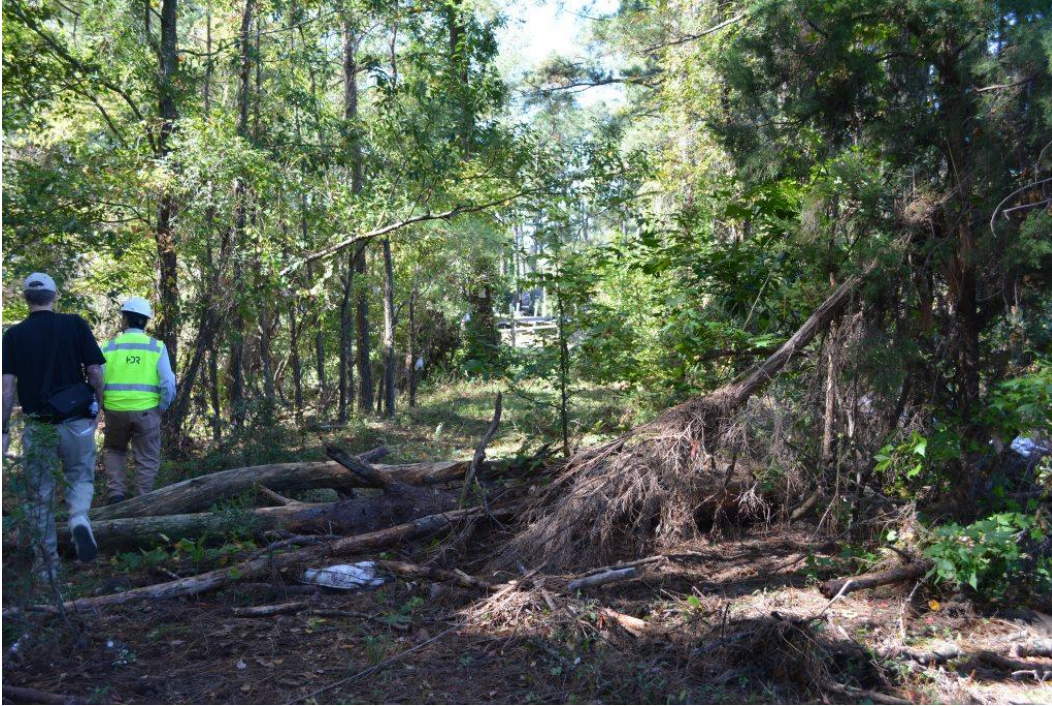
Photo 3: Right embankment crest looking toward right abutment showing tree growth on upstream and downstream slopes

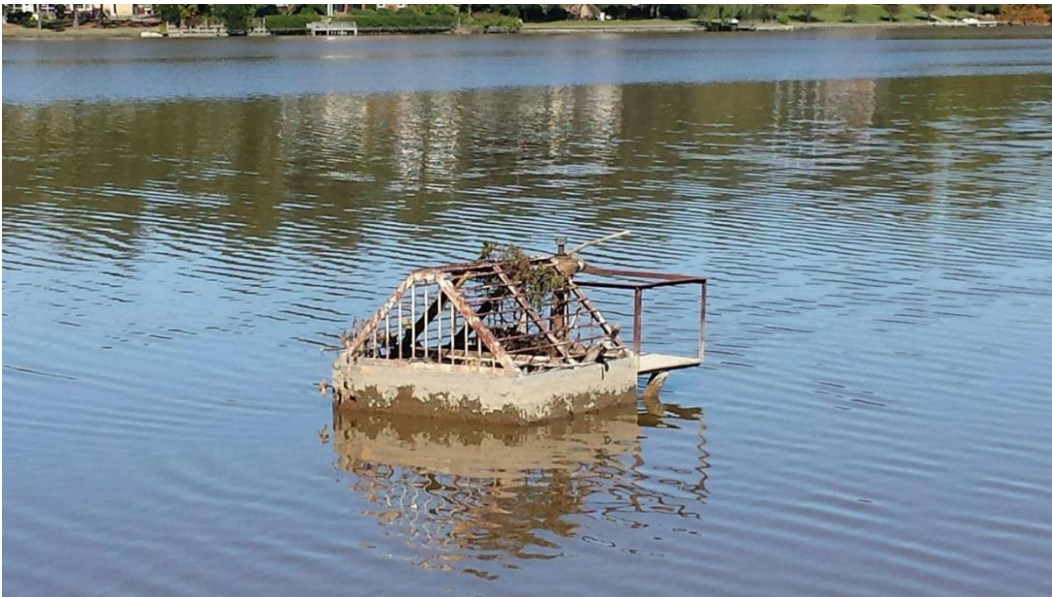
Photo 4: Service spillway concrete riser intake upstream of concrete/rockfill spillway

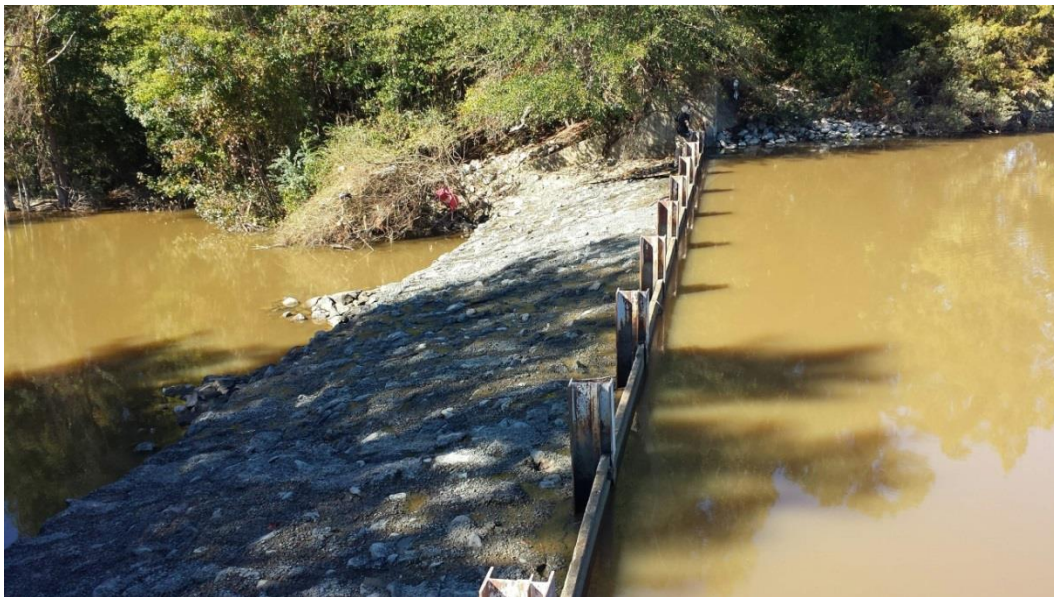
Photo 6: Concrete/rockfill overflow spillway with flashboards

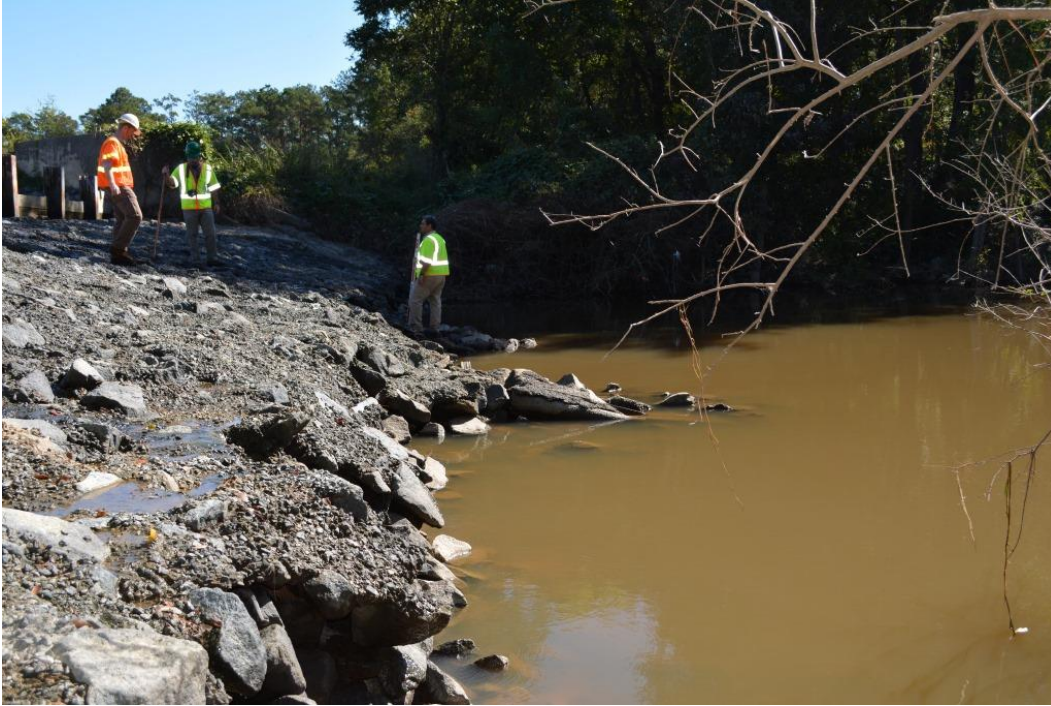
Photo 7: Toe of concrete/rockfill overflow spillway; outlet pipe of service spillway submerged at toe of spillway

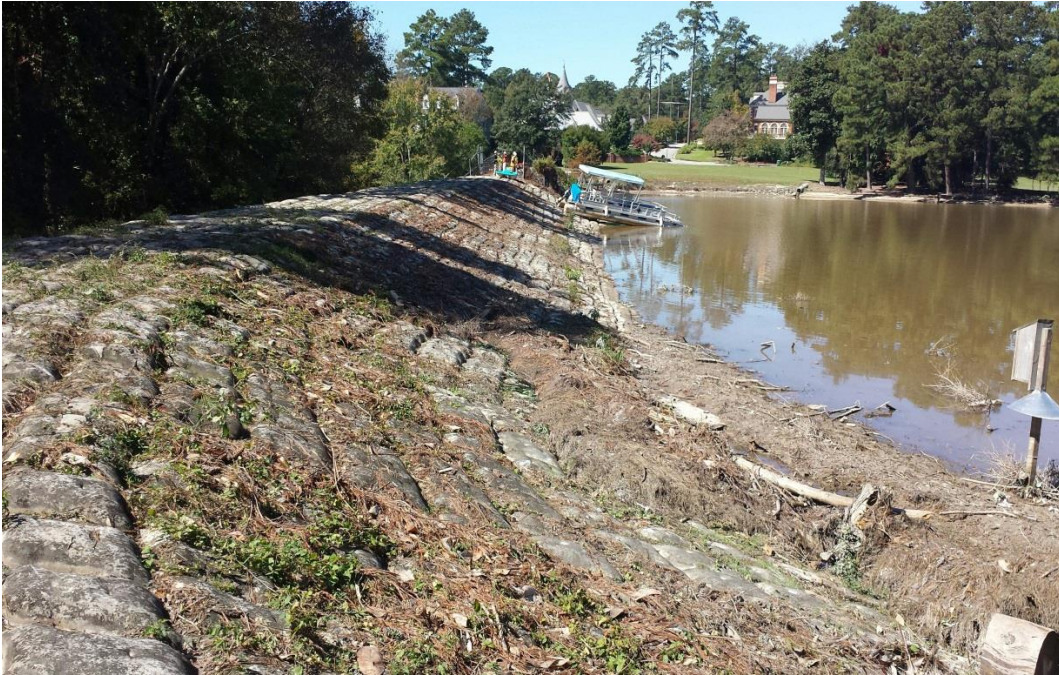
Photo 1: View of crest and upstream slope of armored left embankment dam looking from the left abutment

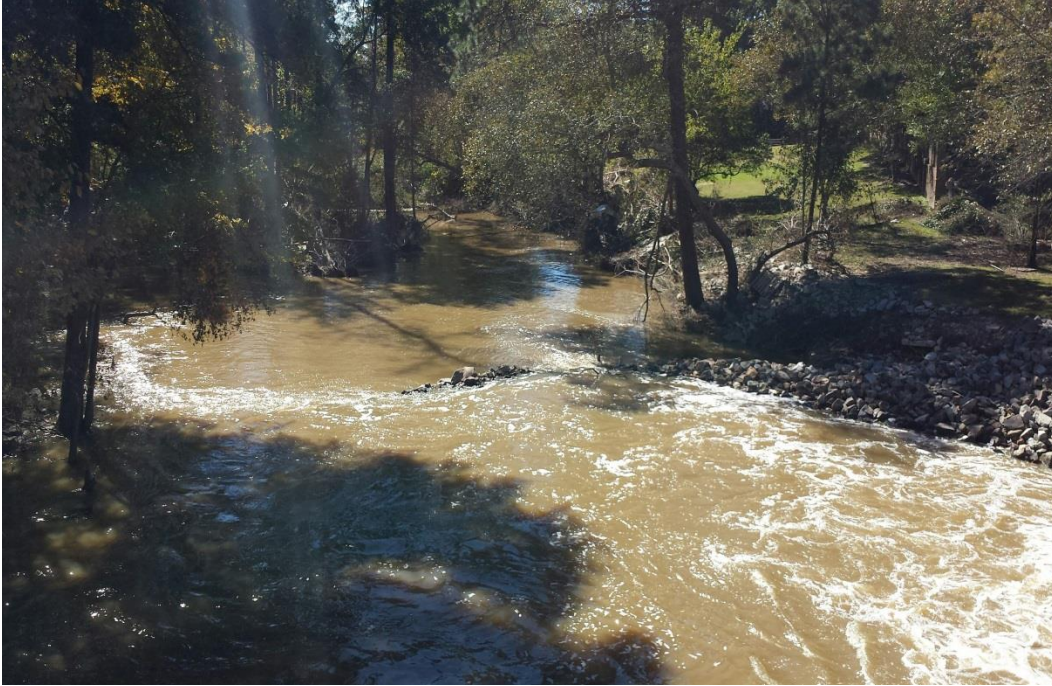
Photo 3: View of downstream channel with rock deposition and riprap on right bank

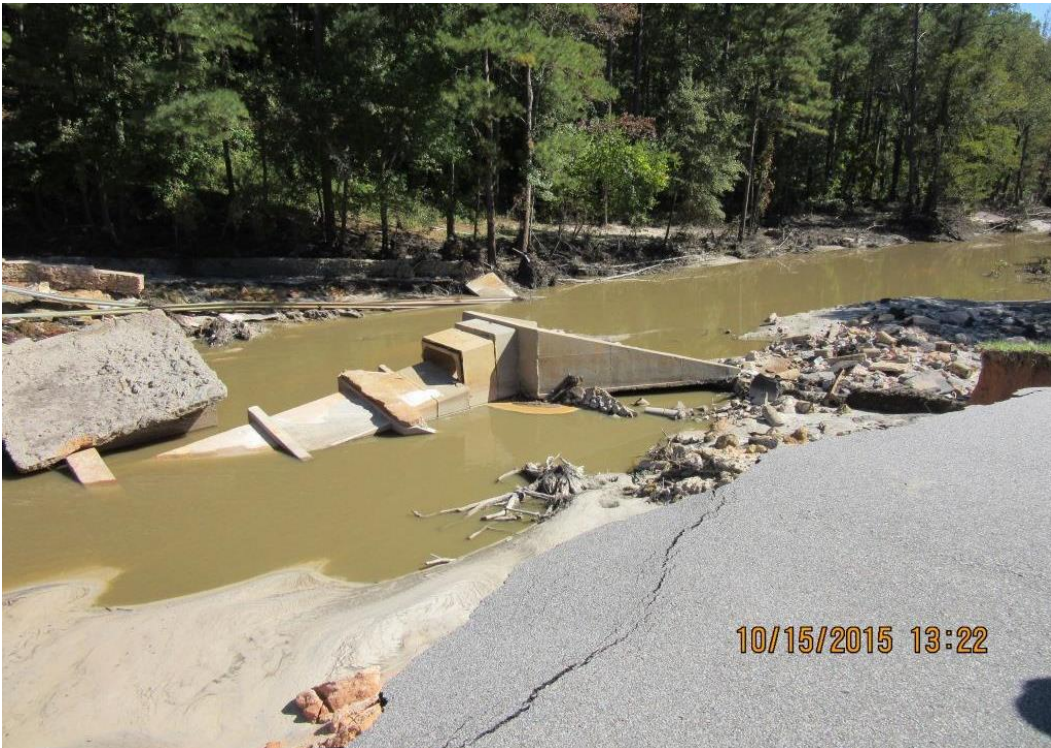
Photo 2: Remnants of low-level outlet concrete box culvert and discharge structure.

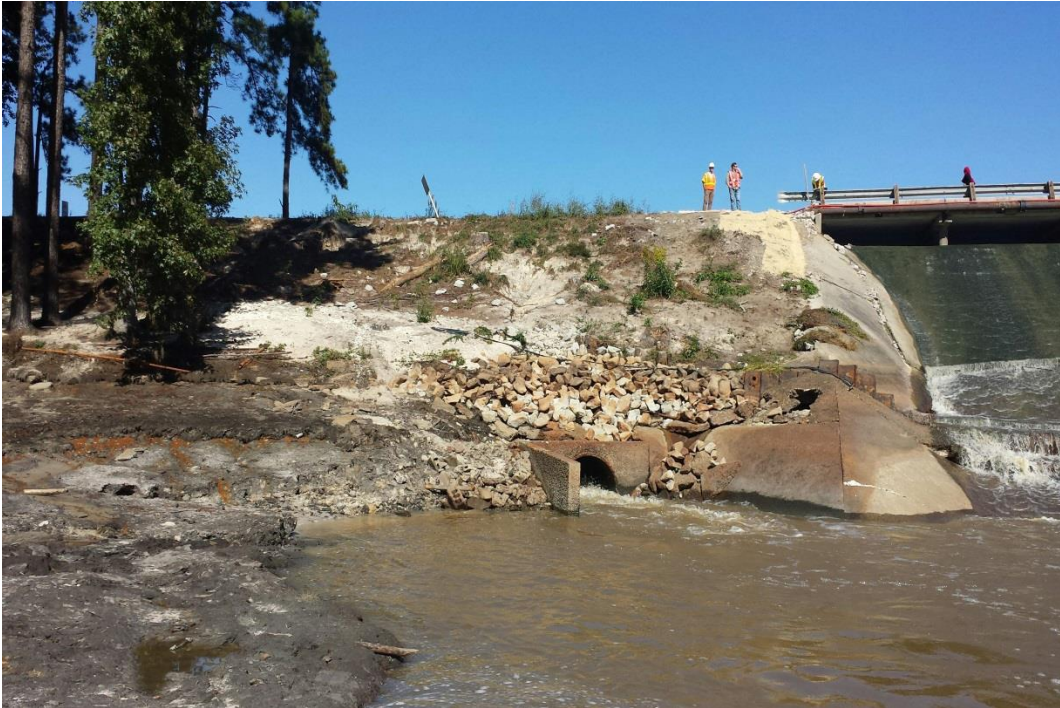
Photo 1: View of downstream slope of right embankment; note the void in concrete near the toe of the auxiliary spillway, and jute mat located adjacent to the bridge to stabilize an eroded area

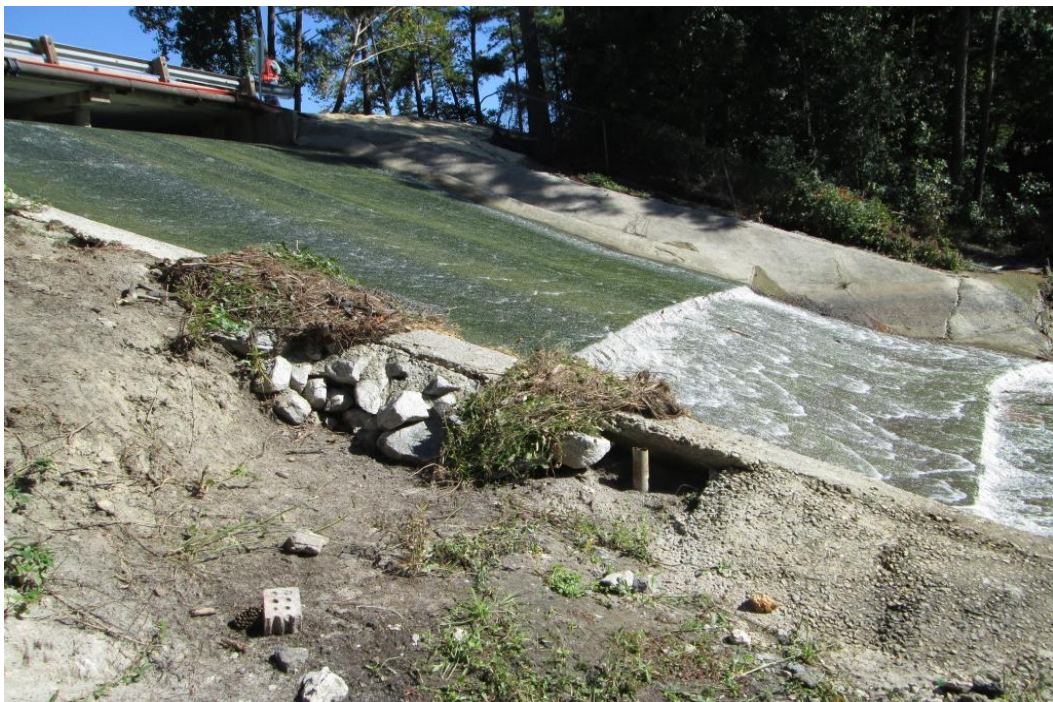
Photo 6: Eroded/filled areas along right side of auxiliary spillway channel

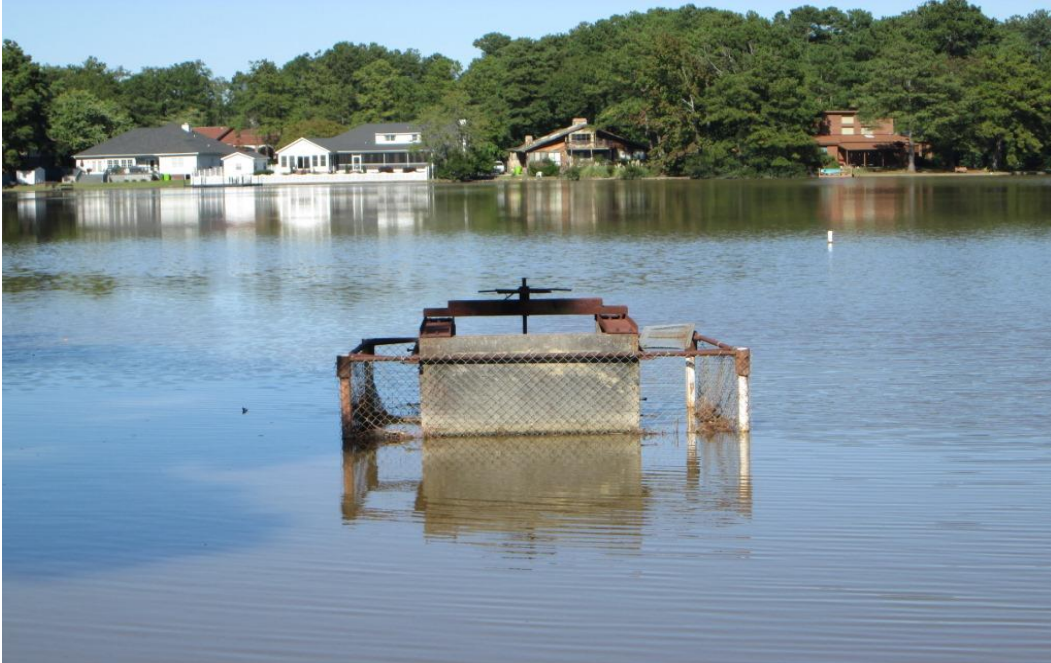
The service spillway is a low-level outlet (48-in. RCP) controlled by a concrete drop inlet located approximately 60 feet upstream of the dam. The inlet has a trash screen that appeared relatively free of debris (Photo 9). The outlet discharge is located to the right of the auxiliary spillway (Photo 10). Standing water with red coloration was observed at the headwall of the outlet structure, indicating potential seepage.

Photo 9: Service spillway drop inlet structure

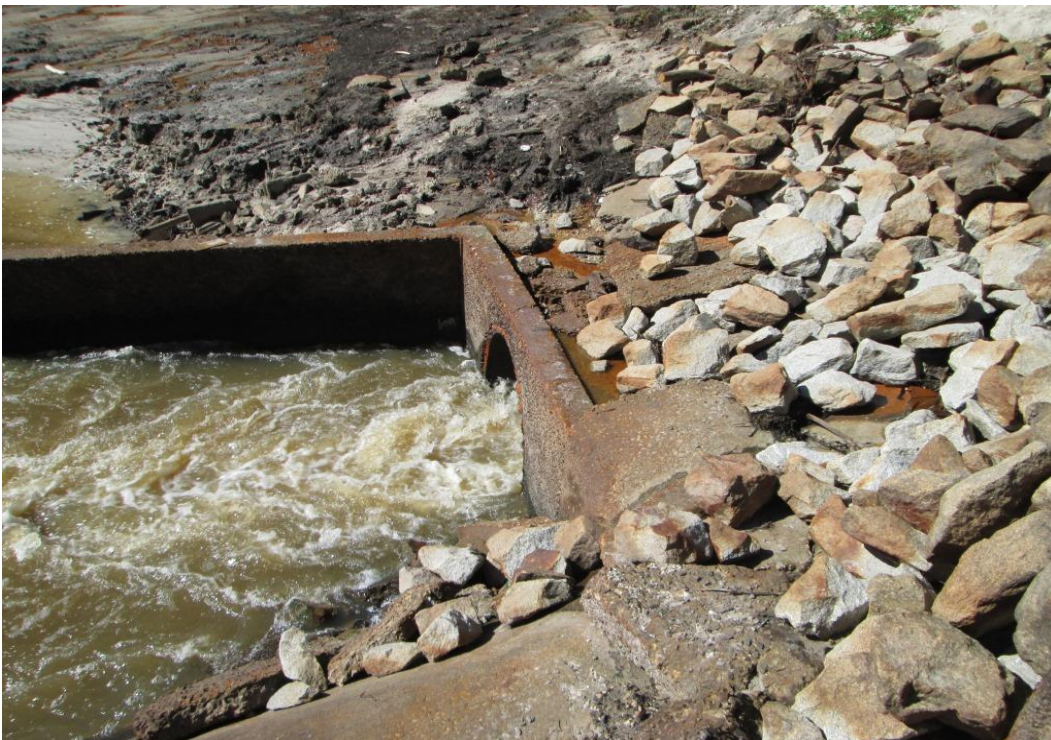
Photo 10: Low-level outlet structure; note discolored water just above the headwall

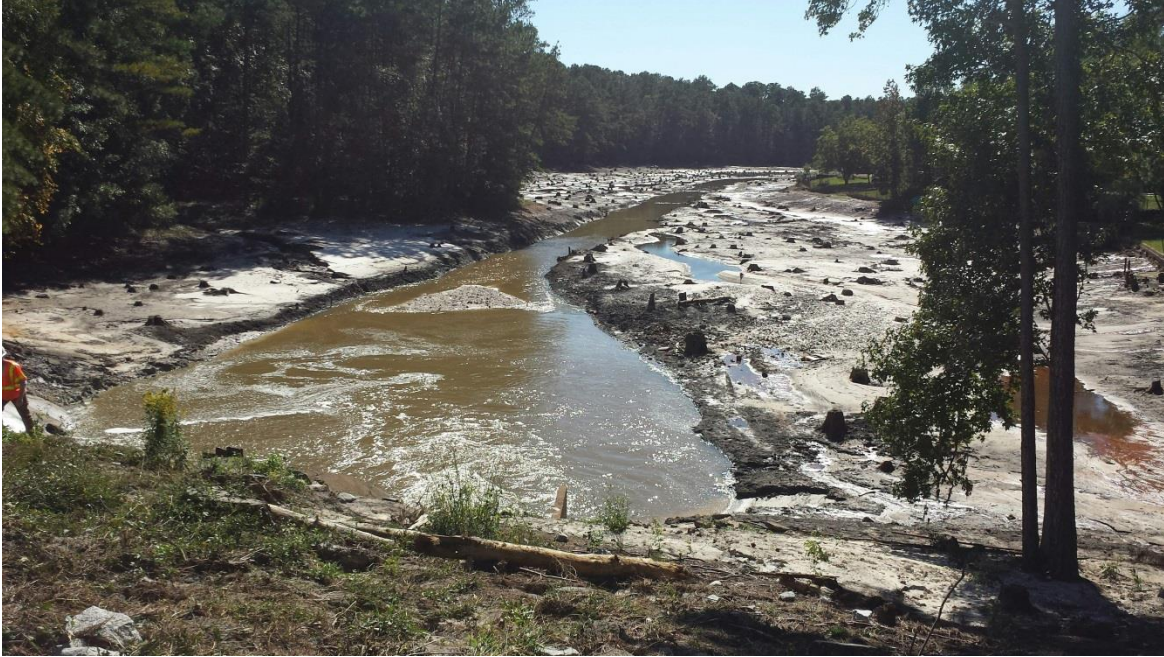
Photo 11: View looking downstream of the dam (Pine Tree Dam, an unregulated dam that breached, is located downstream beyond the bend).

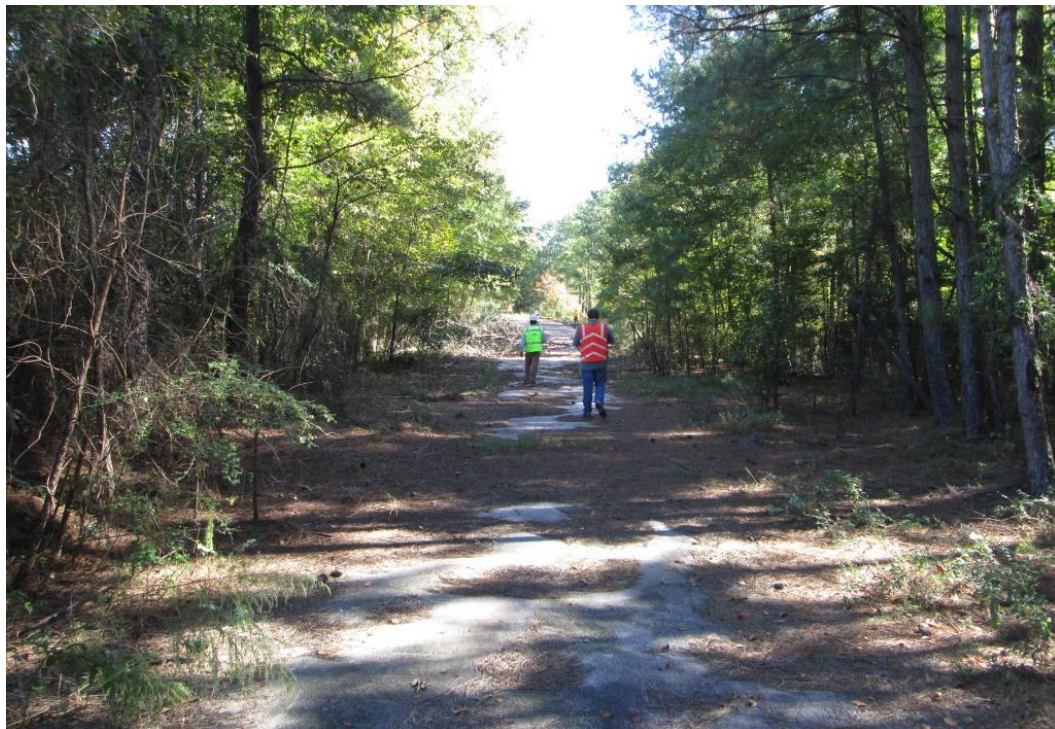
Photo 1: Crest of embankment dam looking toward the left abutment. Note mature trees and thick underbrush on embankment slopes.

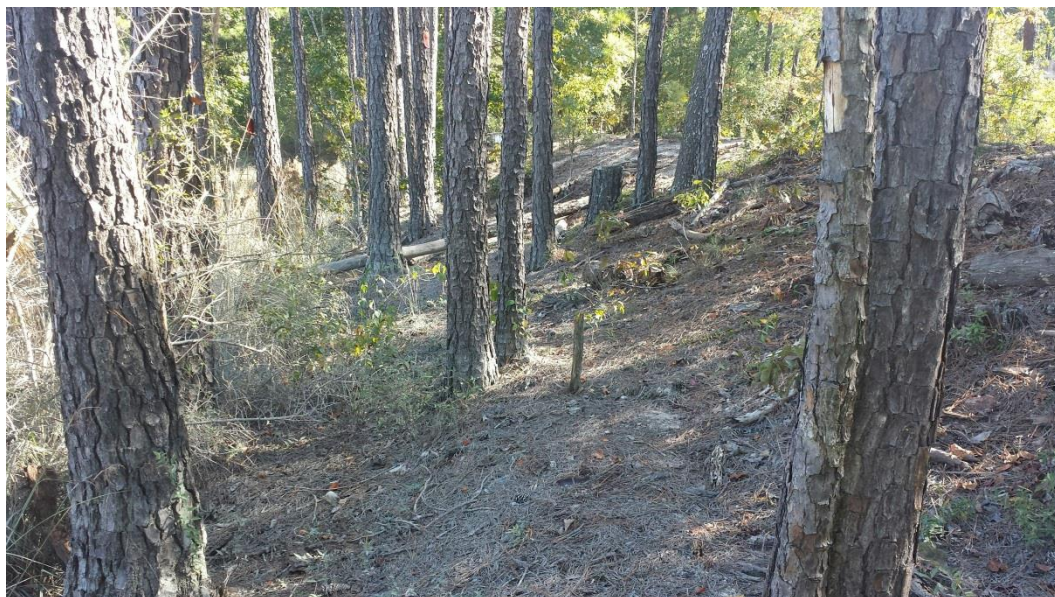
Photo 2: Tree growth on upstream embankment slope

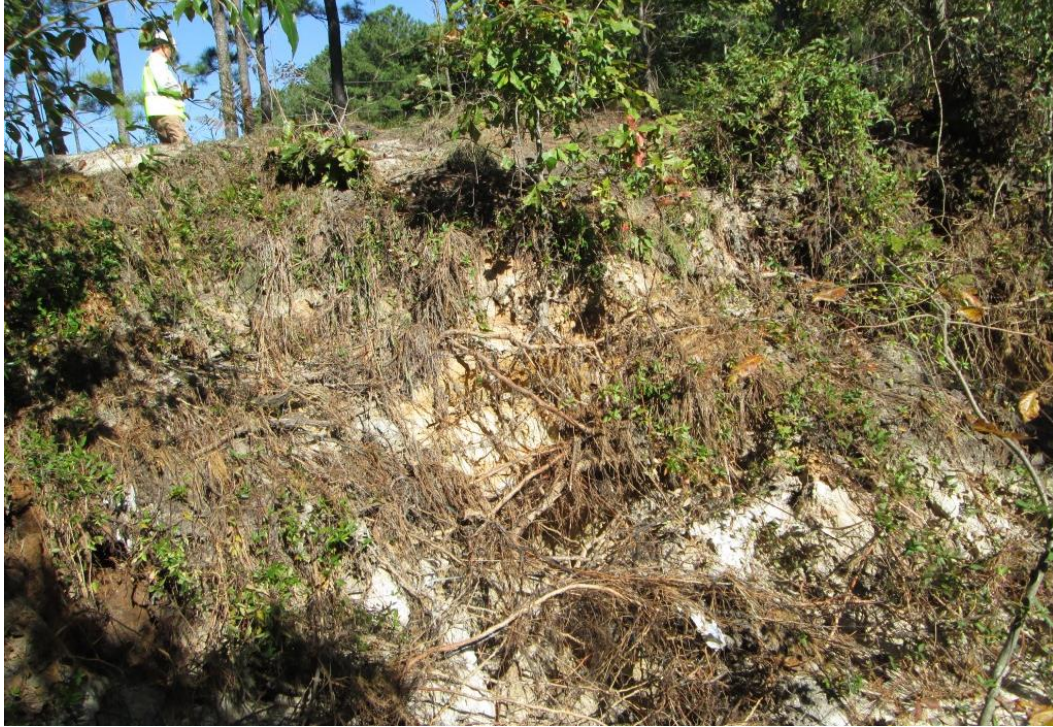
Photo 3: Significant erosion and undercutting of downstream slope of embankment resulting in a near-vertical slope maintained by root systems.

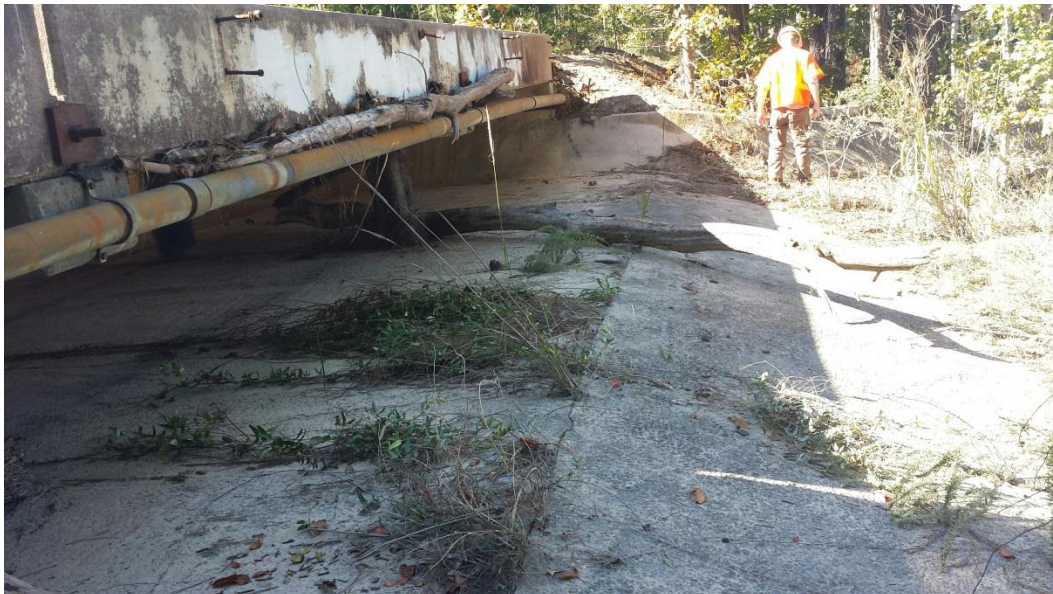
Photo 6: Auxiliary spillway crest looking toward the right abutment

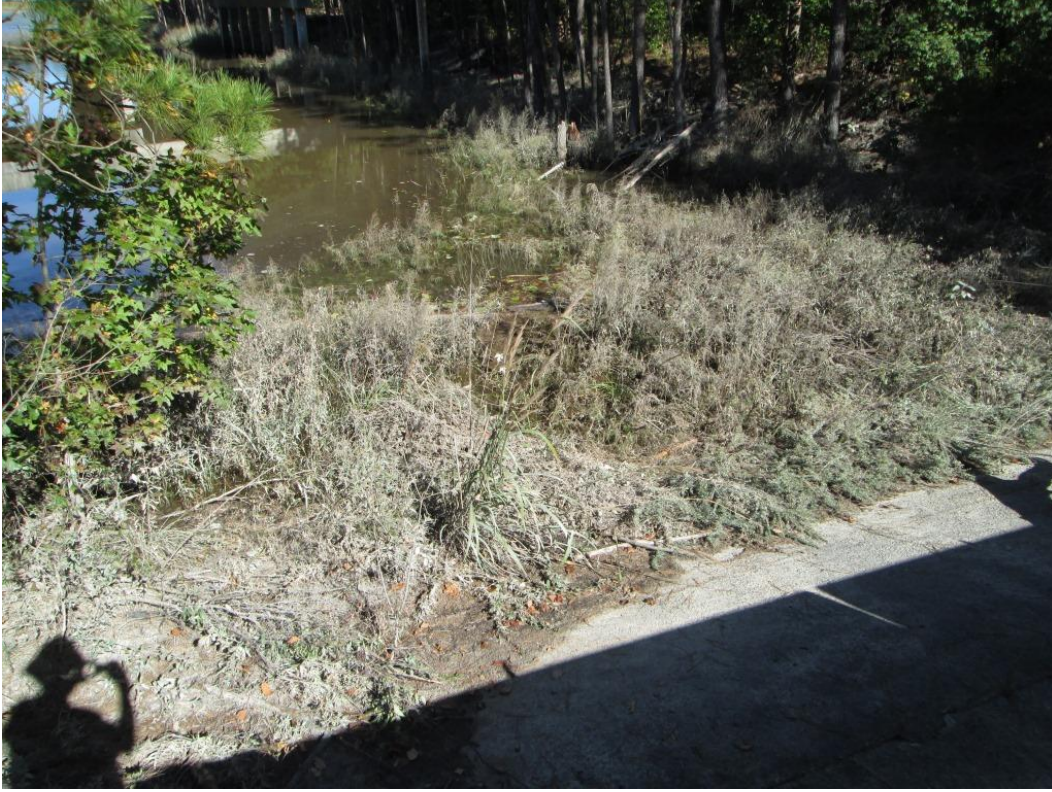
Photo 8: Area upstream of auxiliary spillway

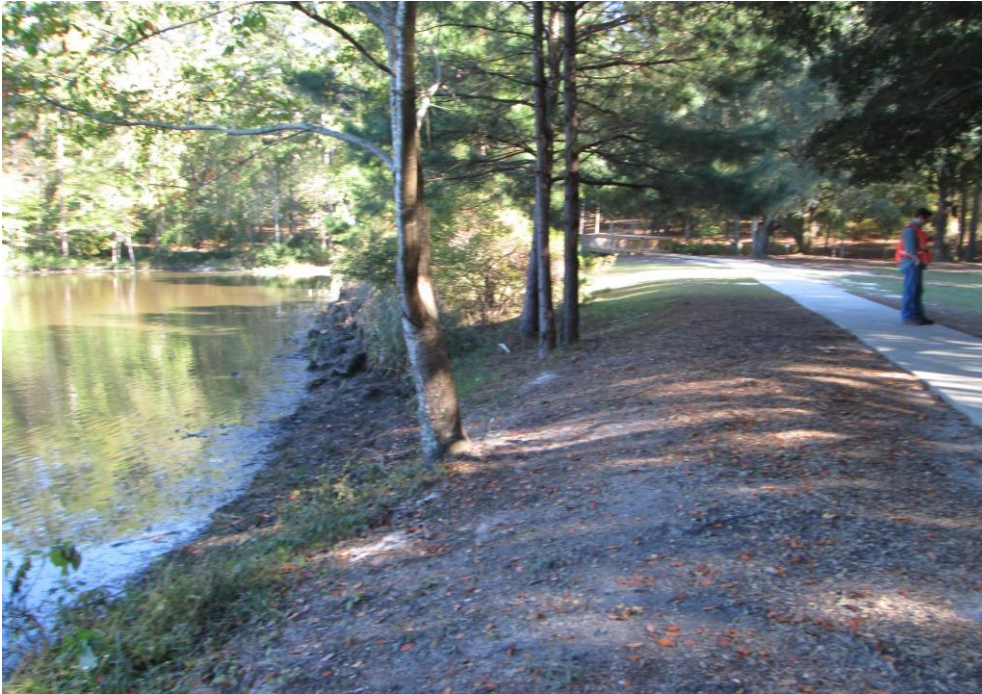
Photo 1: Embankment dam upstream slope and crest with concrete sidewalk

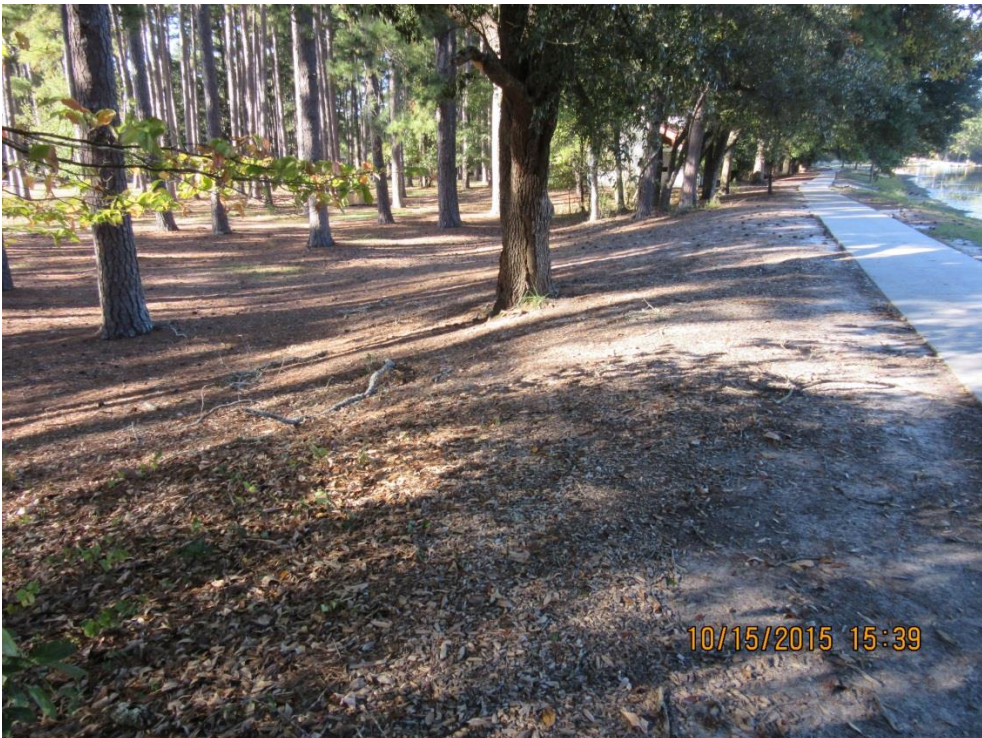
Photo 2: Embankment dam downstream slope and crest with concrete sidewalk

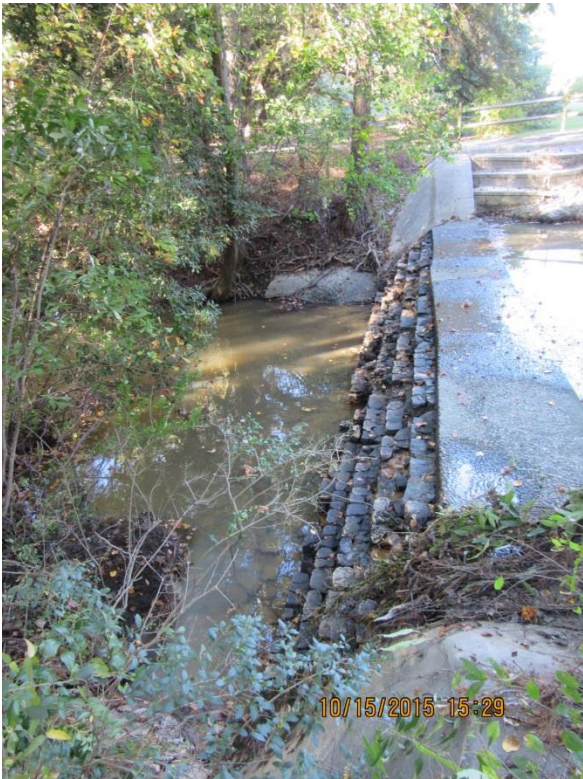
Photo 6: Auxiliary spillway lower masonry stone dam

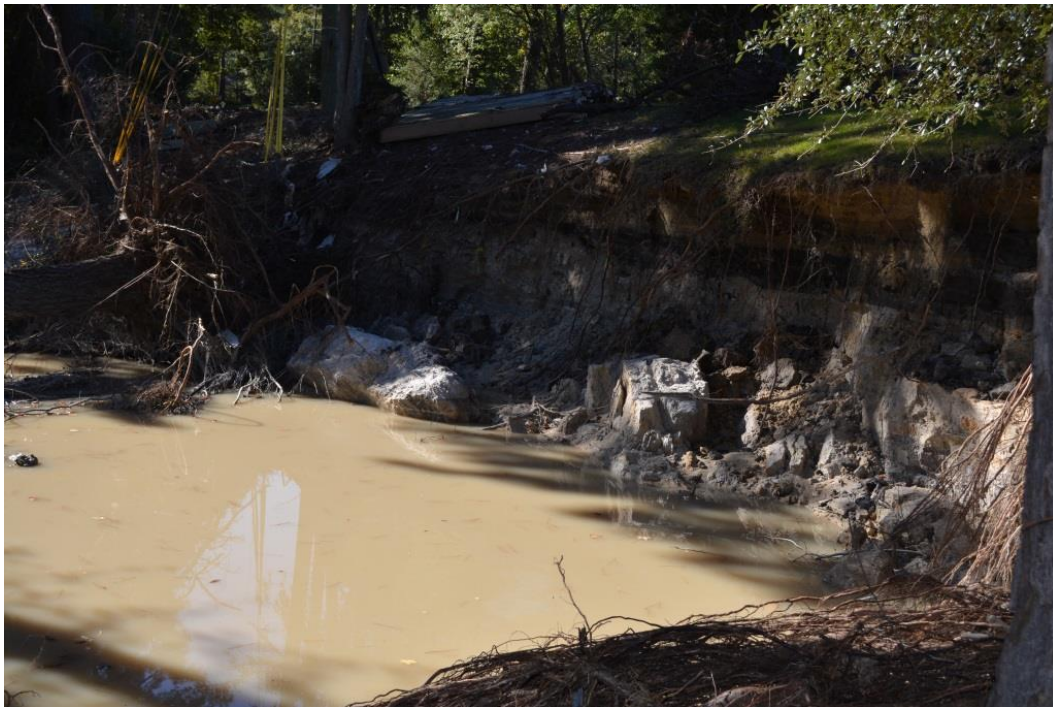
Photo 2: Eroded downstream face of embankment dam

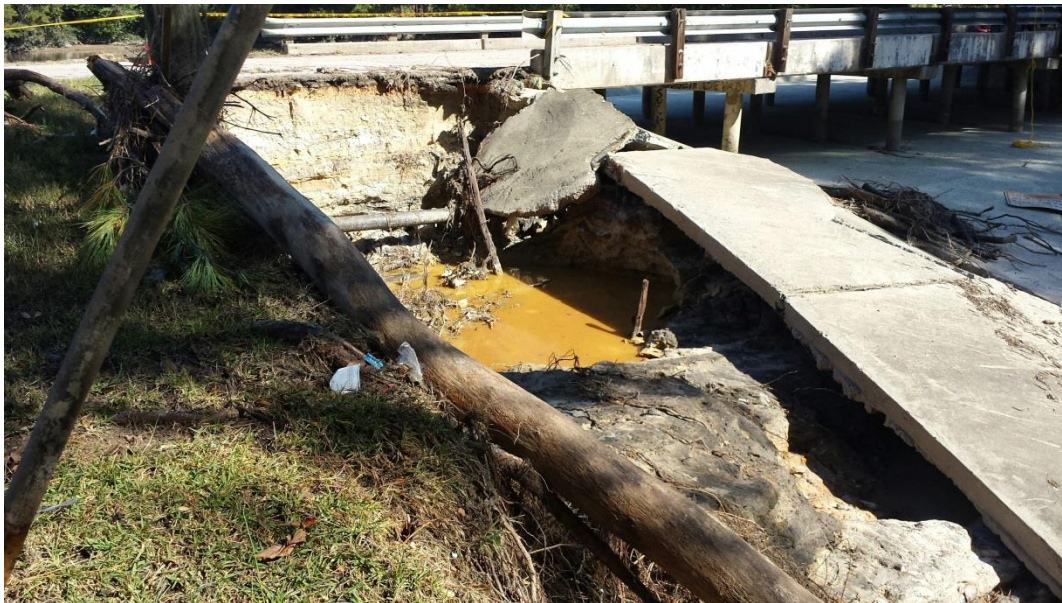
Photo 8: Erosion of concrete of auxiliary spillway adjacent to embankment

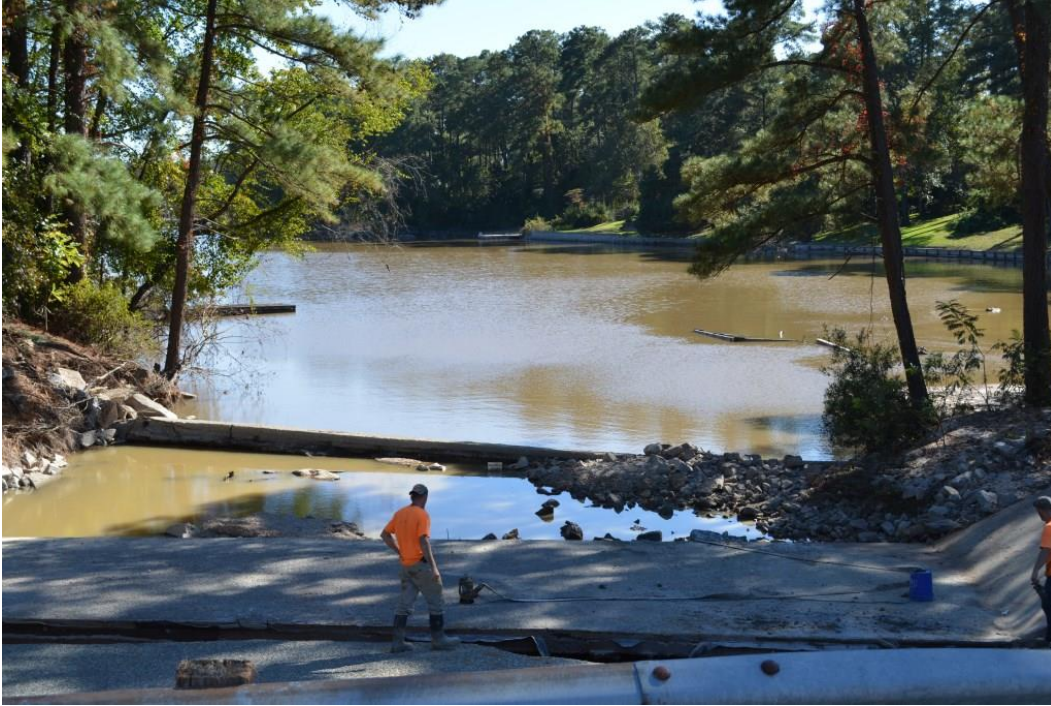
Photo 9: Downstream view from bridge over auxiliary spillway

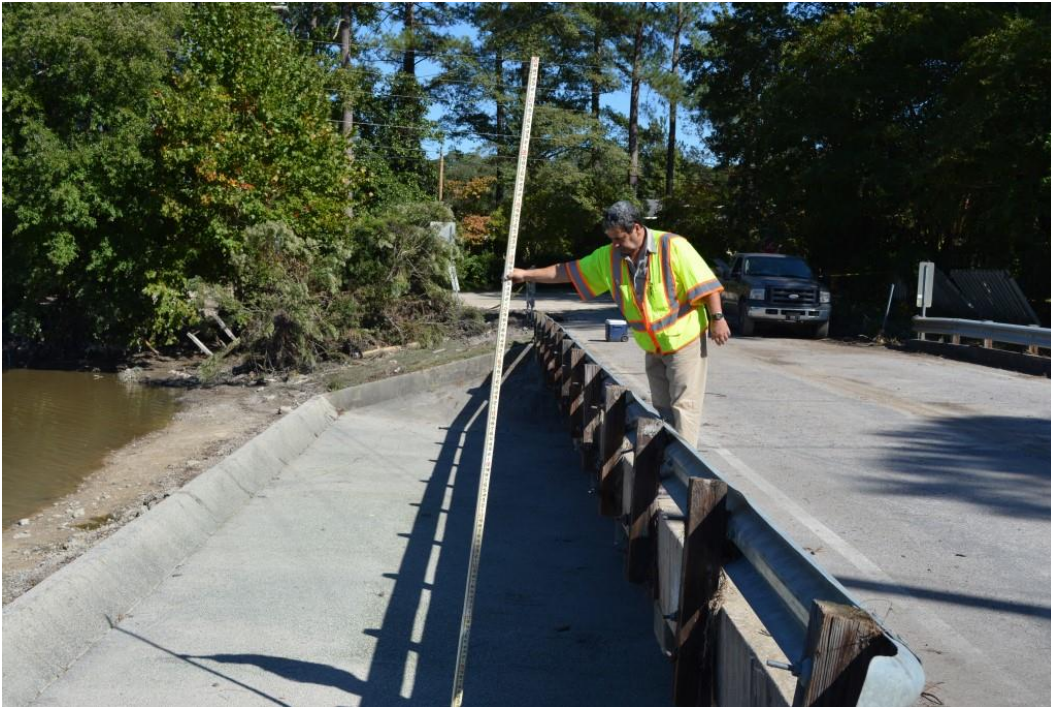
Photo 10: View of auxiliary spillway upstream of bridge

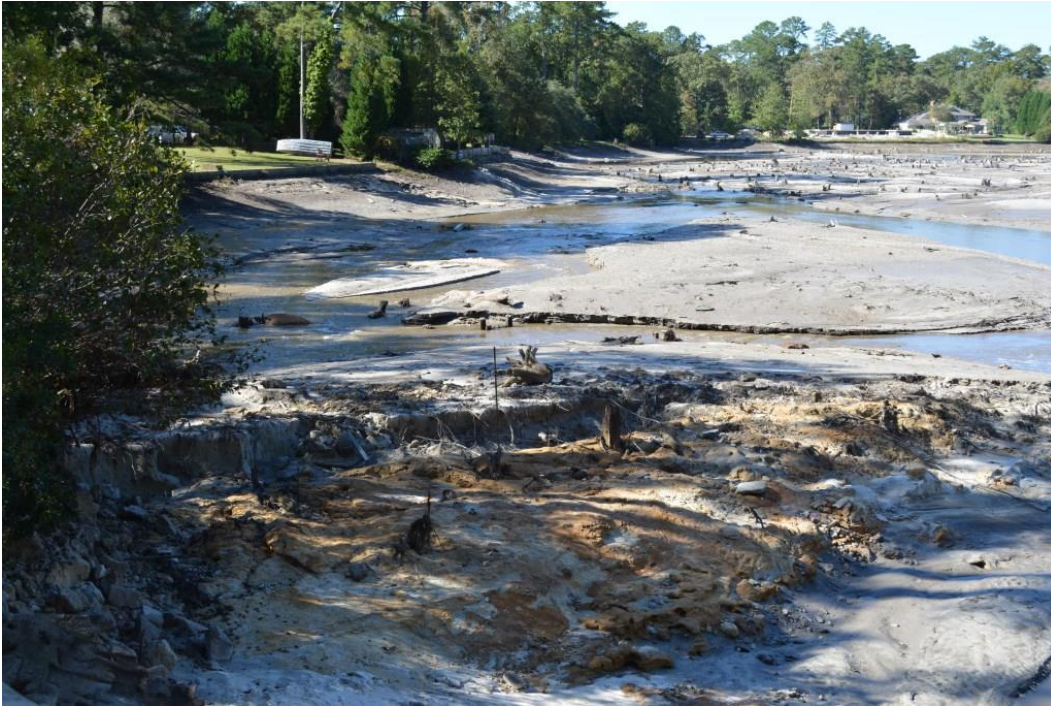
Photo 1: View upstream from the auxiliary spillway

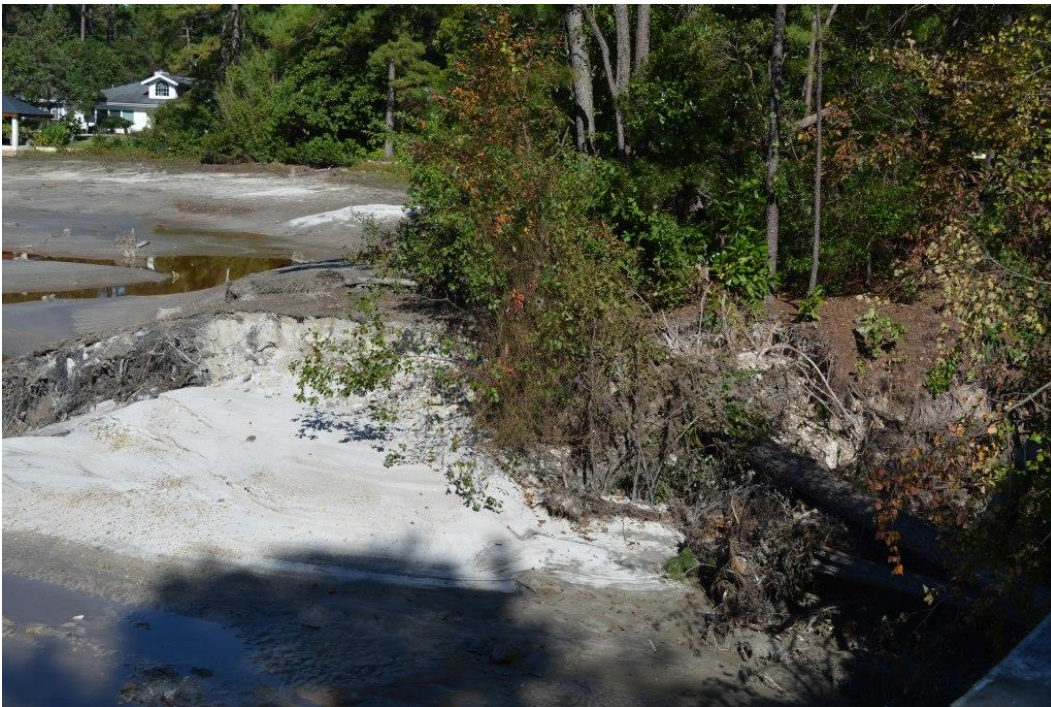
Photo 2: Erosion along the left side of approach channel to the auxiliary spillway

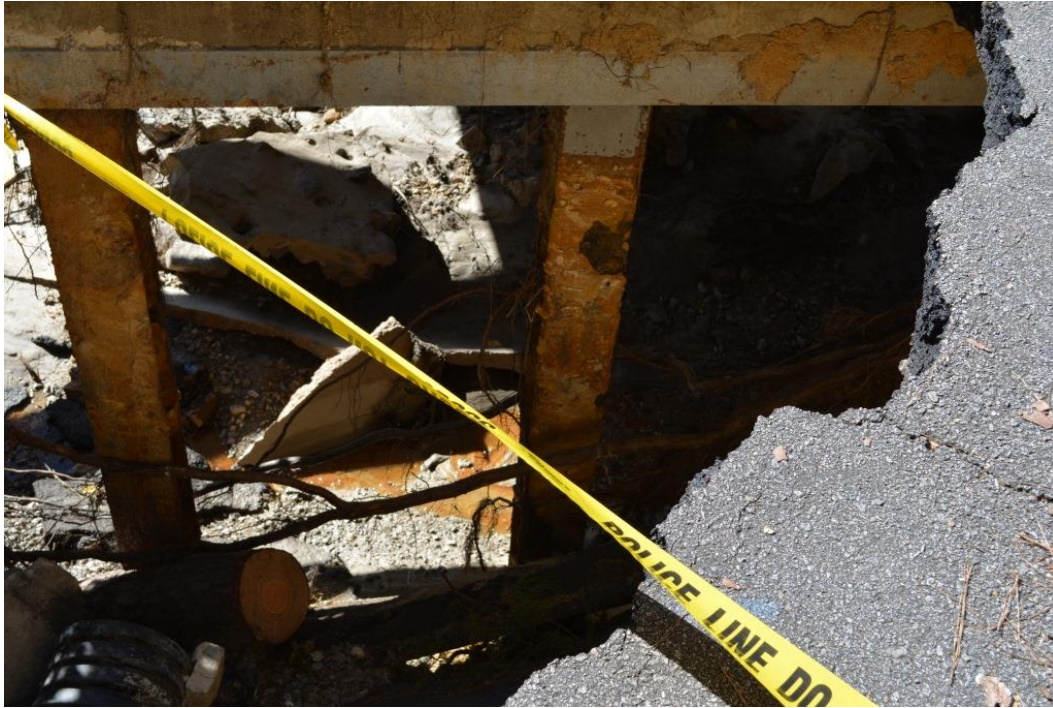
Photo 3: Area of auxiliary spillway wash-out at the left bridge abutment

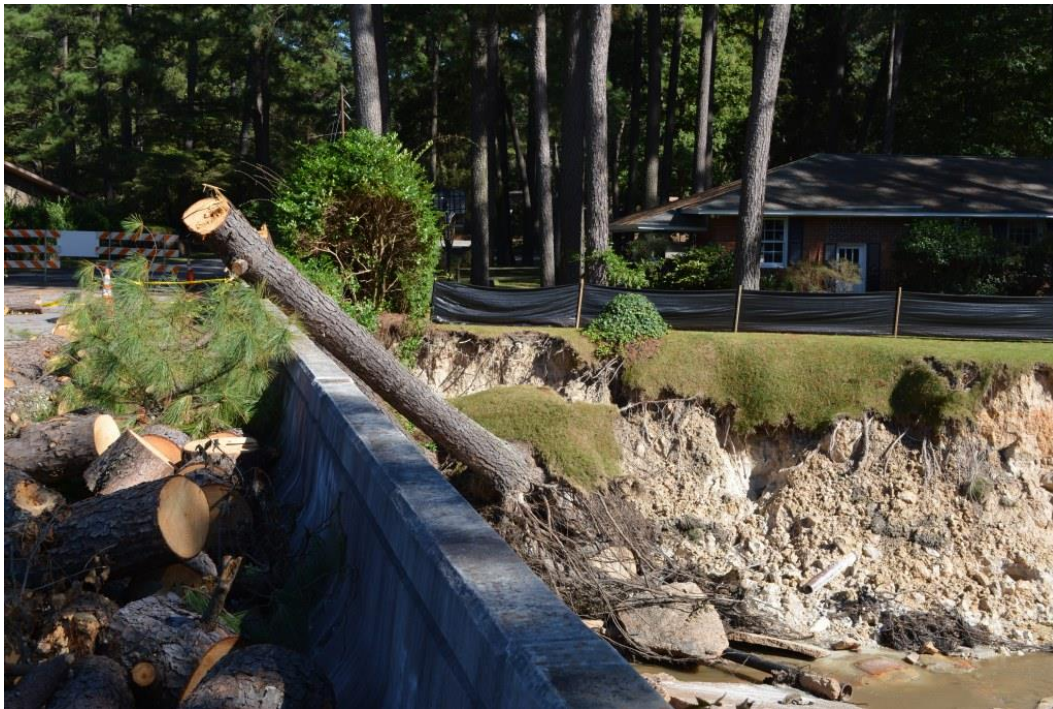
Photo 4: Erosion at the left abutment viewed from the bridge

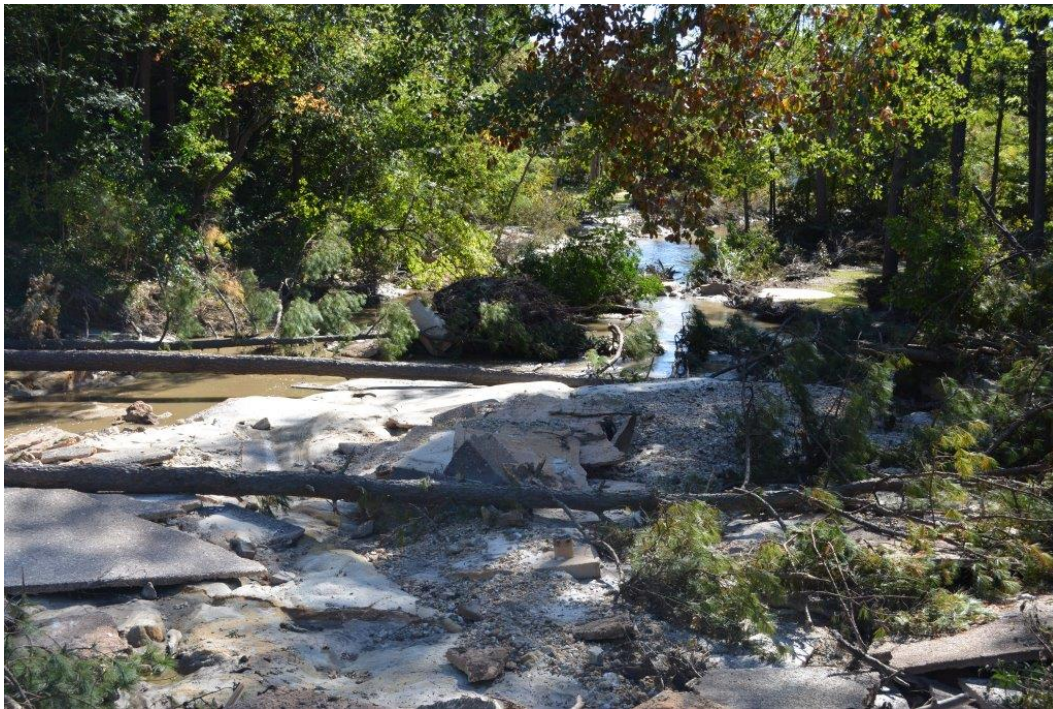
The auxiliary spillway was completely washed out from the flood. Photo 6 shows portions of the concrete spillway in the channel downstream of the bridge.

Photo 6: View of the auxiliary spillway looking downstream of bridge; concrete debris is seen in the foreground

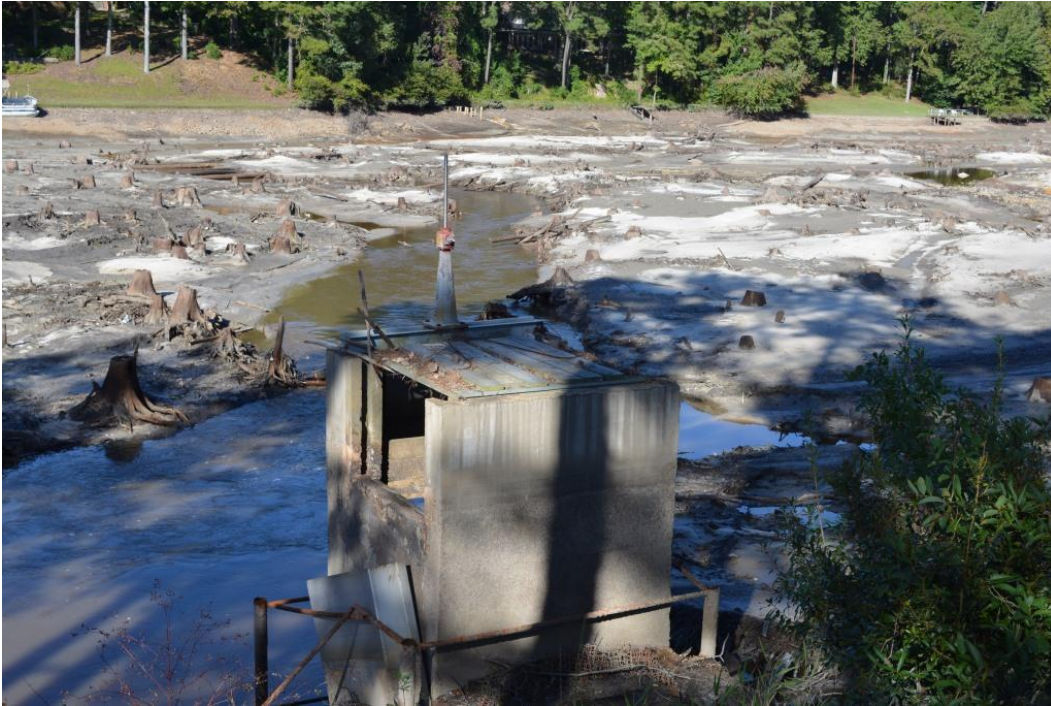
Photo 1: Service spillway drop inlet structure

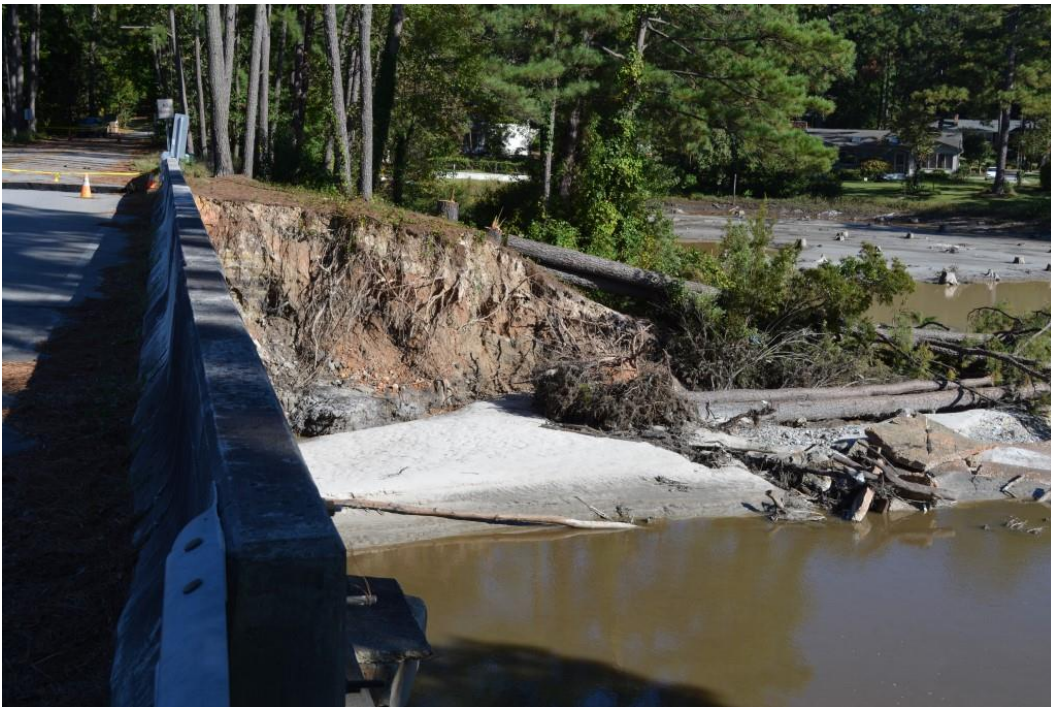
Photo 2: View of eroded embankment at left abutment of the auxiliary spillway looking downstream
