Gills Creek Watershed: Assessment of Regulated Dams

February 15, 2016

PROJECT NAME: Gills Creek Watershed Assessment of Regulated Dams Report

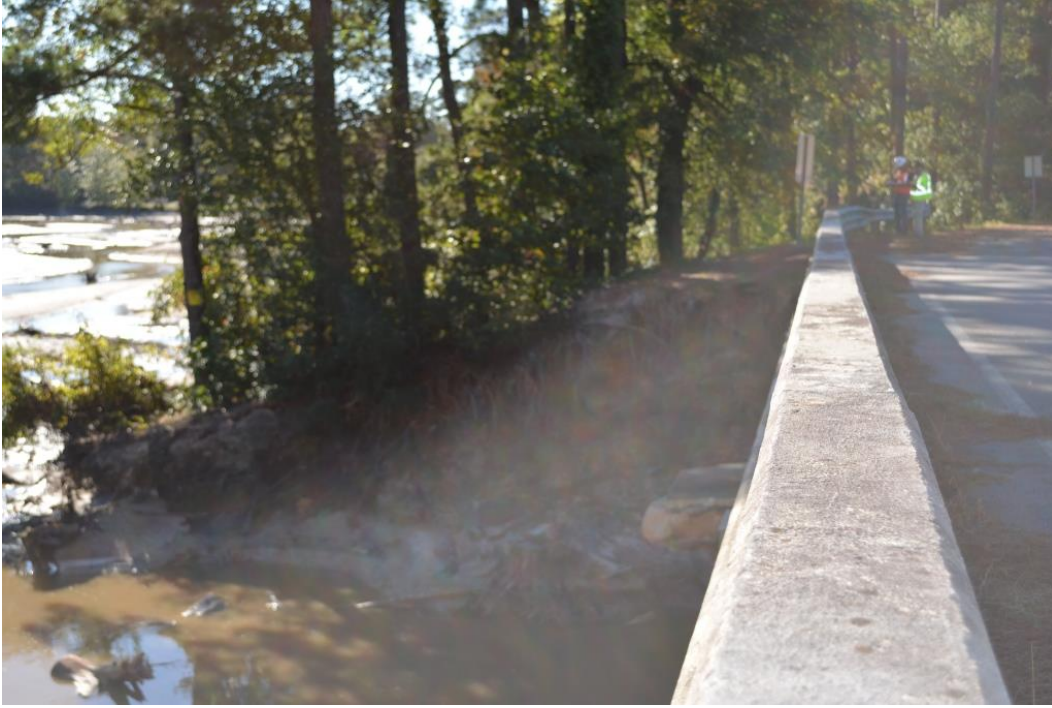
Photo 3: Erosion of embankment at the right abutment of the auxiliary spillway looking downstream

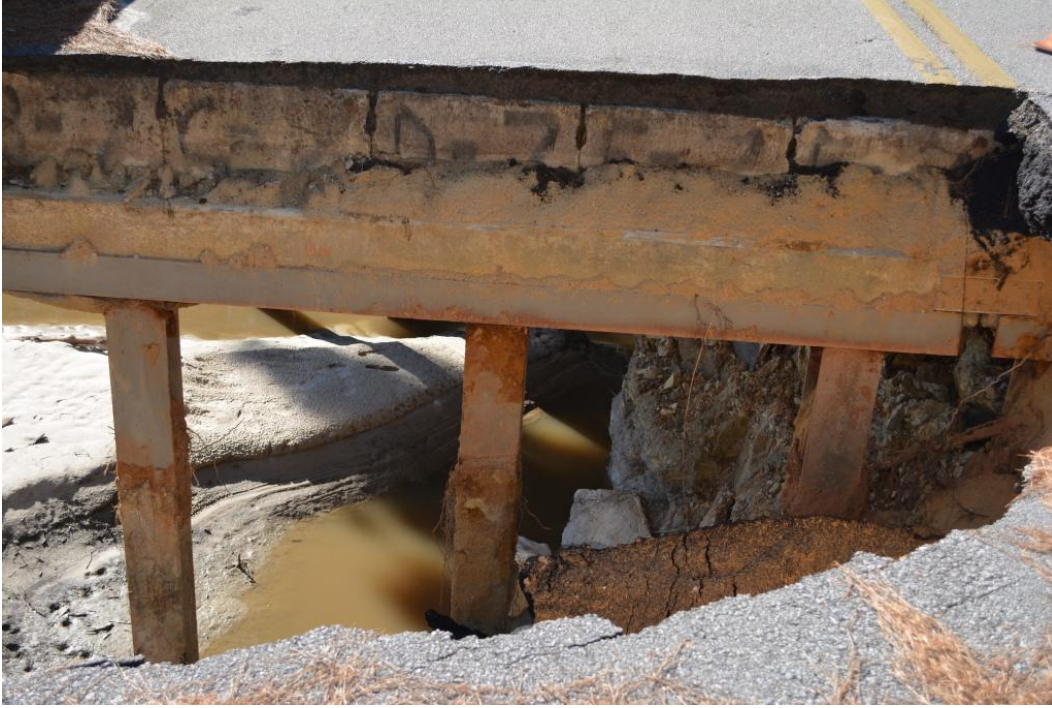
Photo 4: Erosion at bridge abutment

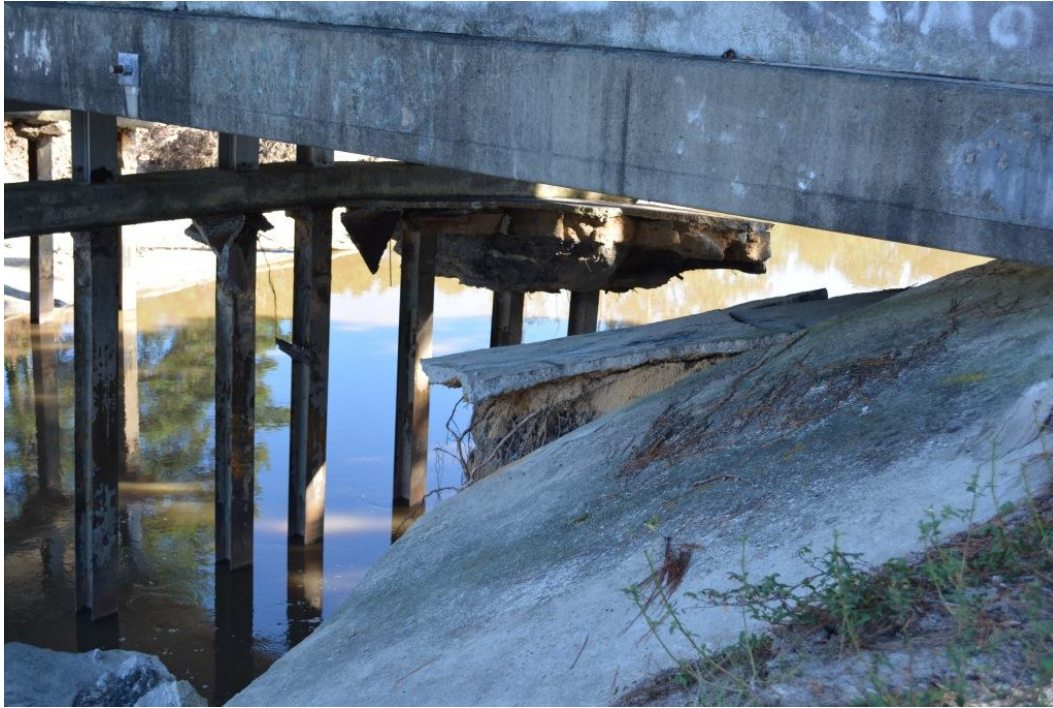
Photo 5: View of eroded auxiliary spillway area beneath the bridge

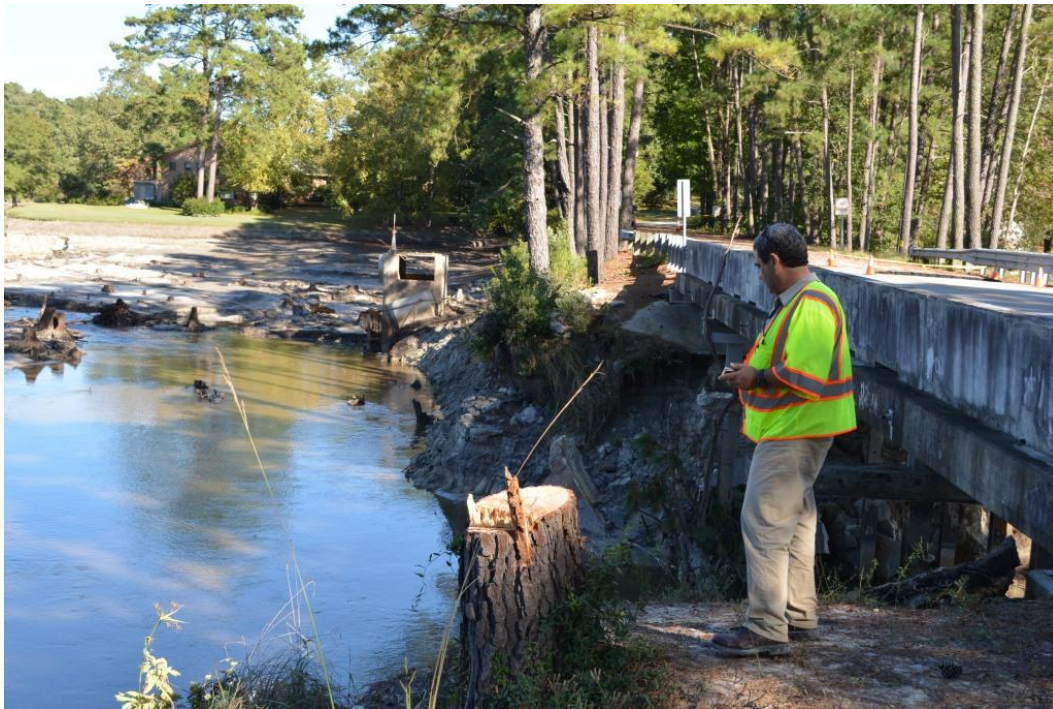
Photo 6: View upstream of bridge and auxiliary spillway

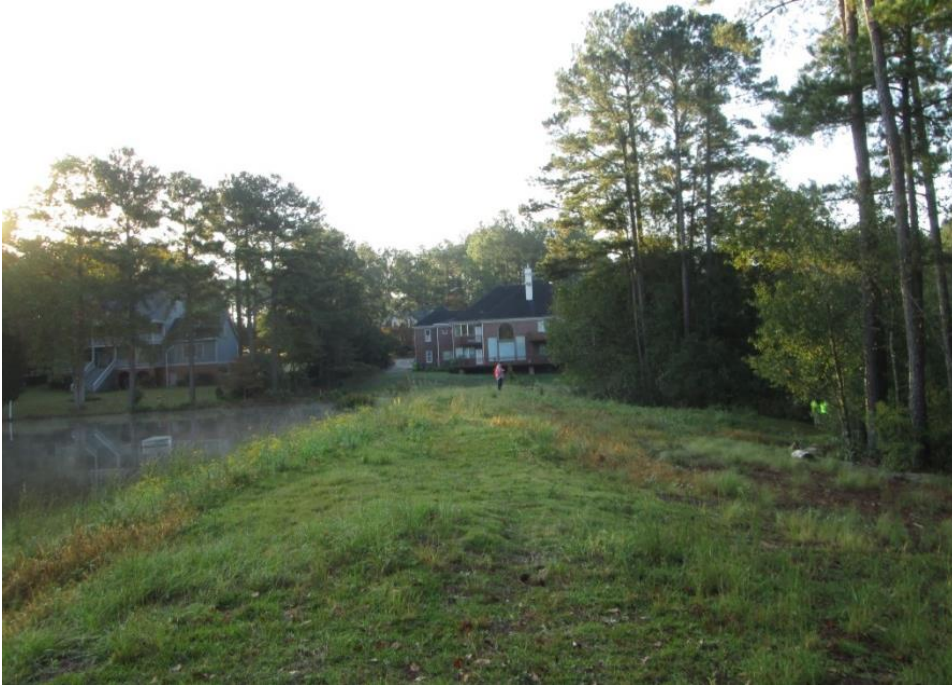
Photo 1: Embankment crest viewed from right abutment. Grass cover on upstream slope; trees and underbrush on downstream slope and toe.

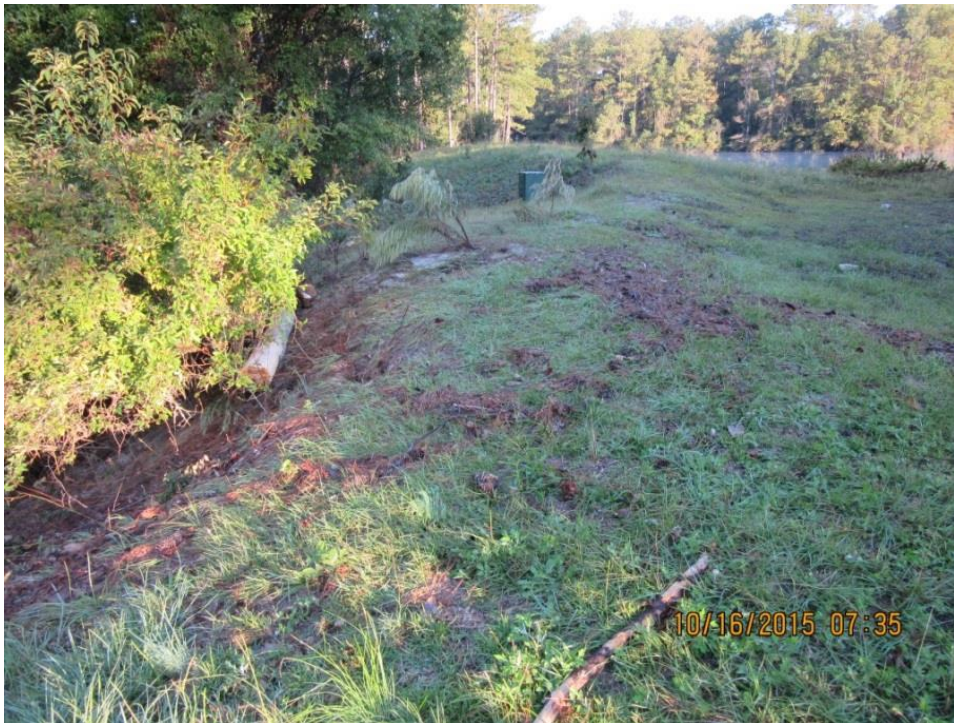
Photo 4: Woody growth on the left downstream slope

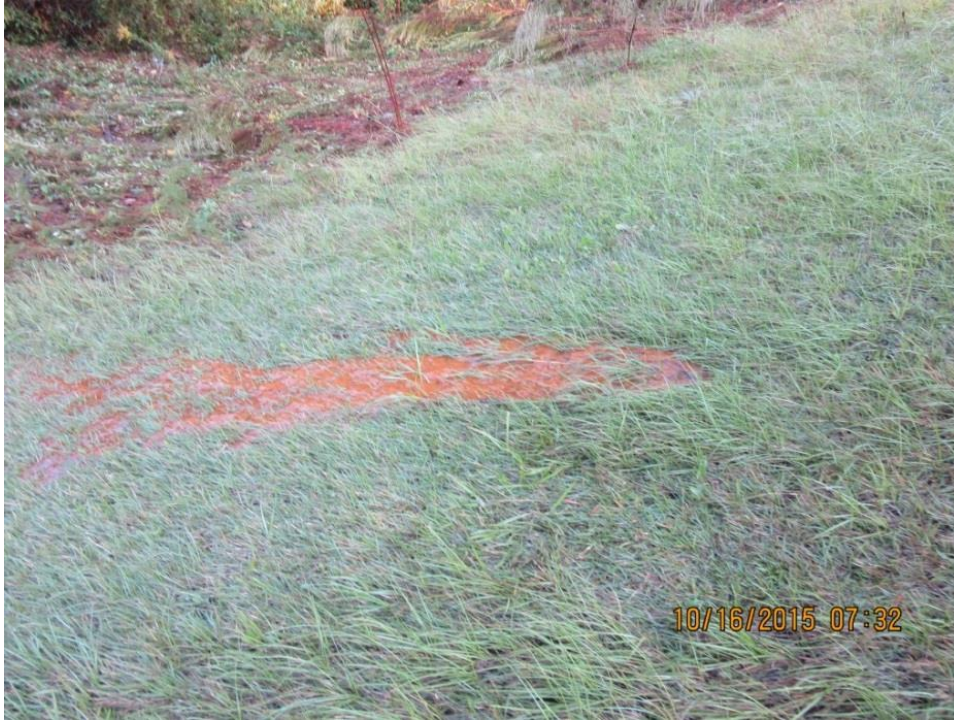
Photo 9: Seepage at downstream end of auxiliary spillway

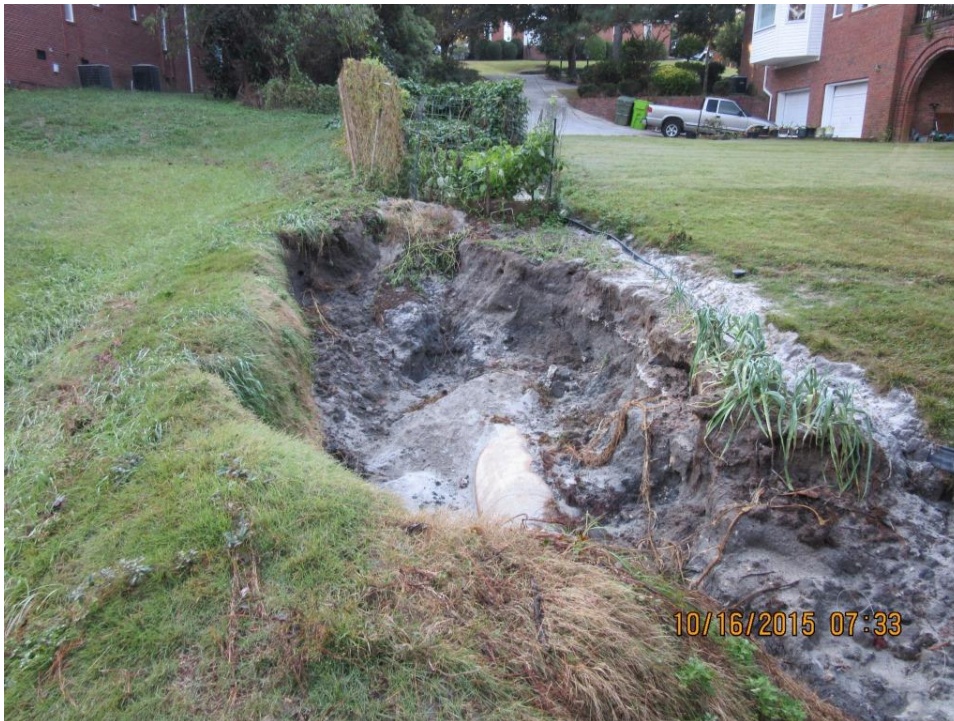
The auxiliary spillway is an earthen-grassed, uncontrolled, overflow channel located at the left abutment. It has a crest length of approximately 80 feet and conveys flow about 200 feet to the stream. Overtopping of the spillway during the flood event to a depth of 1 to 2 feet was evident. The spillway appeared to generally be in good condition (Photo 8) with some minor surficial erosion. Water was observed to be emerging at a location on the downstream slope of the auxiliary spillway about 100 feet downstream from the pond, approximately 5 feet below pond level (Photo 9). This seepage appears to be indication of piping of subsurface red clay material through the auxiliary spillway. A significant erosion channel was developed in the downstream area of the auxiliary spillway which exposed what appears to be a stormwater main (Photo 10).

Photo 10: Eroded area at downstream end of auxiliary exposing RCP pipe, presumably a stormwater main

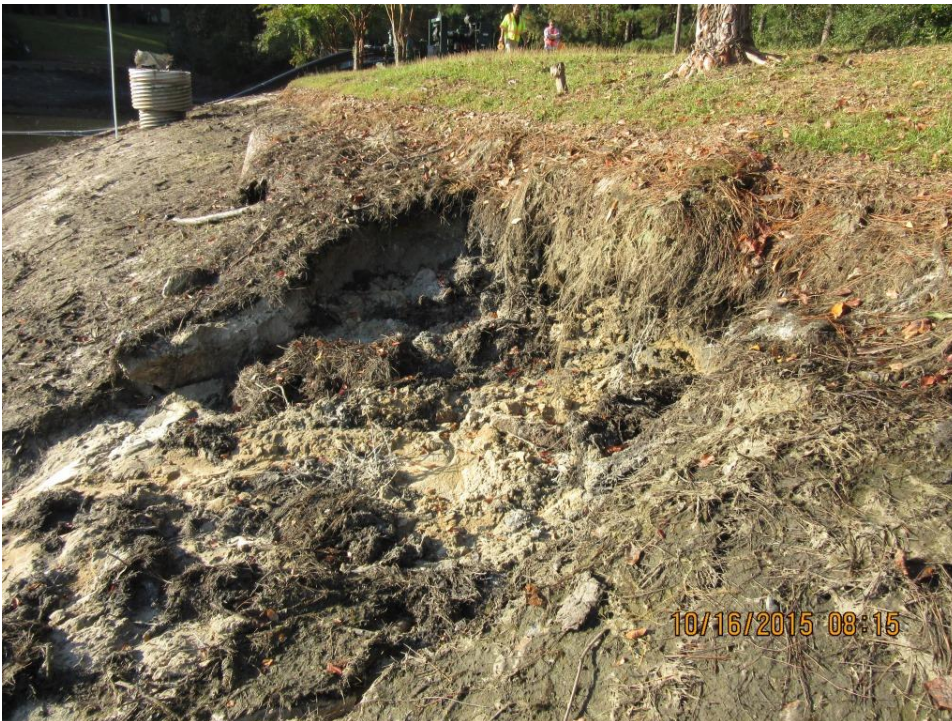
The upstream slope had two areas of moderate sloughs (Photo 2). A few *crepe myrtle* trees were growing on the upstream slope, and there were mature trees and underbrush on the lower portion of the downstream slope and toe. Riprap was observed on the upper portion of the upstream slope near the right abutment (Photo 4). The earthen embankment has an upstream slope of approximately 2H:1V and a downstream slope of approximately 2H:1V.

Photo 2: Upstream embankment slope slough

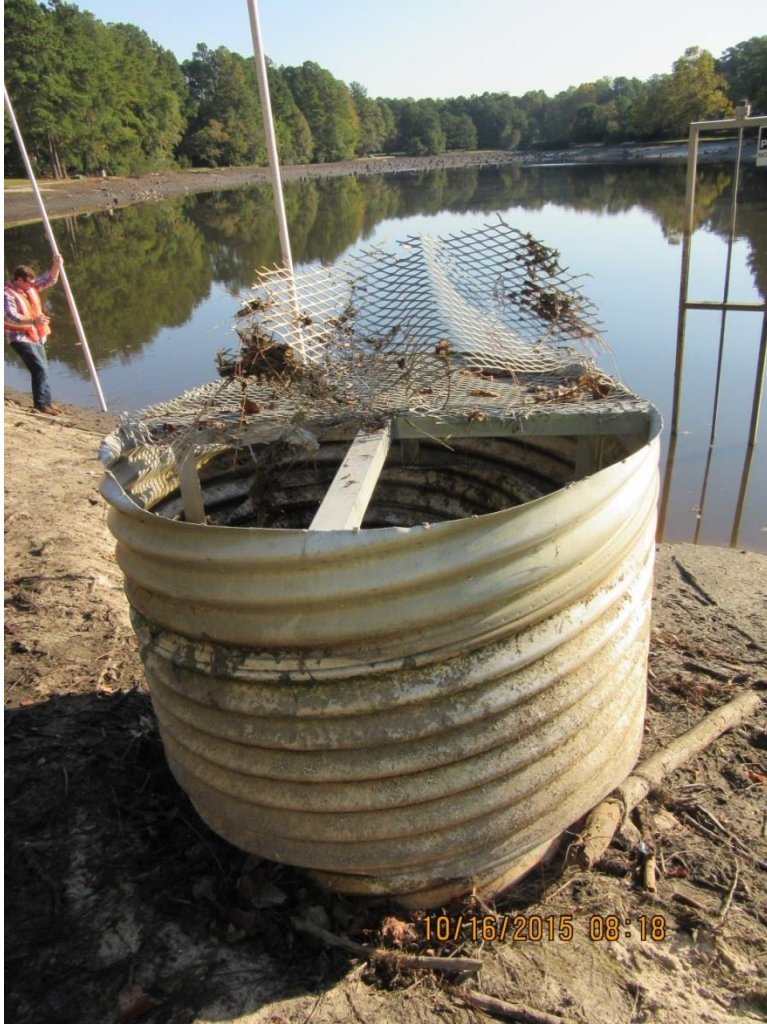
The service spillway is a low-level, 30-inch CMP pipe with drop inlet equipped with a trash screen. The trash screen was dislocated. The outlet pipe was submerged, but there was no indication of flowing water. The pond level is below the drop inlet elevation, and it is assumed that the low-level inlet to the service spillway cannot be operated to discharge at lowered pond conditions, or it is prudent not to discharge through the low level outlet due to concerns for effects to the failed slope area. As previously noted, temporary pumps are being used to discharge water from the pond downstream.

Photo 5: Service spillway drop inlet

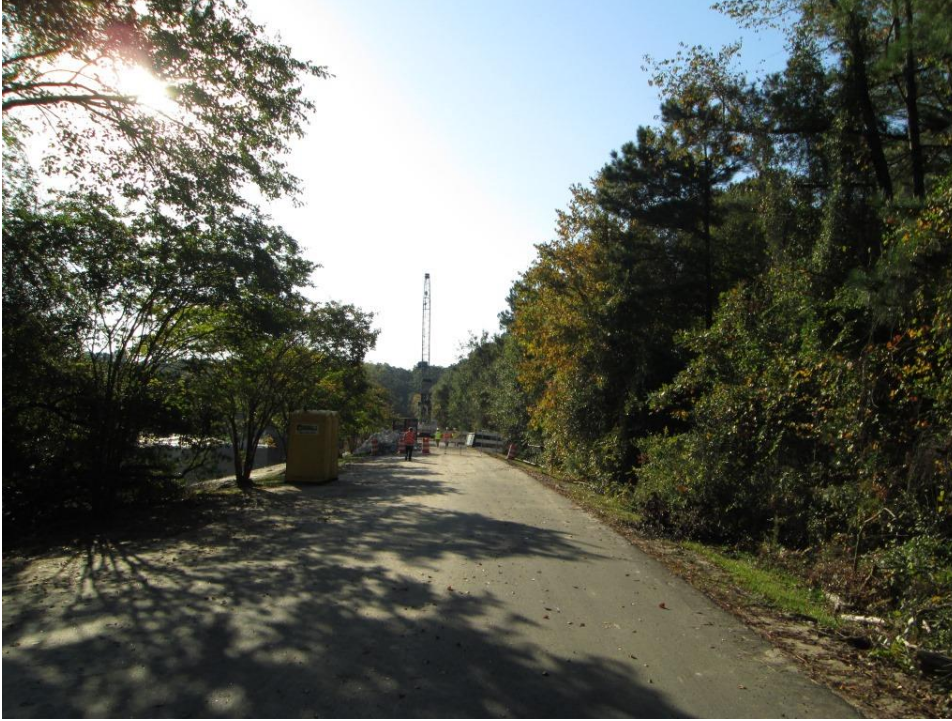
Photo 1: Roadway along embankment crest viewed from right embankment

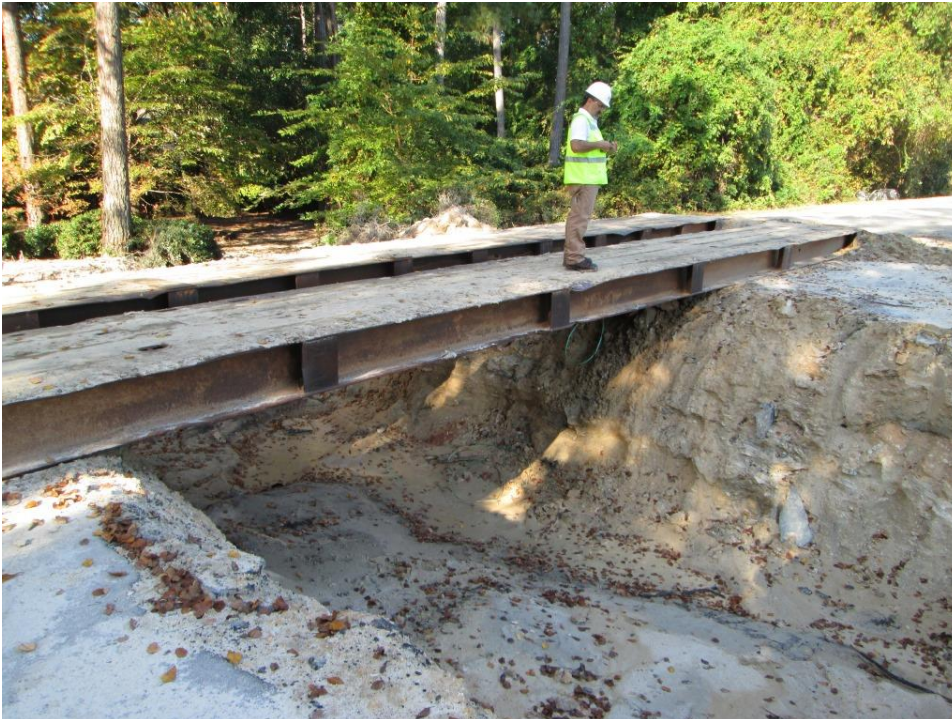
Photo 2: Temporary trench excavated to function as an emergency channel near the left abutment

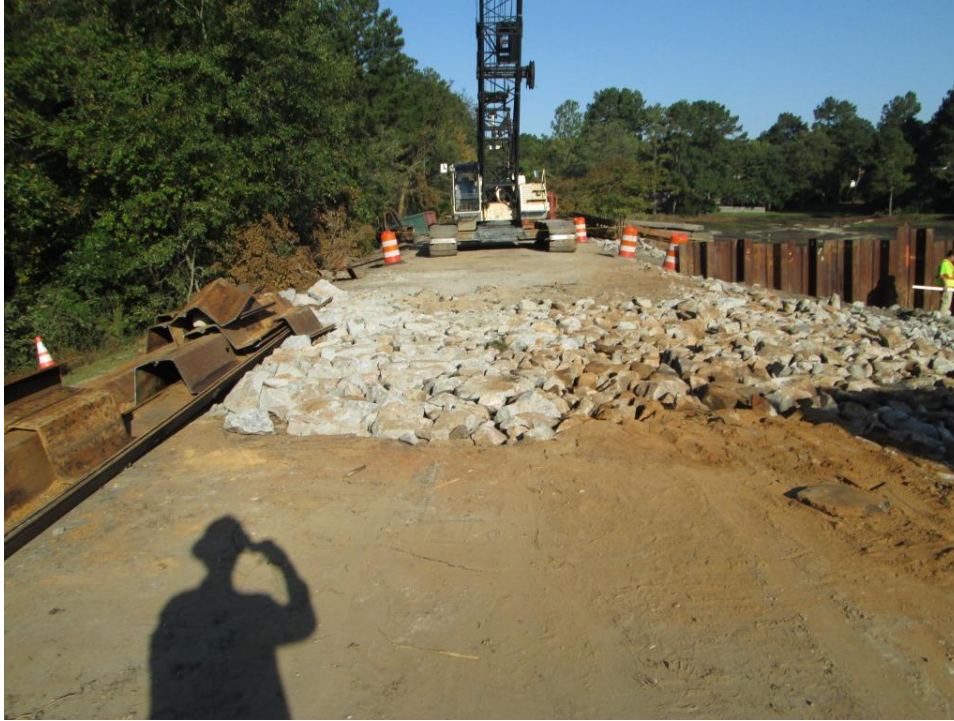
Photo 3: Sinkhole area on embankment crest showing temporary rock fill

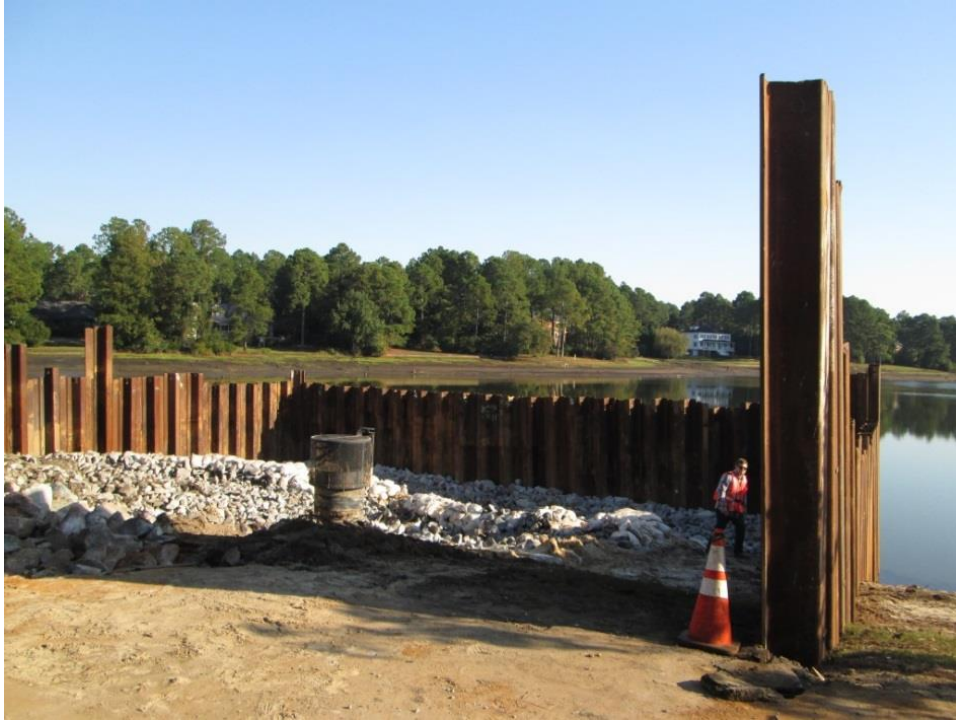
Photo 5: Temporary sheet-pile cofferdam installed to isolate the sinkhole area

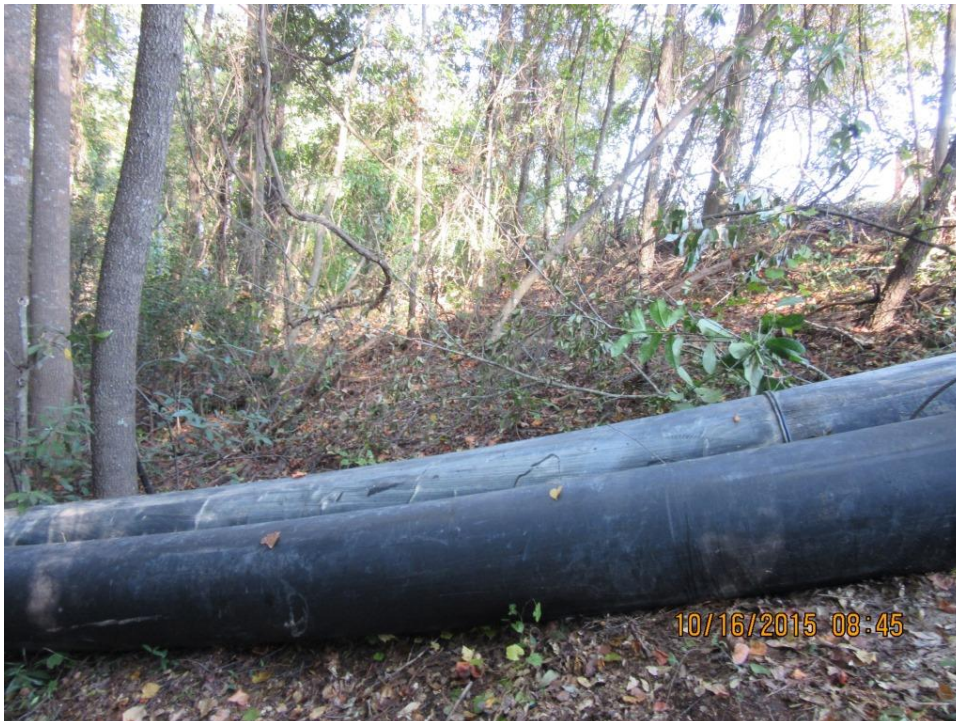
Photo 6: Tree growth on downstream slope of embankment; temporary pump discharge pipes are in the foreground

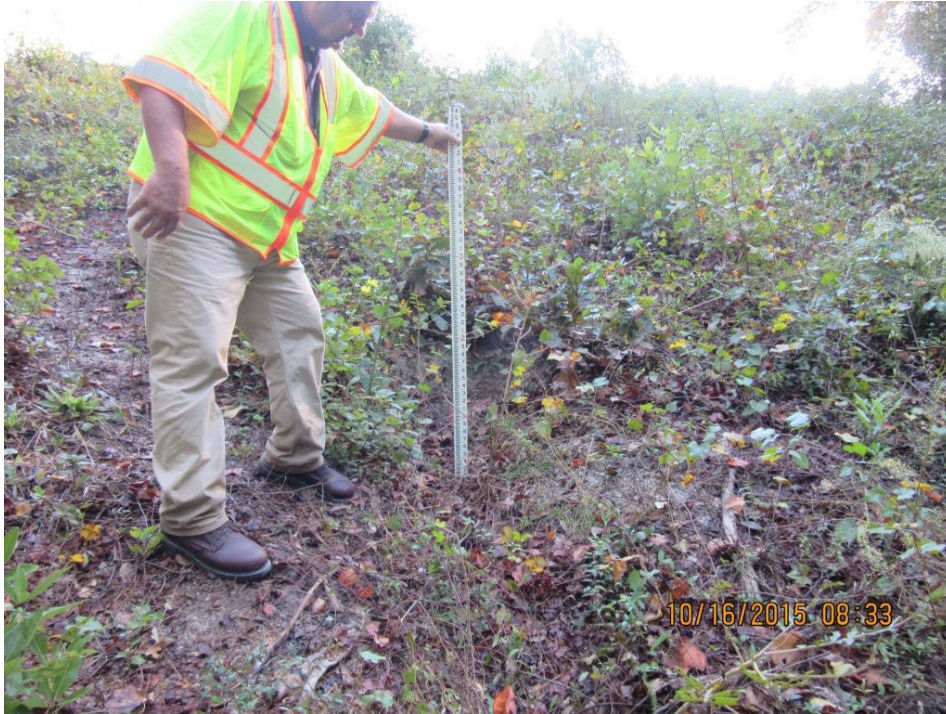
Photo 7: Erosion on the downstream slope of the embankment

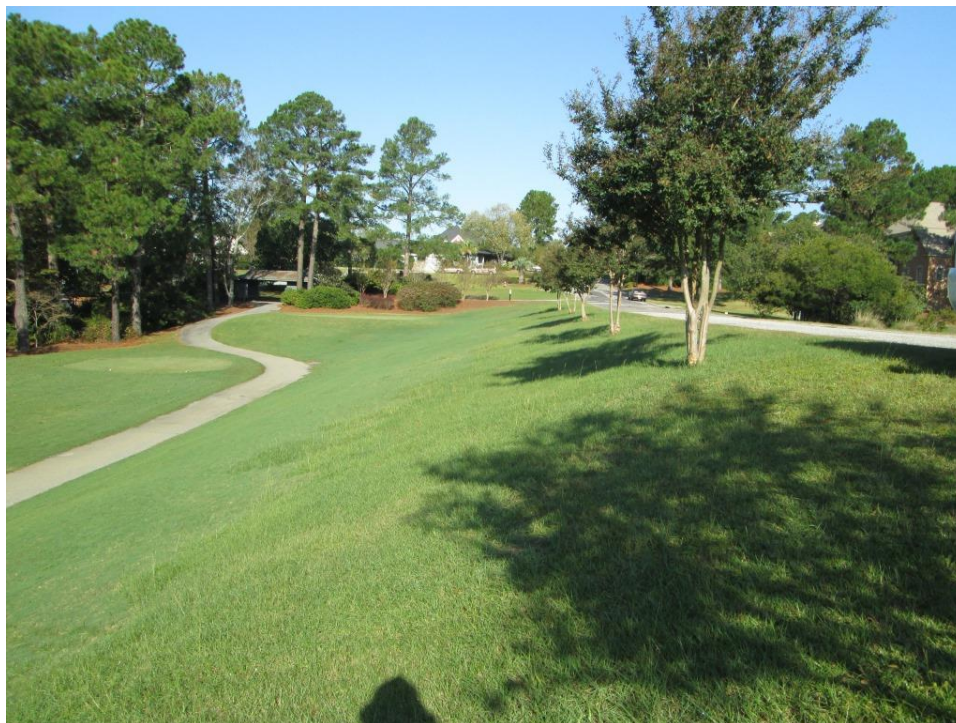
Photo 2: Downstream slope of the embankment dam viewed from left abutment

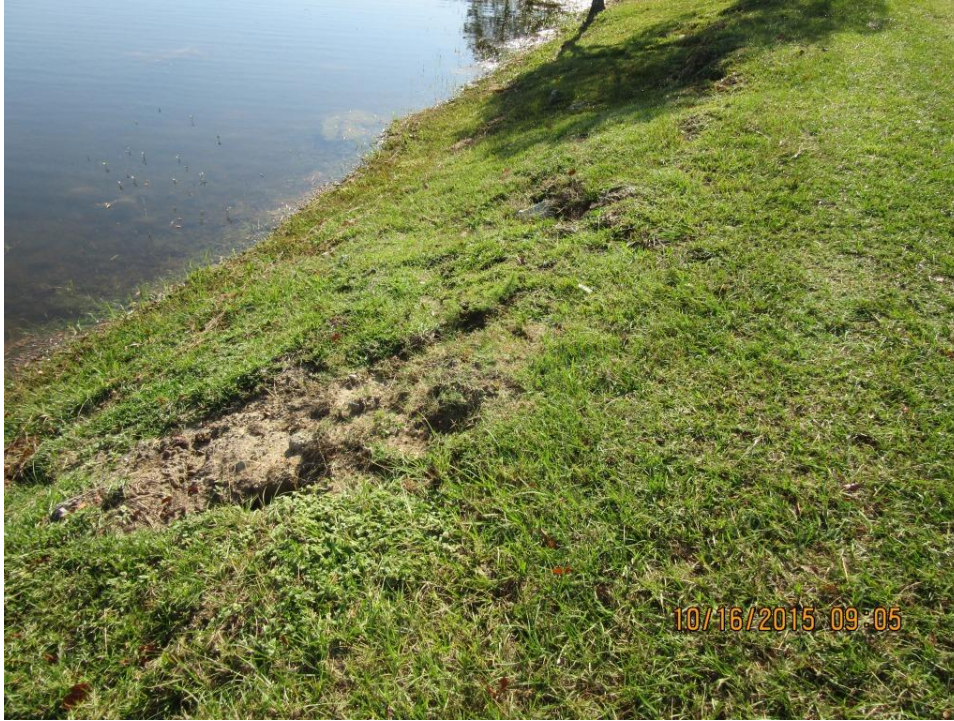
Photo 3: Slough on upstream slope of the embankment dam

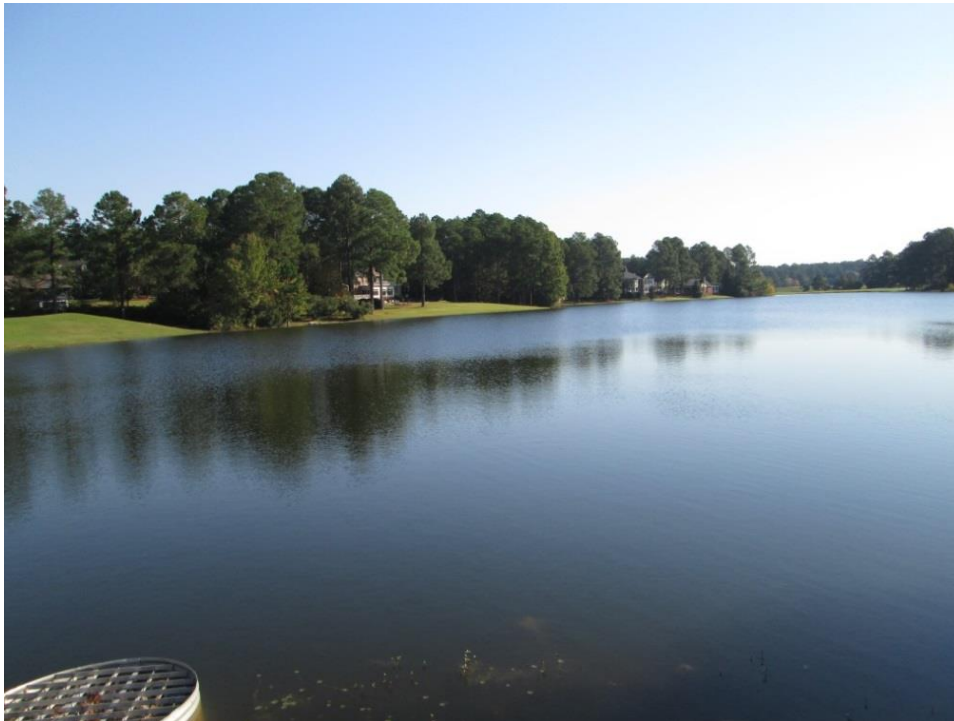
The service spillway is a low-level, 30-inch CMP pipe with drop inlet equipped with a trash screen. The inlet (Photo 4) and outlet pipe (Photo 5) appeared to be in good condition. No debris was observed on the inlet trash screen.

Photo 4: View of pond with service spillway drop inlet in foreground

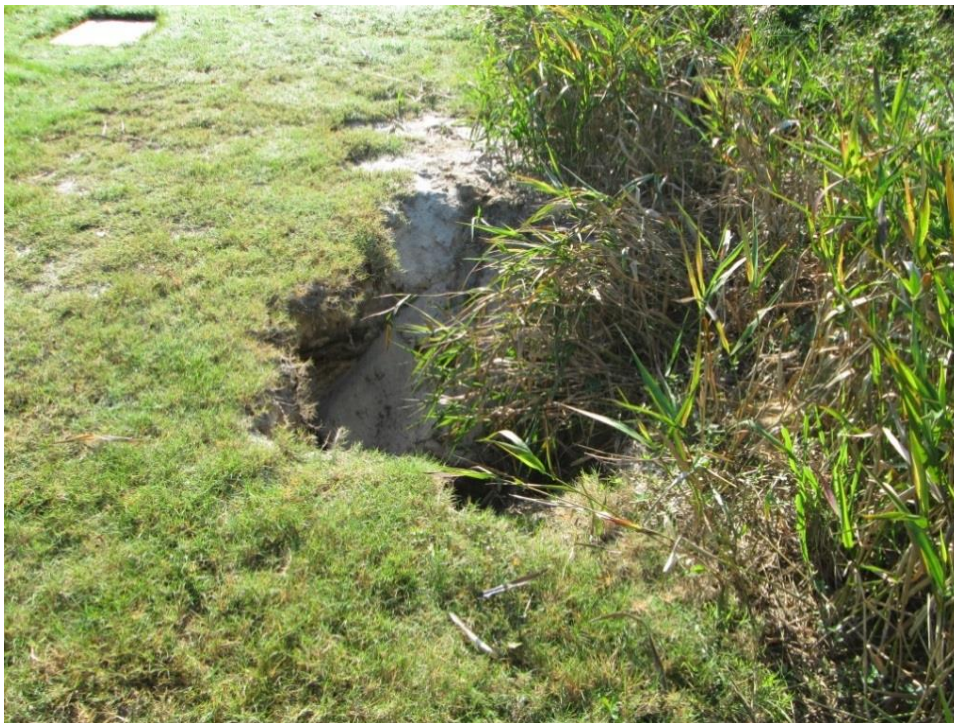
Photo 6: Erosion on downstream slope of embankment, approximately 30 feet upstream of the service spillway outlet

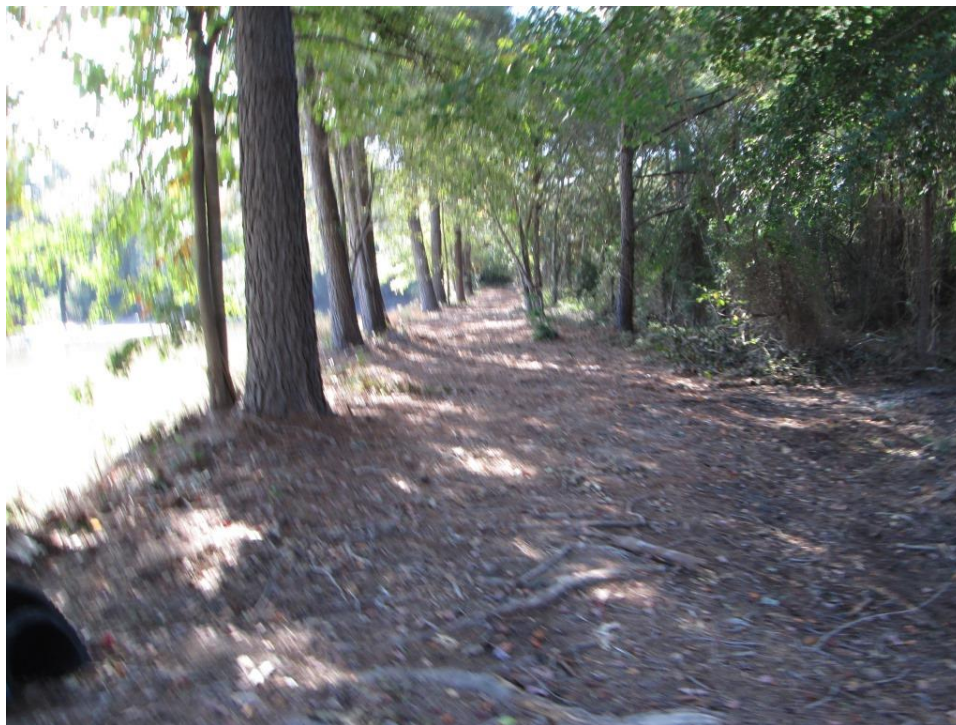
Photo 1: View along crest of embankment dam looking toward the left abutment

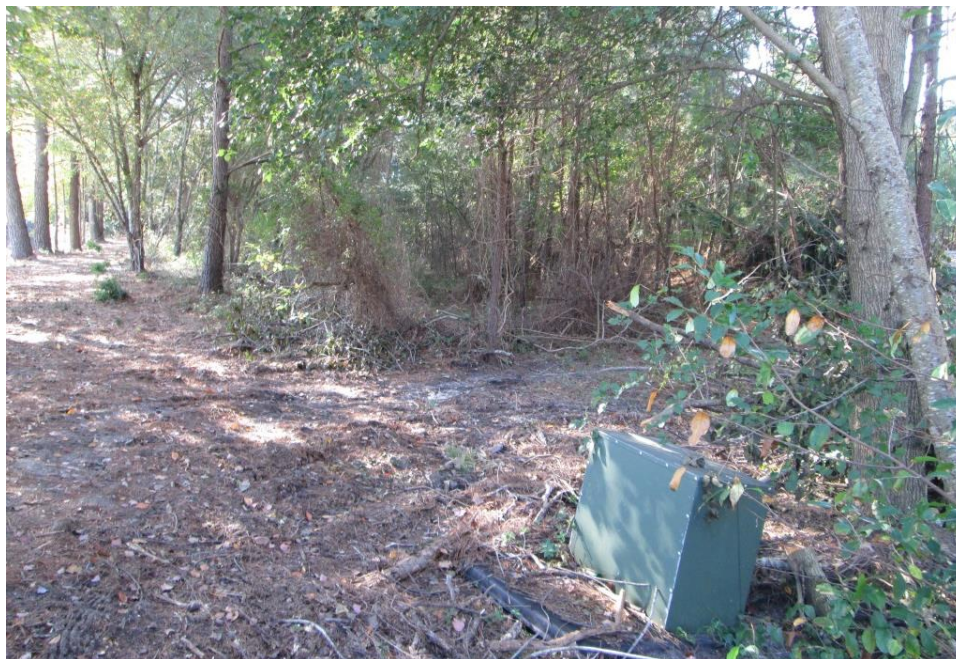
Photo 2: View of downstream slope of the embankment dam from the service spillway toward the left abutment

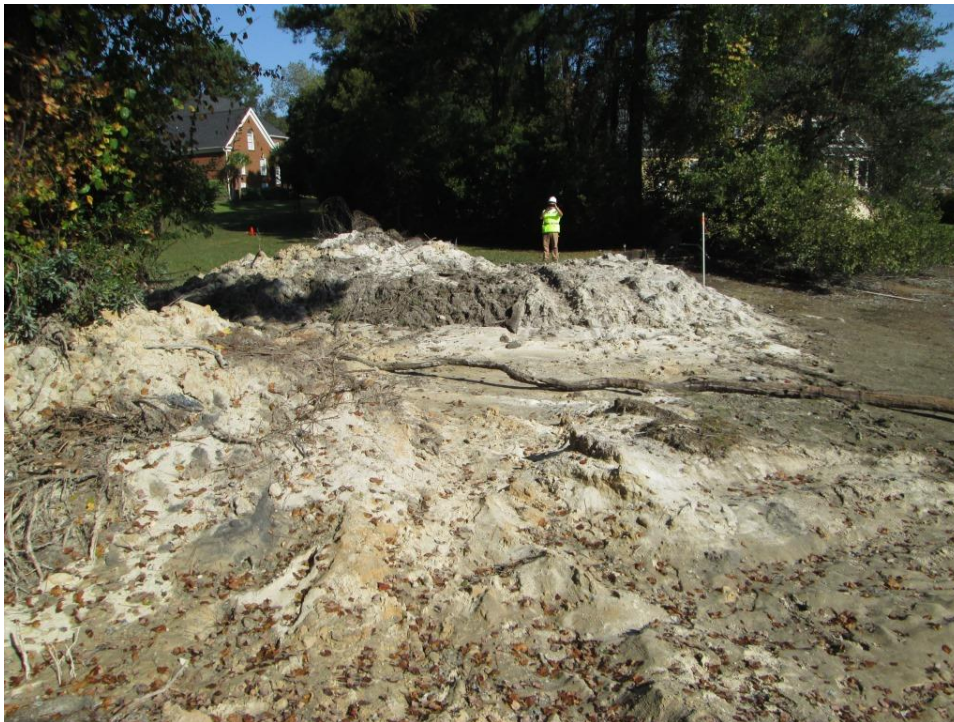
Photo 3: View of approach to the emergency channel that was excavated at the right abutment during the flood to convey water downstream

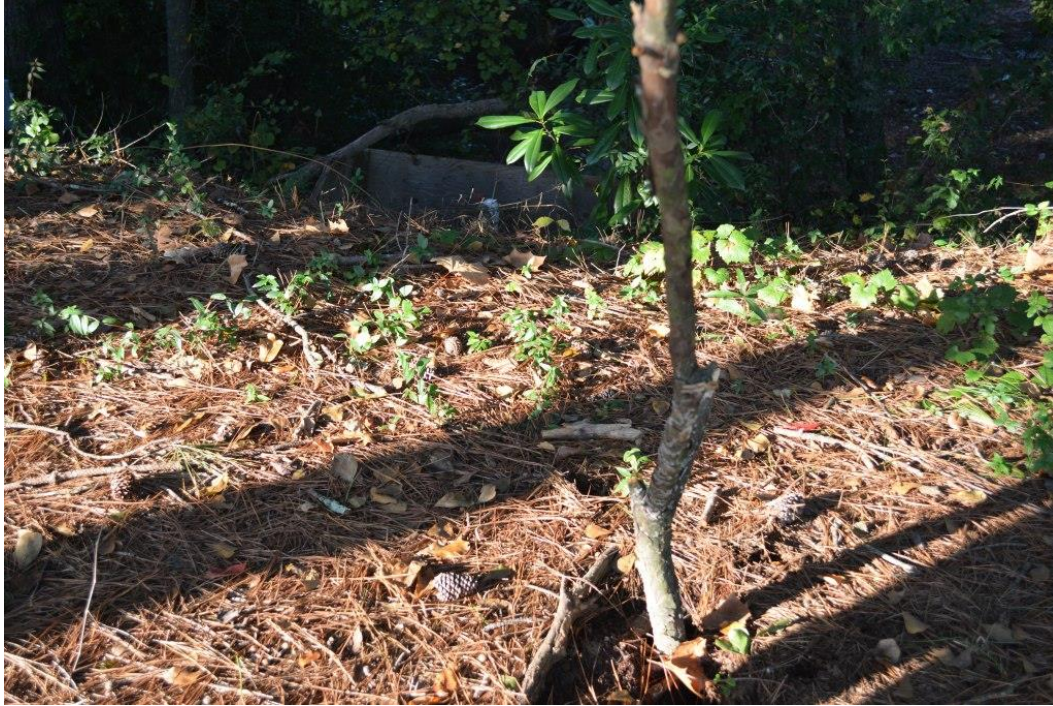
Photo 5: Pump house (in background) viewed from area of depression on embankment crest shown in Photo 4

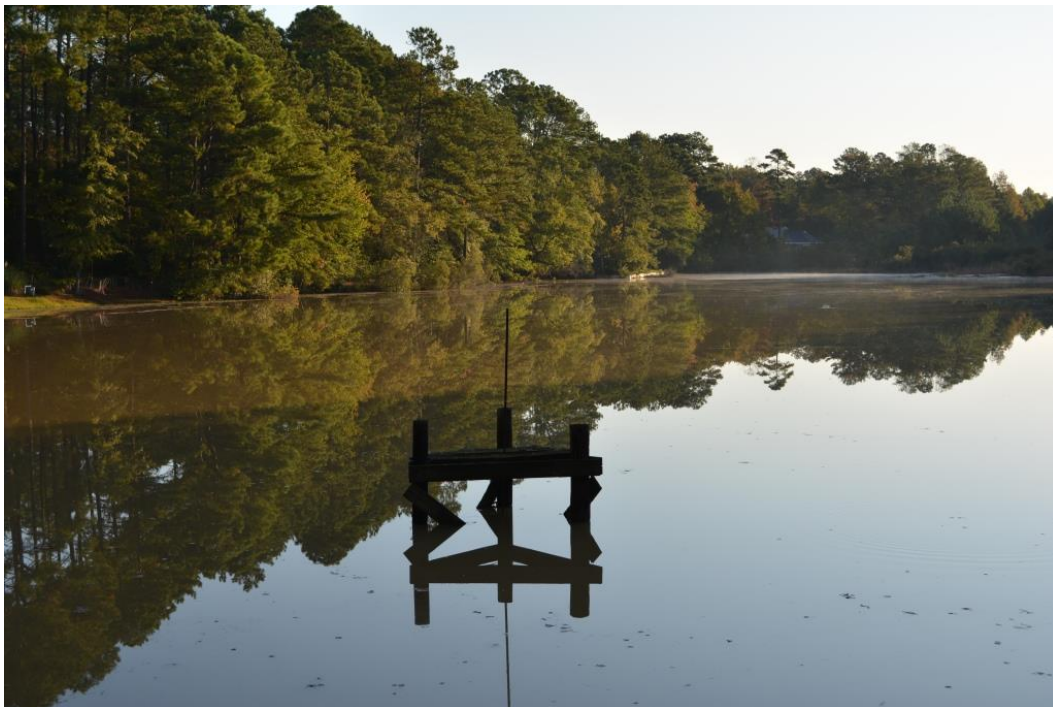
with a control valve. The 15-inch riser pipe was not observed during the site visit and was presumed submerged; however, the platform for the low-level inlet control valve was visible (Photo 6). The 12-inch diameter outlet was not found during the site visit. A 2-inch PVC irrigation pipe outlet with shut-off valve was observed (Photo 7). There was no discharge from the irrigation pipe. The irrigation pipe outlet drains into a ditch that travels downstream transverse to the dam. Photo 8 shows the outlet drain ditch. Minor seepage was noted in the ditch approximately 20 feet downstream from the toe of the dam. This seepage did not appear to be originating from around the irrigation pipe outlet.

Photo 6: Service spillway intake platform

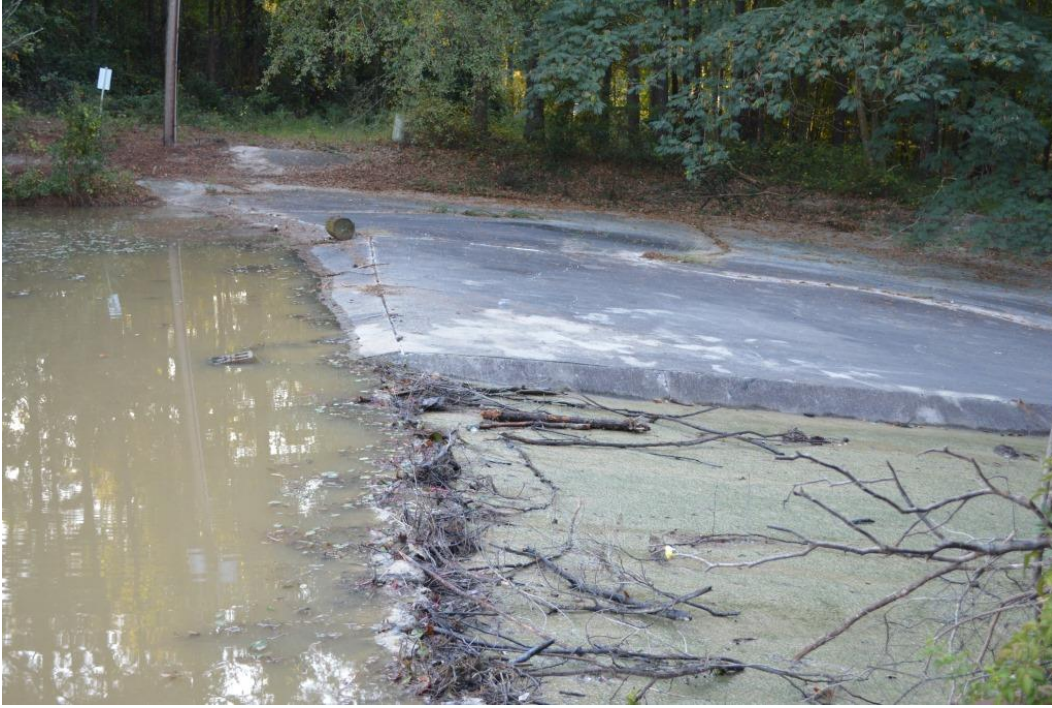
The auxiliary spillway is a concrete-lined overflow channel, approximately 80 feet wide, that extends from the left extent of the embankment to the left abutment. The spillway has two sections with one section nearest the left abutment approximately 8 inches higher in elevation than the interior section. Photo 9 shows the auxiliary spillway. The debris in the lower section has resulted in the elevation of the reservoir being elevated. The consistent placement of the debris may be the work of beavers. At the downstream end of the auxiliary spillway there is significant erosion and structural damage where water is conveyed under the road in two 48-inch and two 24-inch culverts. Photos 10 and 11 show the damage to the end of the spillway next to the road.

Photo 9: Auxiliary spillway with debris

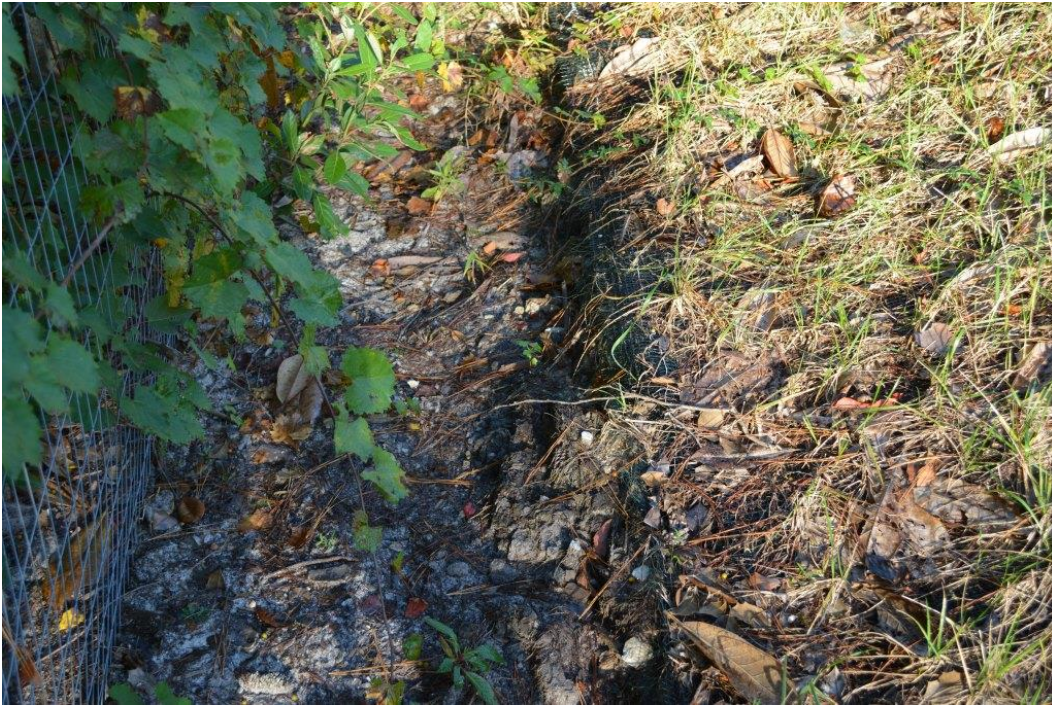
The embankment has an approximately 30-foot-wide crest, upstream slope varying from 2H:1V to 3H:1V, and downstream slope of 2H:1V to 2.5H:1V. The dam was not overtopped during the flood event. The upstream slope is in good condition having full grass cover to the normal pool level. The crest supports an asphalt road with grass and gravel cover over the shoulders of the road. The downstream slope has grass growth through a geotextile fabric. The downstream slope is generally in good condition but does show erosion at the toe just below the geotextile fabric. Photo 1 presents a view of the upstream slope looking to the left abutment. Photo 2 shows the dam crest and road, and Photo 3 shows the downstream slope. Photo 4 shows the limited areas of erosion on the downstream slope below the geotextile.

Photo 4: Erosion on downstream slope

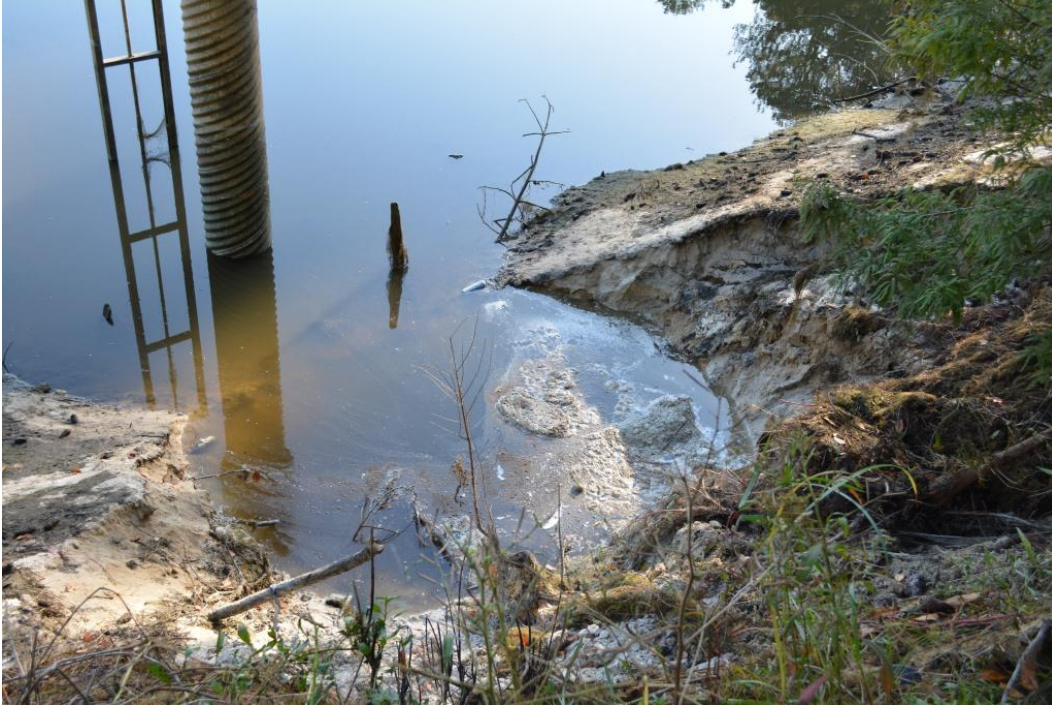
Observations were made that indicate potential seepage through the dam in the area of the service spillway. Movement of water toward the upstream embankment slope in line with the service spillway pipe was observed at the location of the upstream slope failure as shown in Photo 7. Also, depressions in the downstream slope of the embankment were observed located over the service spillway pipe alignment (Photo 8). These observations may indicate potential seepage through the dam along the outlet pipe that may result in piping of embankment material. Wet areas or additional indications of seepage were not observed in open areas;

Photo 7: Upstream slope failure along service spillway alignment

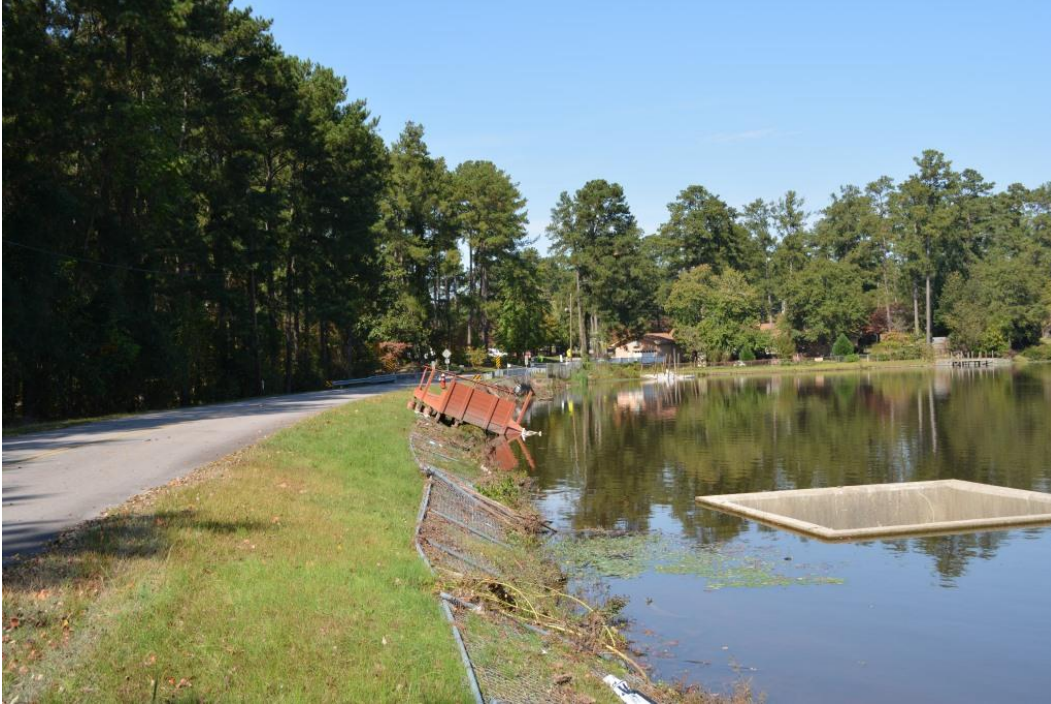
Photo 1: Springwood Lake Dam crest and upstream slope viewed from left abutment
