Gills Creek Watershed: Assessment of Regulated Dams

February 15, 2016

PROJECT NAME: Gills Creek Watershed Assessment of Regulated Dams Report

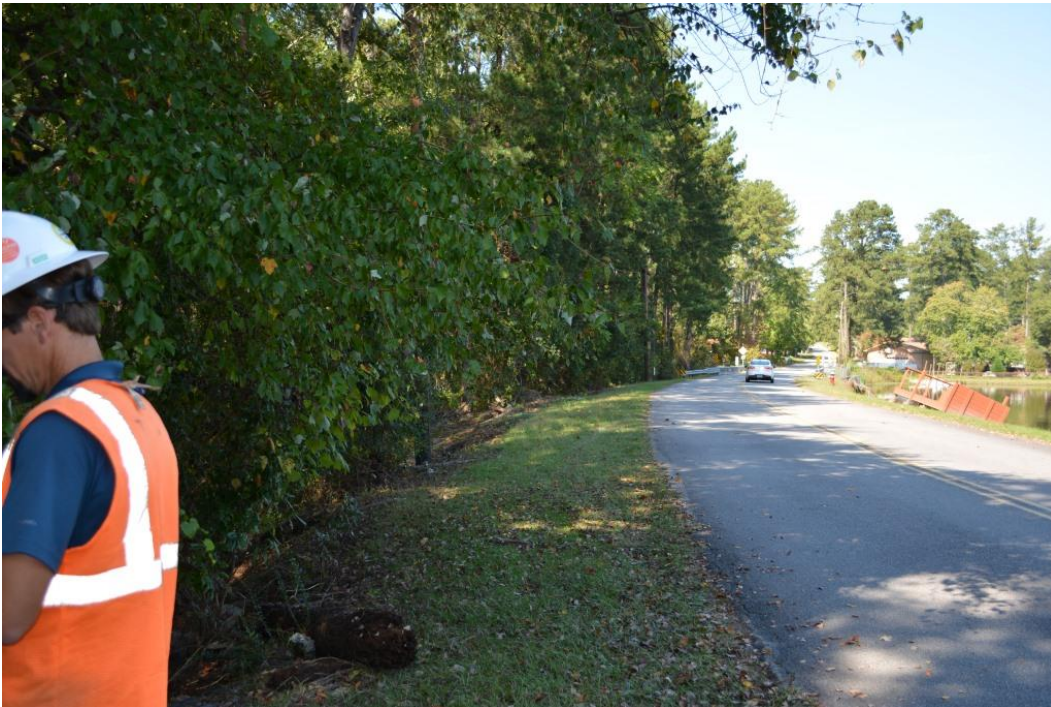
Photo 2: Embankment crest and downstream slope

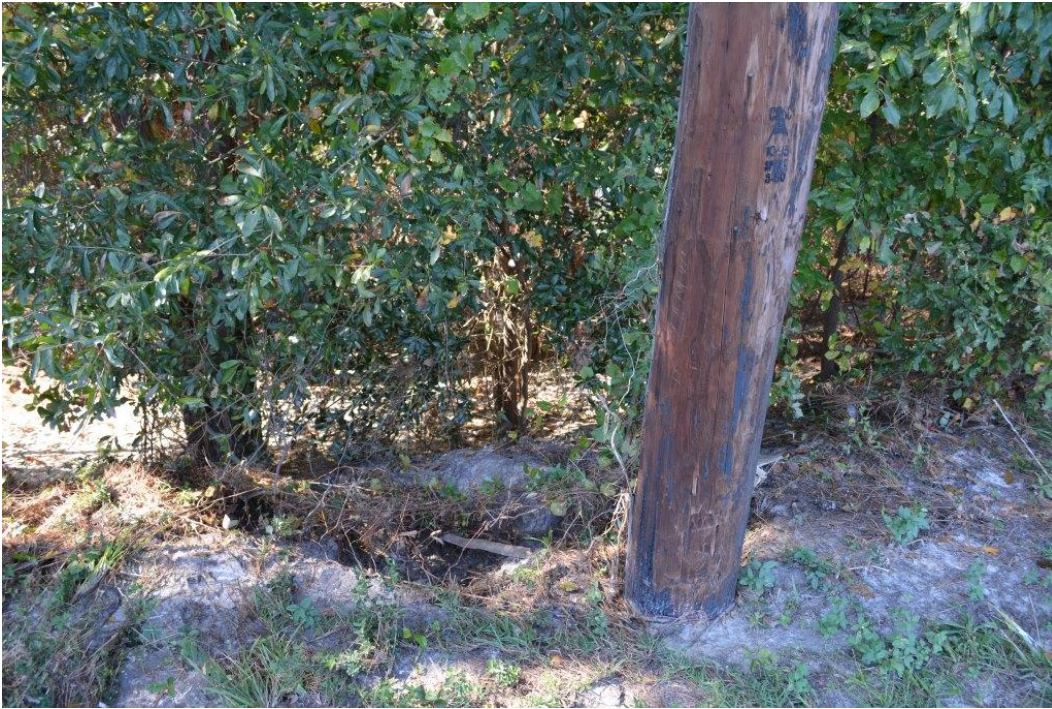
Photo 4: Slough and debris on downstream slope

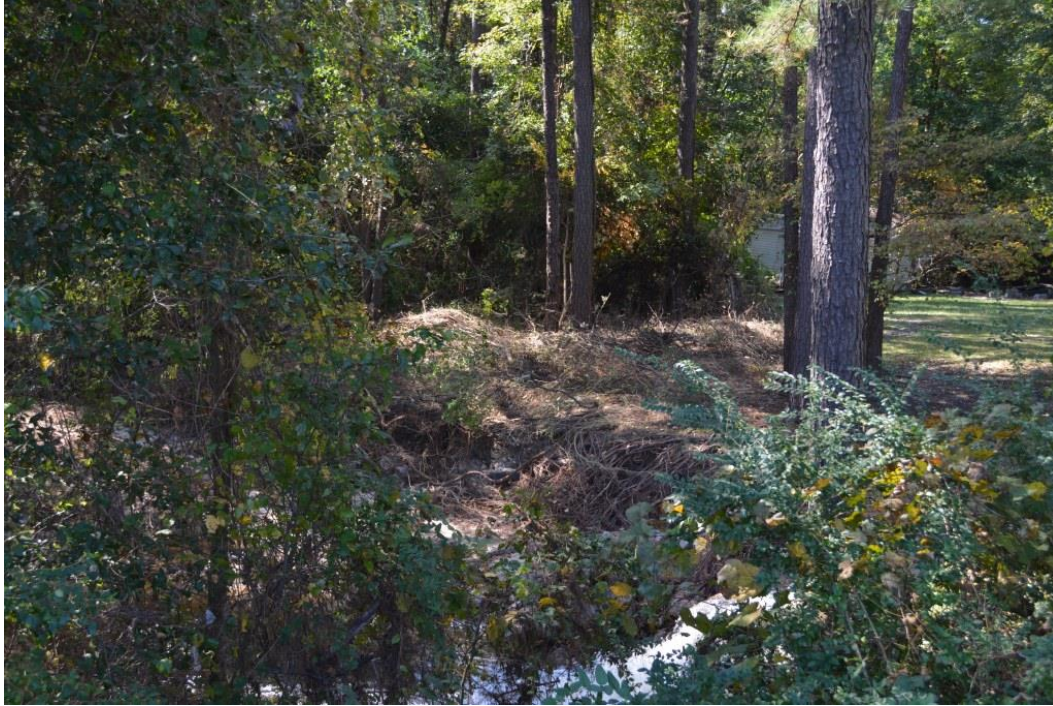
There are two auxiliary spillways. Auxiliary spillway No. 2 is an uncontrolled concrete overflow spillway located near the right abutment of the dam. The spillway is approximately 55 feet wide. The spillway appeared in good condition with only minor erosion at the upstream portion of the right wall. Significant erosion and scour at the downstream extent of the spillway and plunge pool was observed. Photo 7 presents a view of this eroded area. The toe of the spillway could not be directly observed to check for erosion or undermining due to water flowing out of the spillway into the plunge pool.

Photo 7: Erosion at plunge pool of auxiliary spillway no. 2

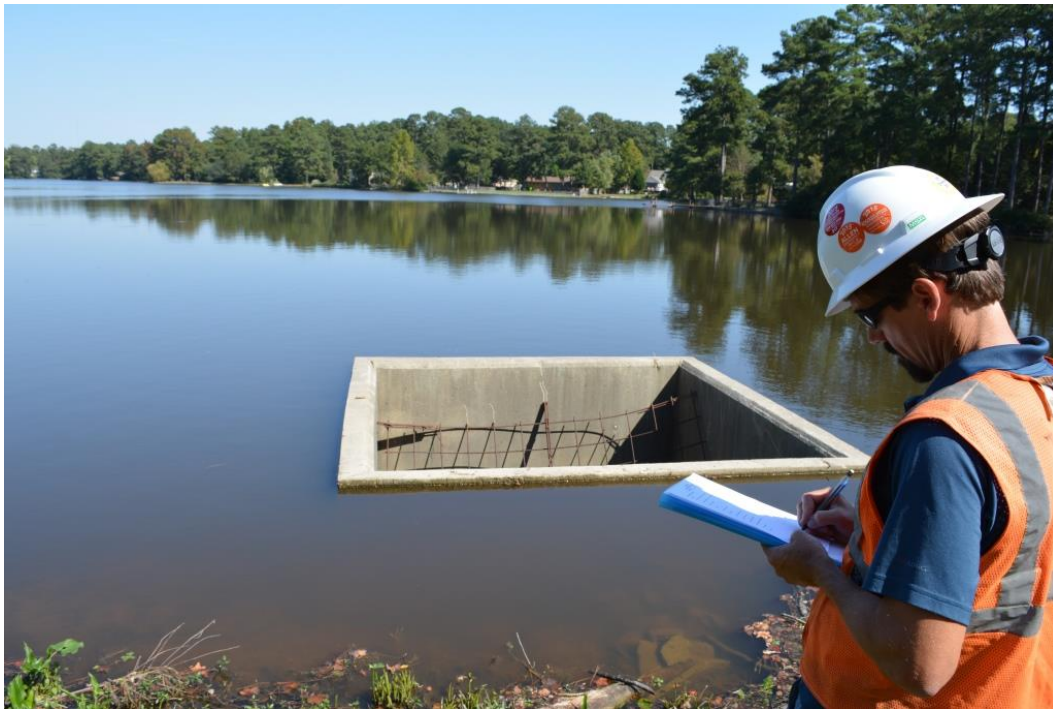
Photo 8: Auxiliary spillway no. 1 intake structure

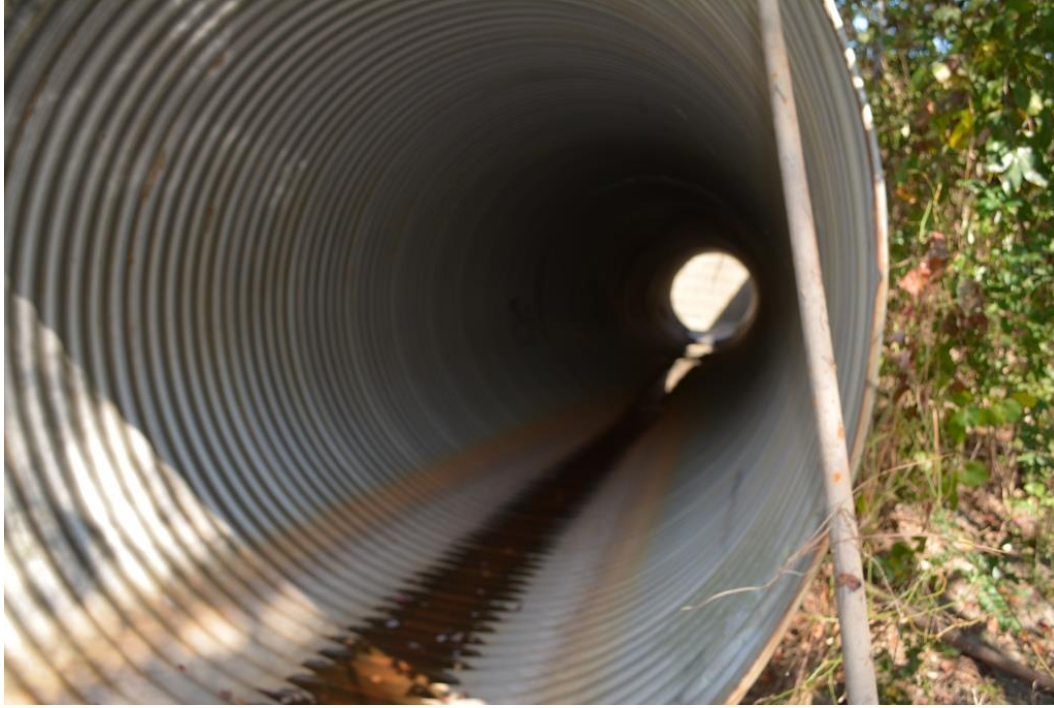
Photo 9: Auxiliary spillway no. 1 pipe (no debris)

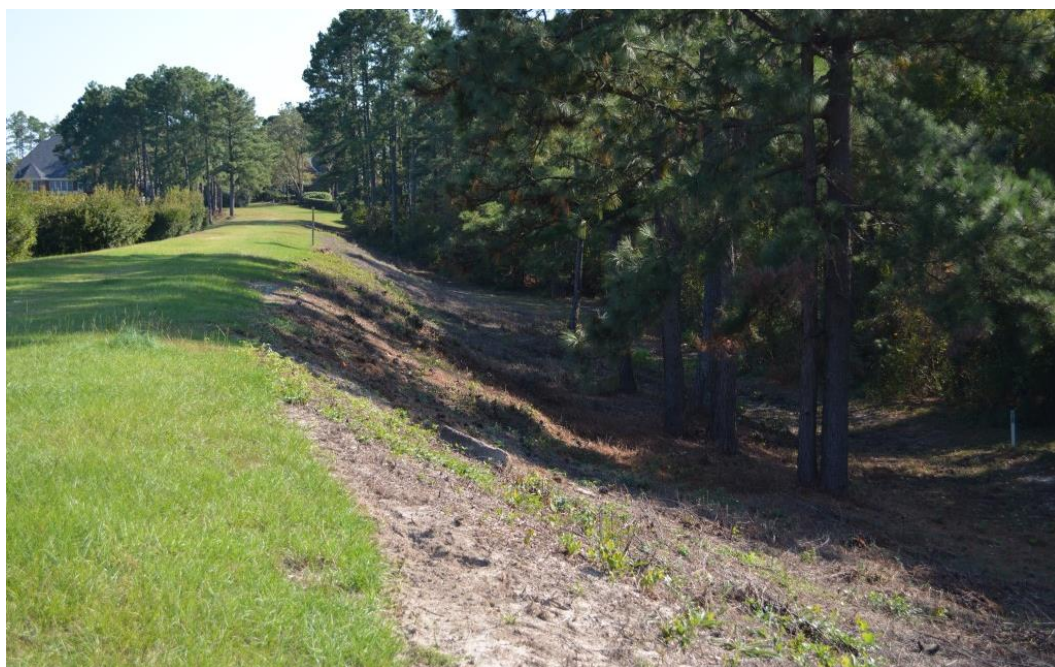
Photo 2: Downstream slope of embankment

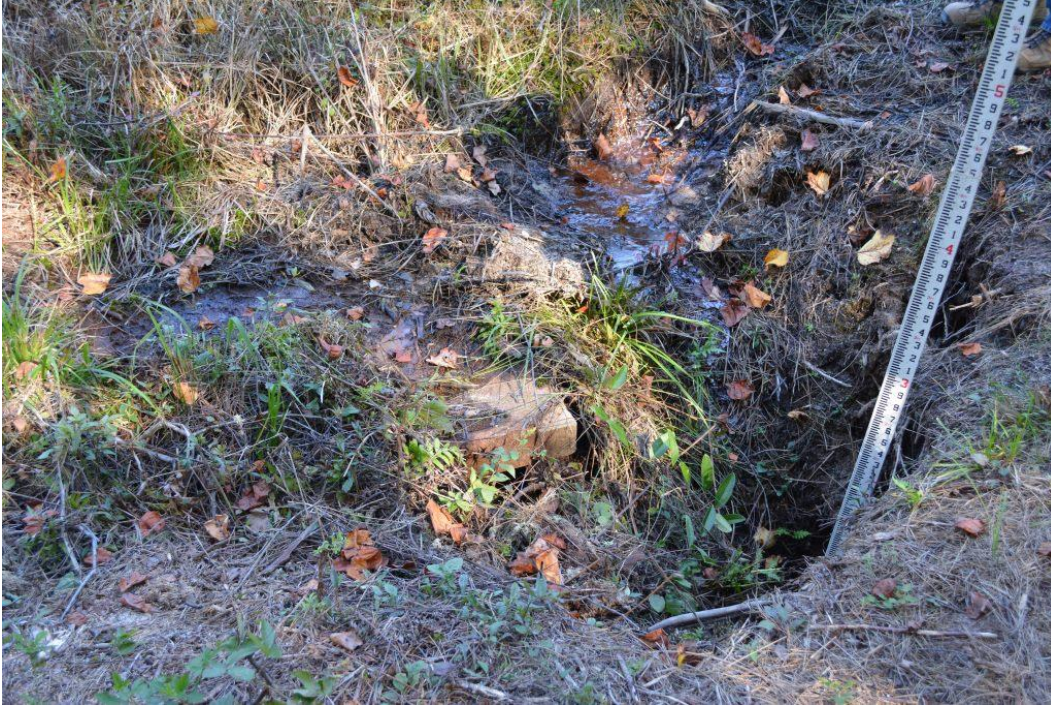
Photo 5: Hole adjacent to catch basin at toe of embankment

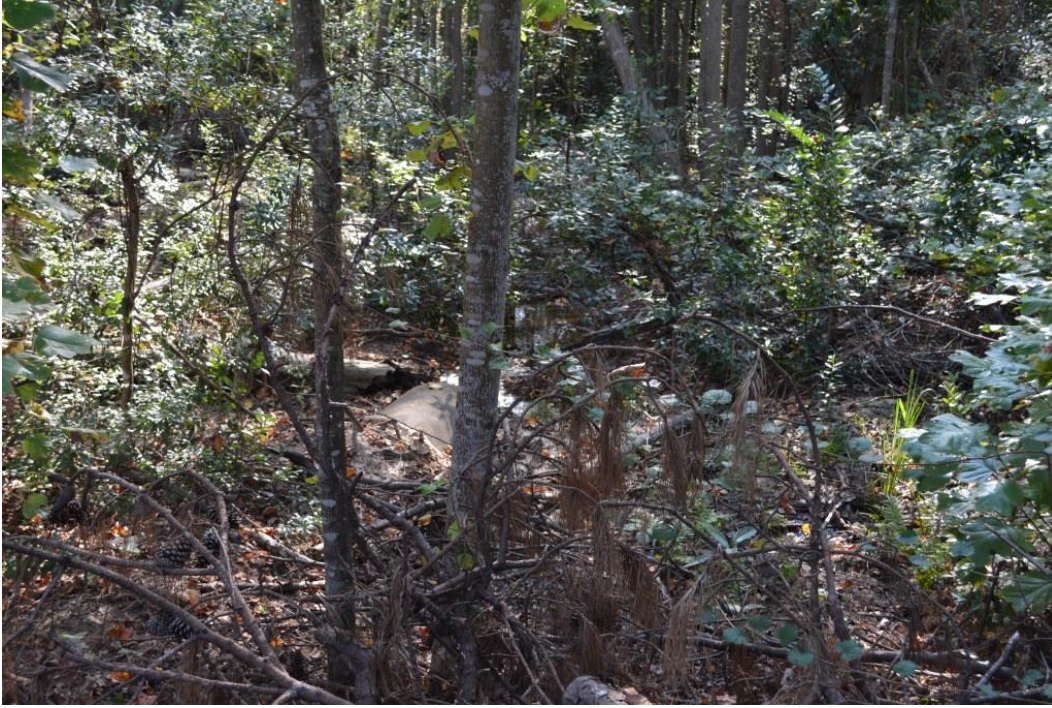
Photo 7: Service spillway outfall

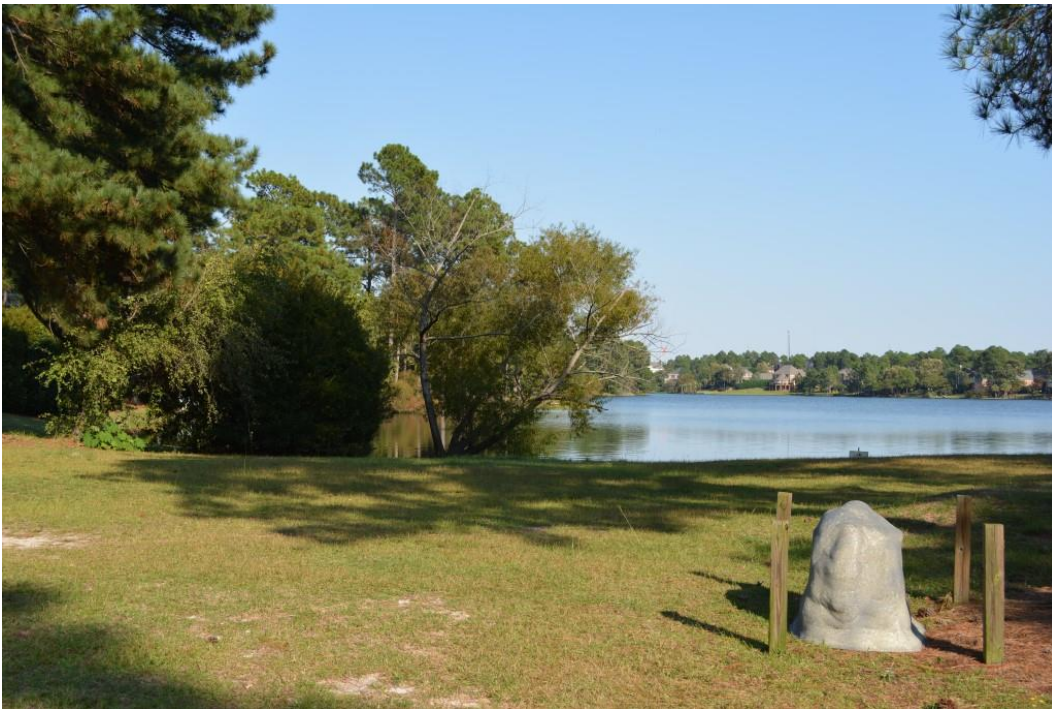
The auxiliary spillway is located on the right abutment of the dam. The spillway is approximately 50 feet wide and is a grass-lined earthen overflow spillway with a 1.5-foot-high training berm on the left of the spillway. Photo 8 shows the auxiliary spillway from downstream of the spillway crest looking upstream into the reservoir. The spillway did not show evidence of flow.

Photo 8: View of auxiliary spillway looking upstream

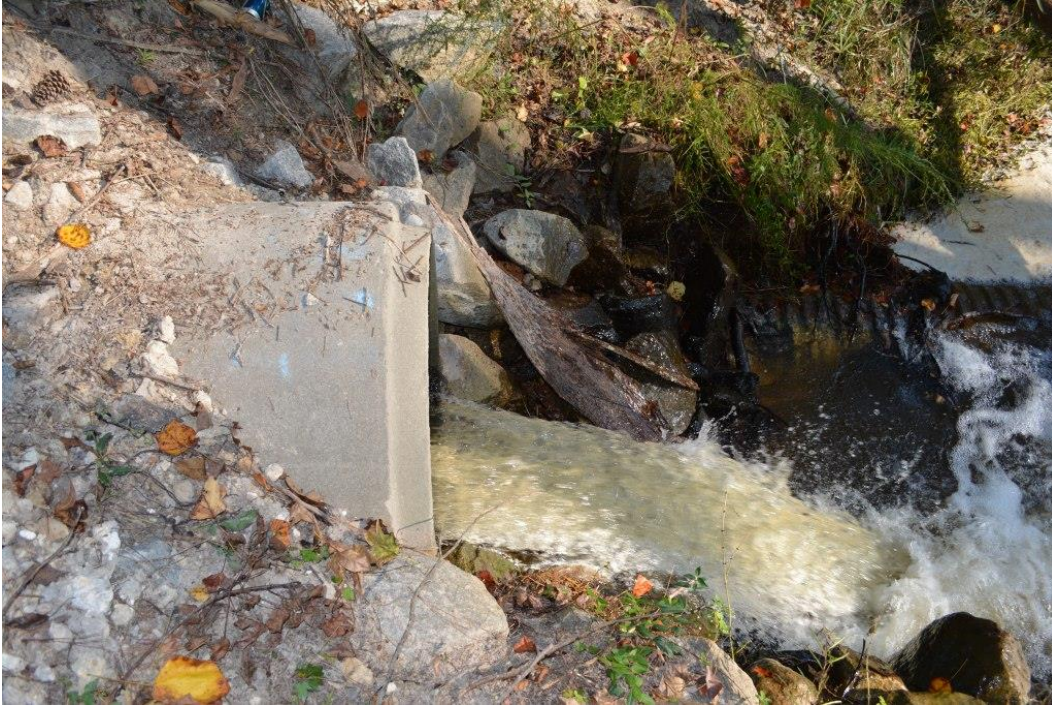
Photo 7: Service spillway outfall

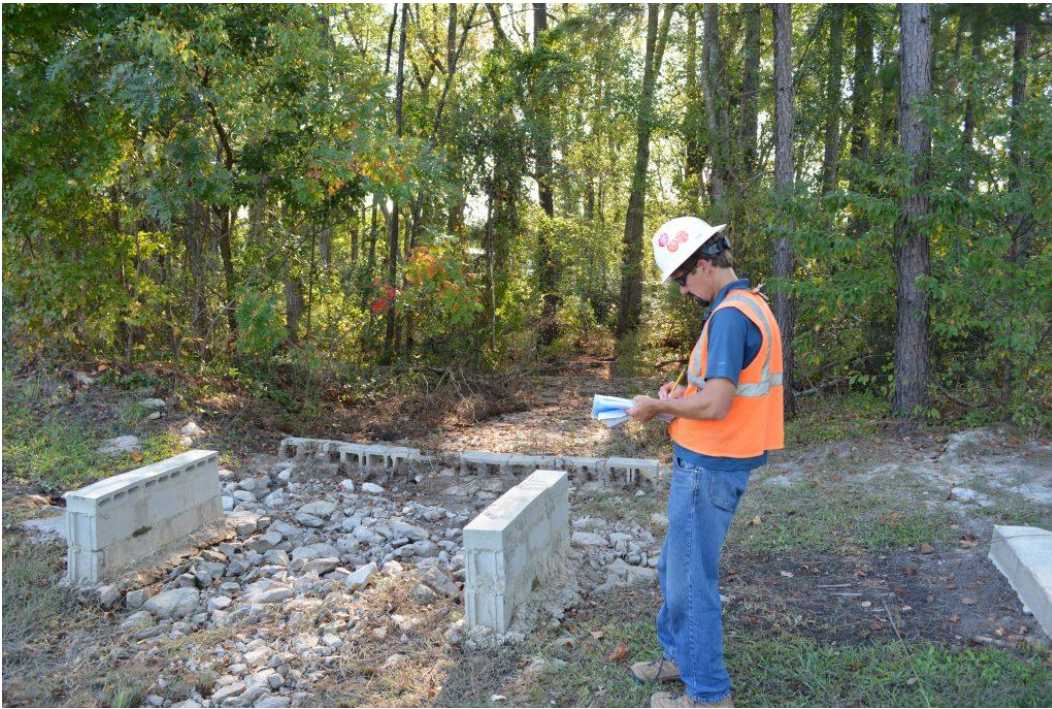
The auxiliary spillway is located at the right abutment. The spillway is an earthen, rock-lined, 20-foot-wide, overflow spillway that is approximately 2.5 to 3.0 feet below the crest of the dam. The auxiliary spillway channel is free of debris, except for debris from a wooden bridge deposited approximately 70 feet downstream; this debris would not result in impairment of spillway capacity.

Photo 8: Auxiliary spillway view looking downstream

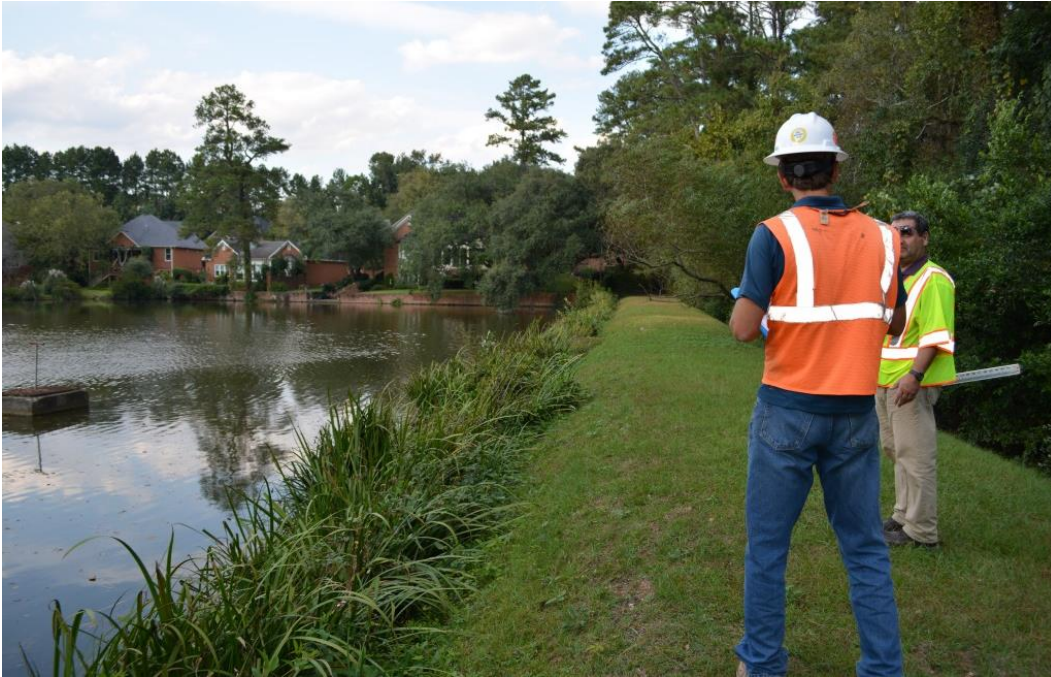
Photo 1: Crest and upstream slope of embankment

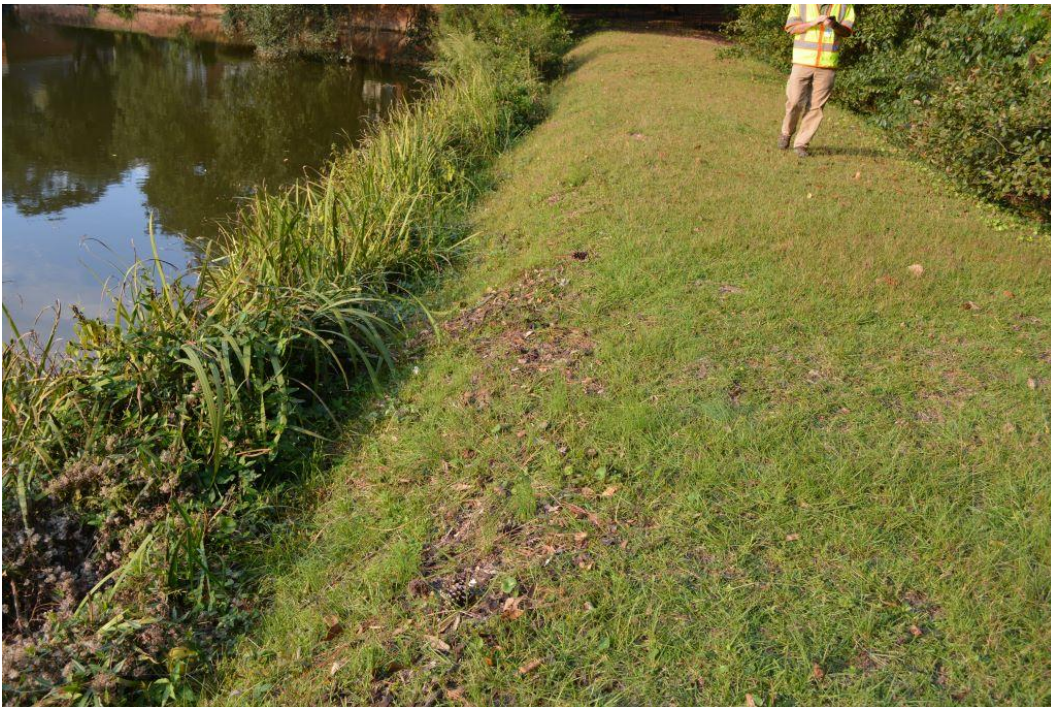
Photo 2: Upstream embankment slope and debris indicating peak flood level

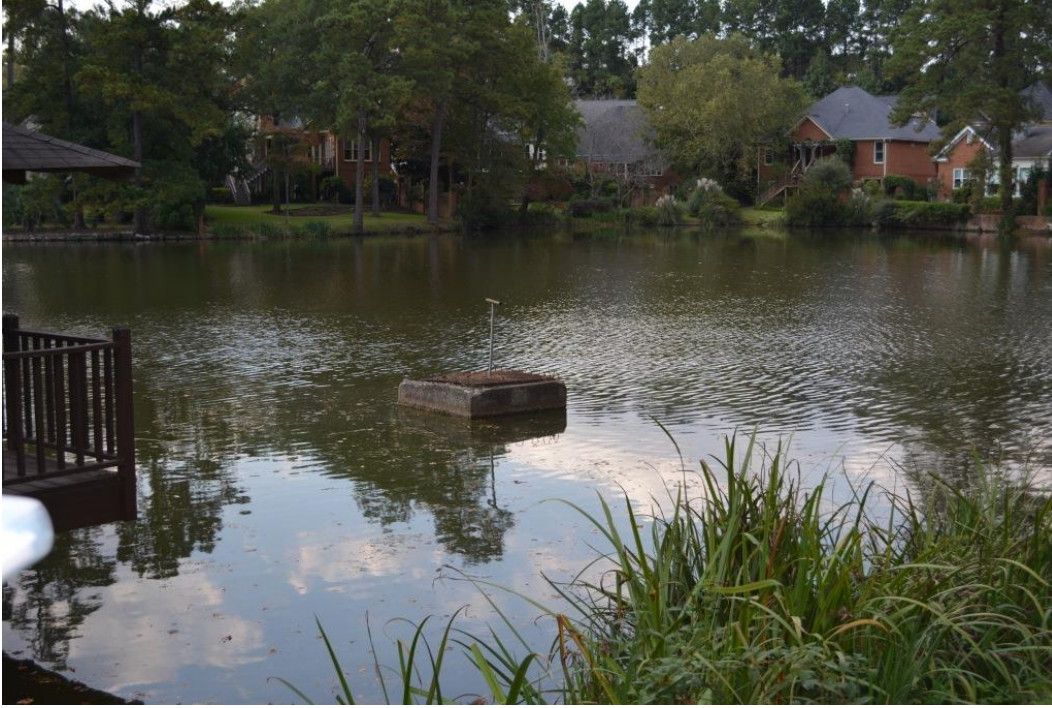
Photo 5: Service spillway intake

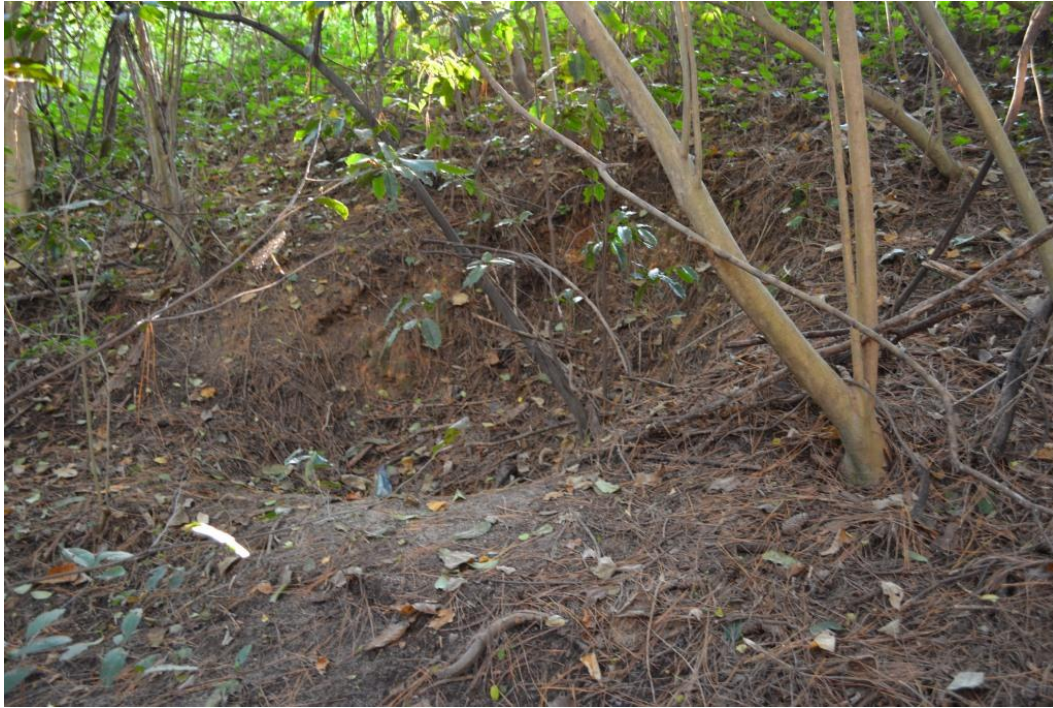
Photo 7: Depression on downstream face above principal outlet pipe
