Gills Creek Watershed: Assessment of Regulated Dams

February 15, 2016

PROJECT NAME: Gills Creek Watershed Assessment of Regulated Dams Report

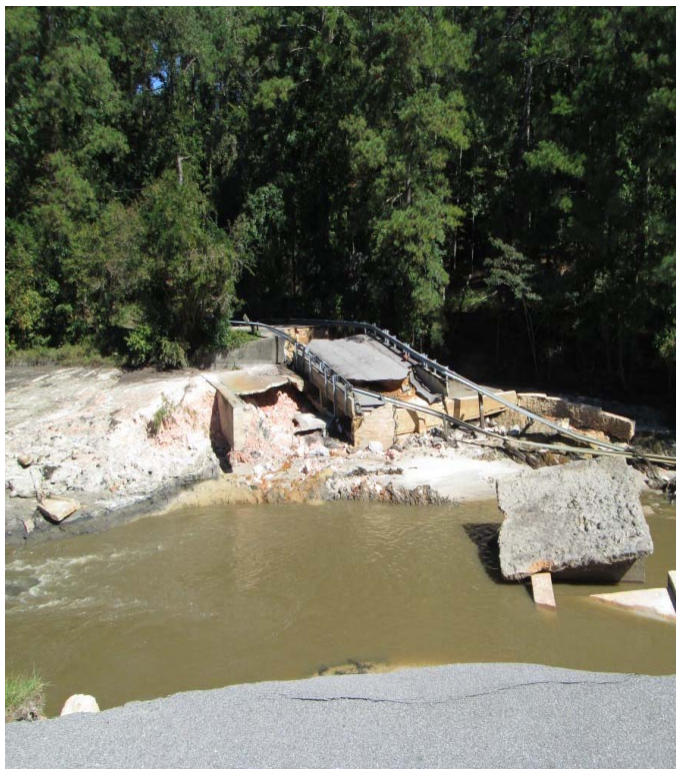
Photo of Cary's Lake Dam Breach

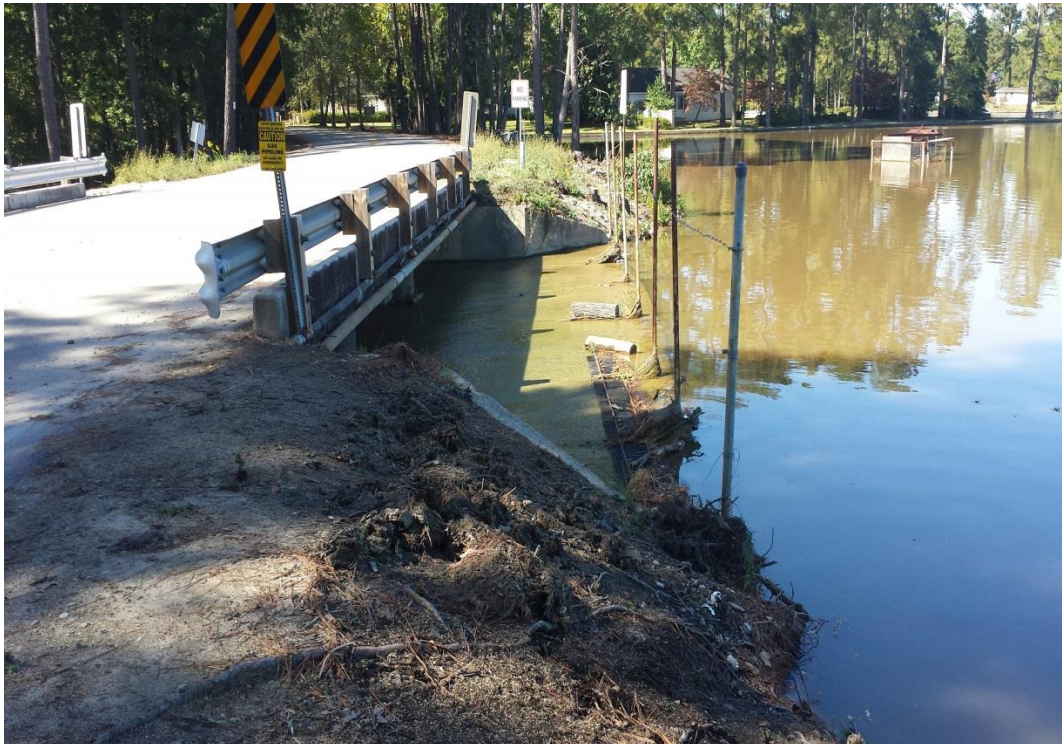
The auxiliary spillway is a concrete, uncontrolled, overflow spillway with a crest that is approximately 45 feet wide and about 5 feet below the bridge roadway surface (Photos 4 and 5). The auxiliary spillway generally appeared to be in fair condition, except for some areas of erosion and deterioration. Erosion and undermining with evidence of seepage was observed along each side of the concrete spillway as noted above (Photos 6 and 8). Significant cracks and voids in the spillway concrete were observed in the vicinity of the steel sheet-piling extending across the spillway surface near the toe (Photos 5 and 7).

Photo 4: Auxiliary spillway

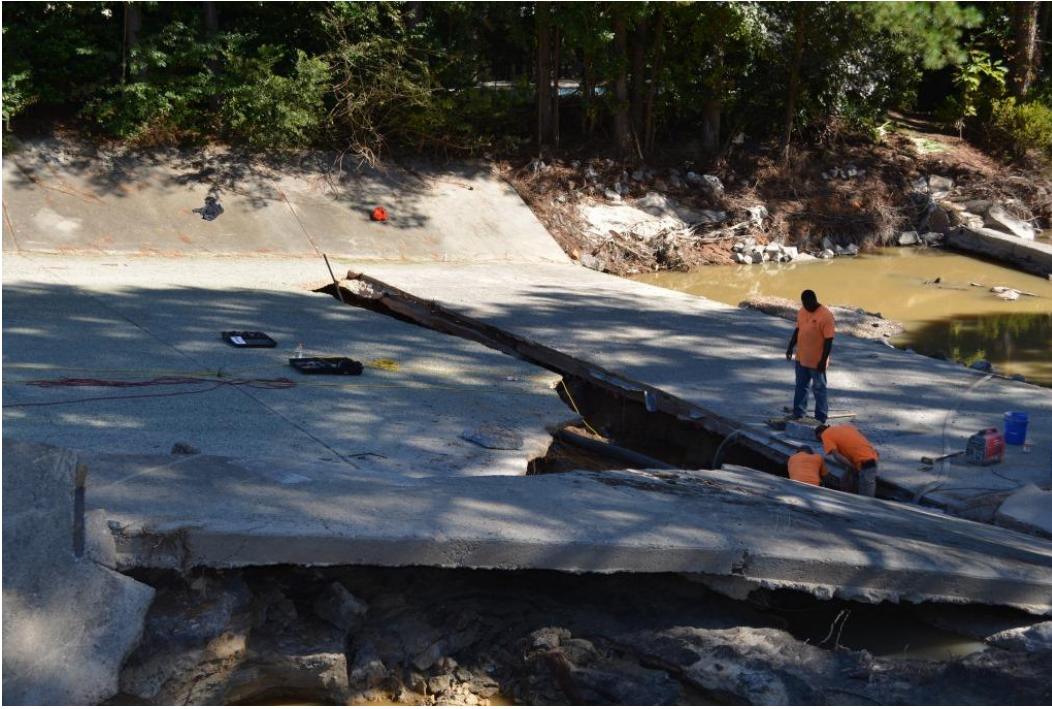
The auxiliary spillway concrete channel is severely damaged, including failure and loss of sections of the spillway concrete floor slab and scouring of subsurface material (Photo 4). It is possible that a washout of a section of the concrete spillway at the right side interface with the embankment (Photo 8) may have contributed to undermining and failure of the concrete spillway floor slab. Photo 9 shows rock that deposited at the downstream weir wall. Photo 10 shows the upstream portion of the auxiliary spillway which is in good condition.

Photo 4: Auxiliary spillway damage

The auxiliary spillway is undergoing temporary structural repair.

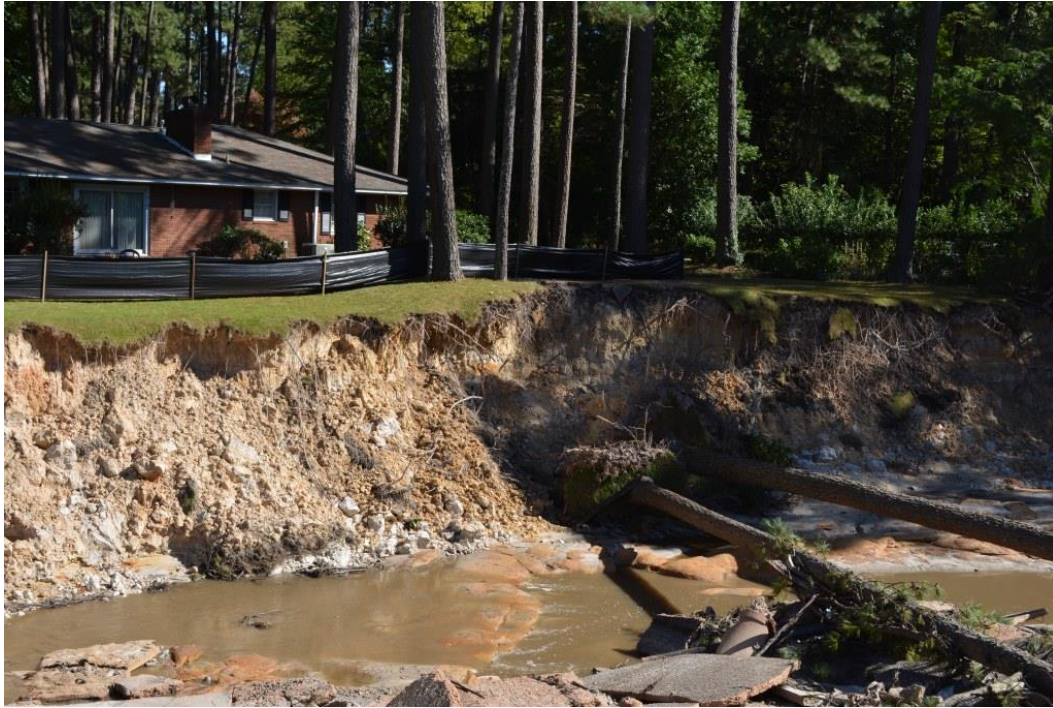
Photo 5: Erosion along the left side of the auxiliary spillway, looking downstream from the bridge

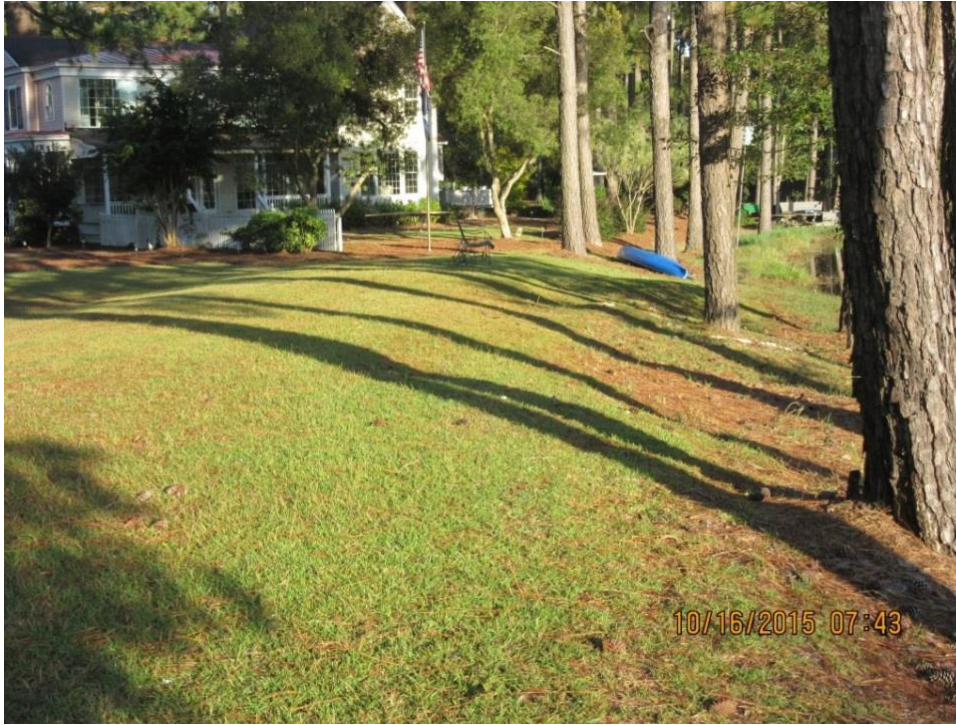
The right abutment is natural grade residential yard (see Photo 5). No erosion of this area was observed.

Photo 5: Right abutment

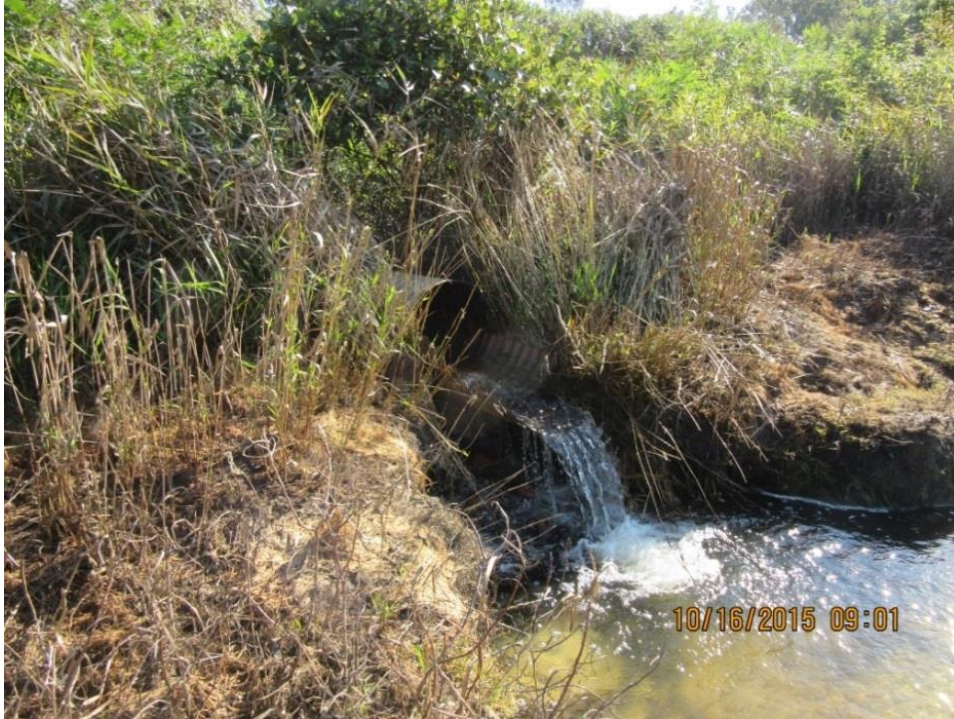
Photo 5: Service spillway outlet pipe. Note minor erosion around the pipe.

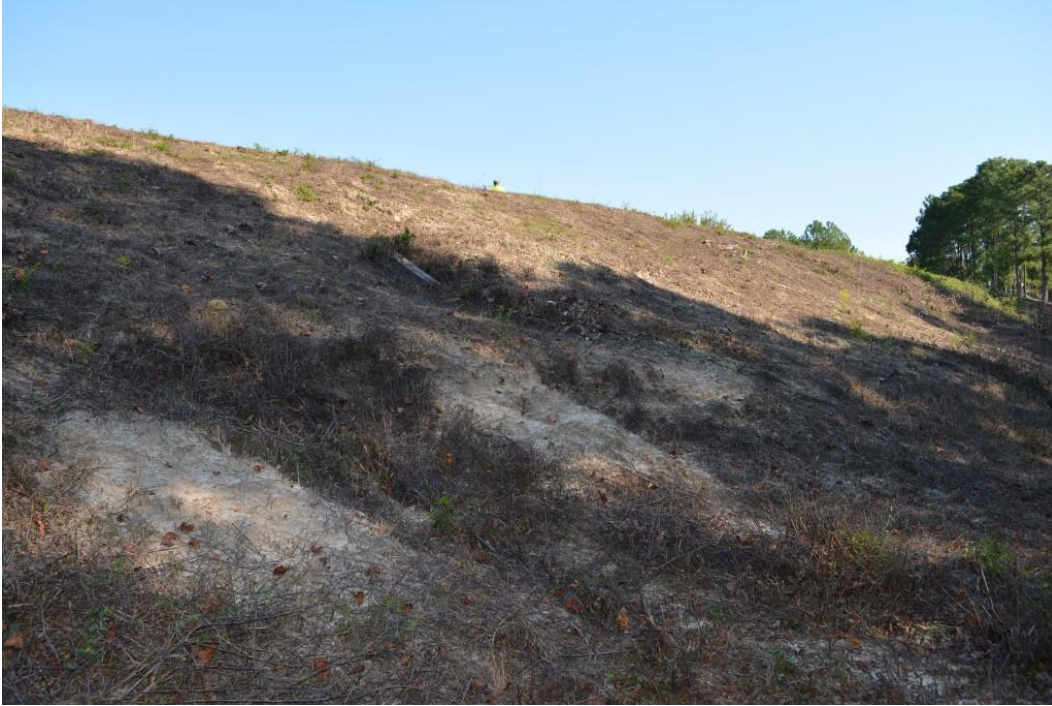
Photo 3: Downstream slope of embankment

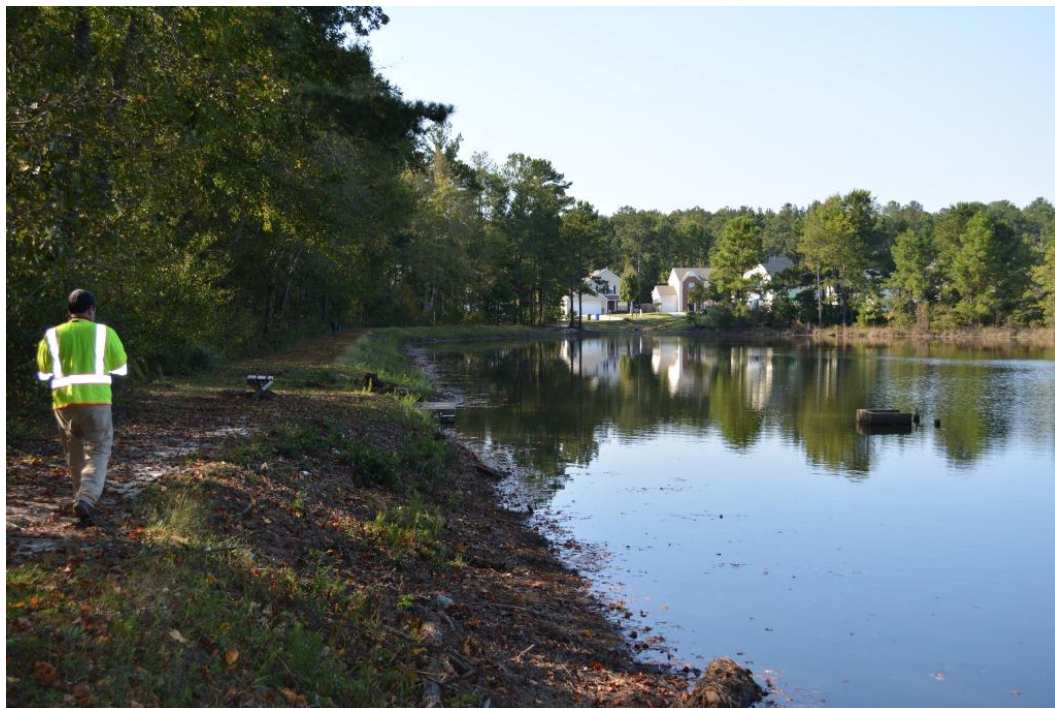
The embankment has an approximately 10-foot-wide crest, upstream slope that varies from 3H:1V to 2H:1V (Photo 1); and downstream slope of 2.5H:1V to 2H:1V. The crest of the dam is not level as indicated by visual evidence that some areas of the crest were overtopped during the flood event by approximately 3 to 4 inches, including the area at the service spillway. The upstream slope appears to be in good condition having moderate grass cover. The crest has grass cover over approximately 60 percent of the surface. Photo 1 presents a view of the upstream slope and crest from the left abutment. The downstream slope has significant tree growth as well as forest undergrowth including vines, ivy, and weeds. The downstream face is generally in good condition; however, a scoured area was observed near the service spillway where the dam experienced overtopping. Photo 2 shows the downstream portion of the crest and tree growth on the downstream slope. Photos 3 and 4 show the limited areas of significant erosion on the downstream slope, and debris accumulation from overtopping.

Photo 1: Deer Lake embankment dam crest and upstream slope

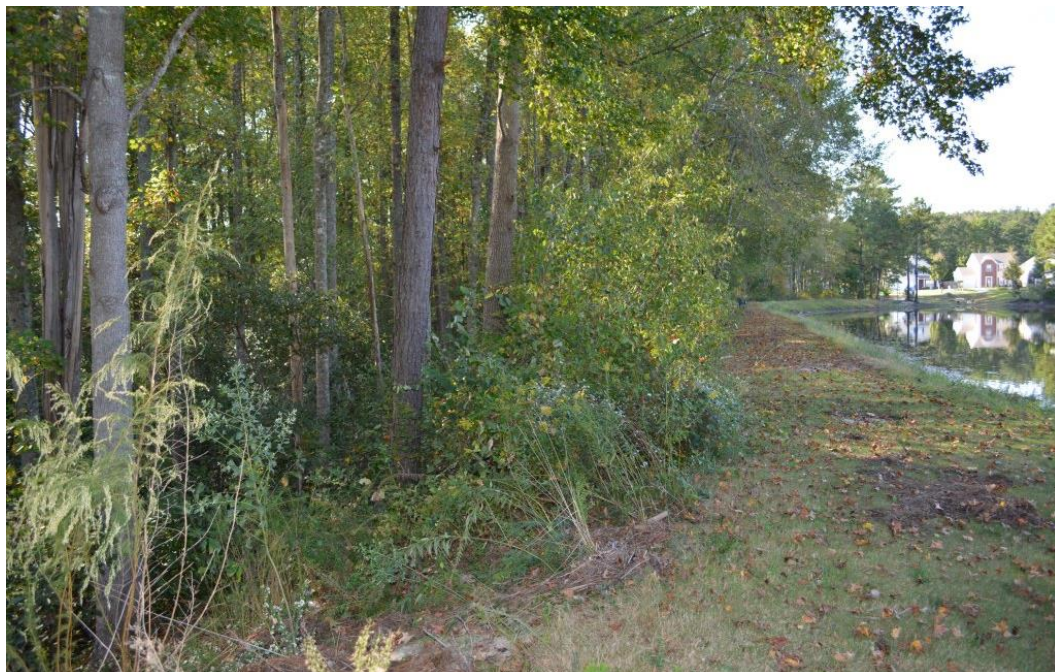
Photo 2: Vegetation along downstream embankment slope

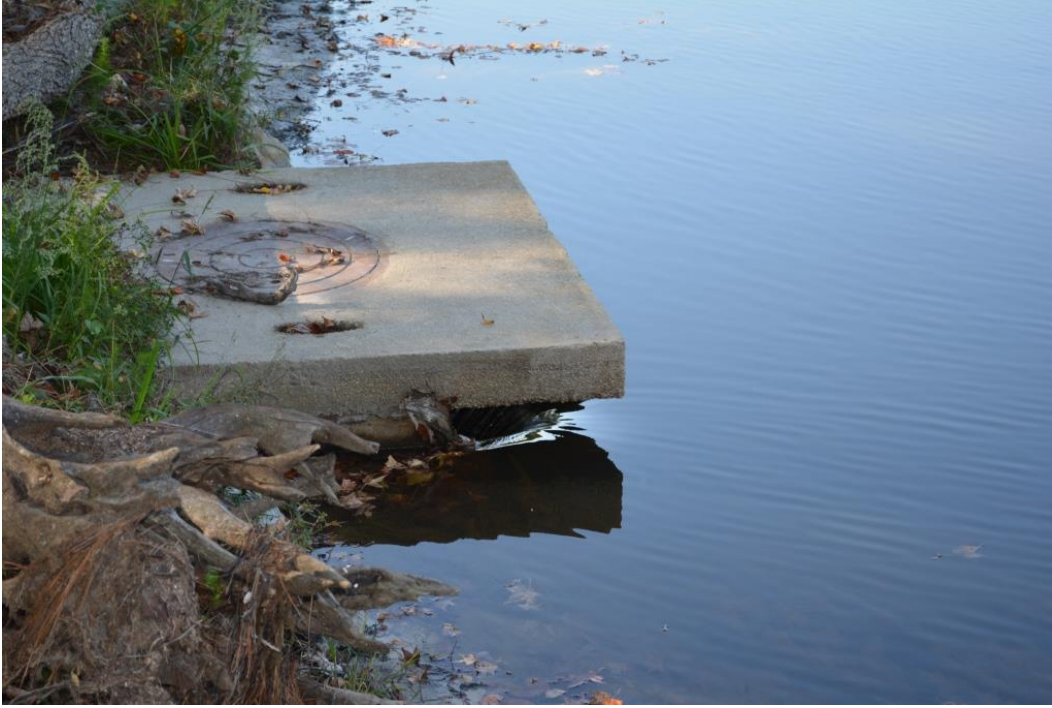
Photo 5: Service spillway intake

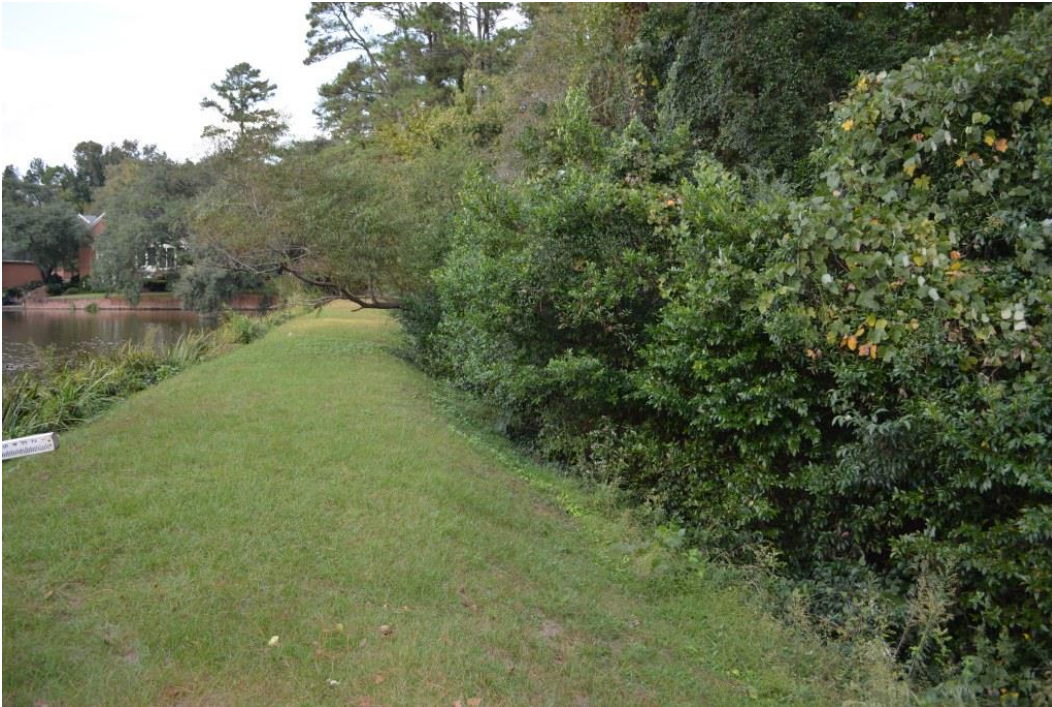
Photo 4: Downstream embankment slope

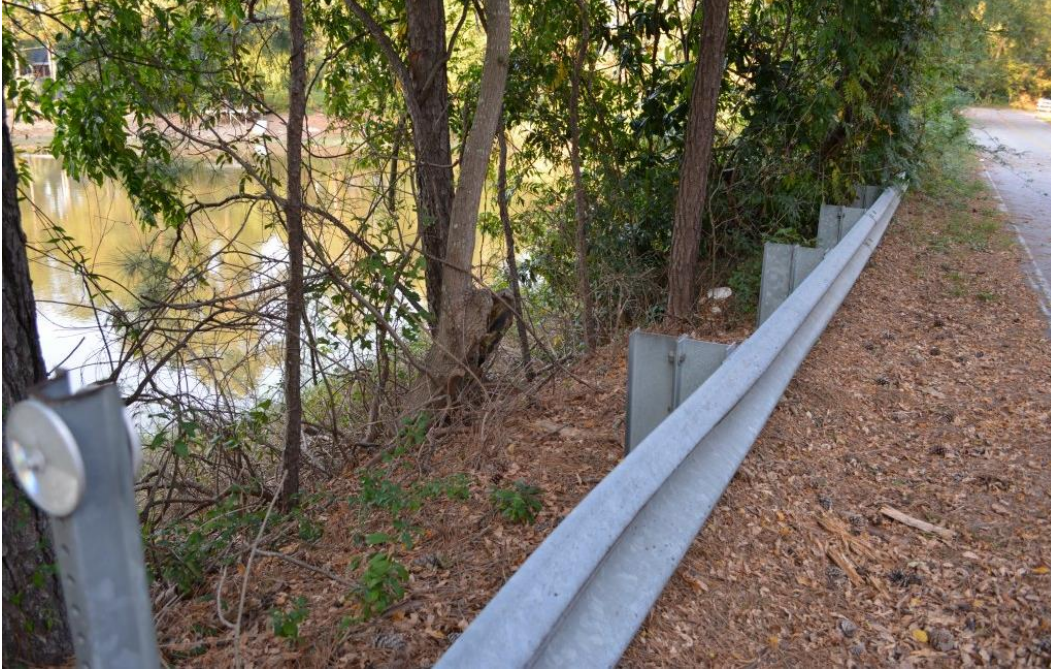
Photo 1: Upstream embankment dam slope

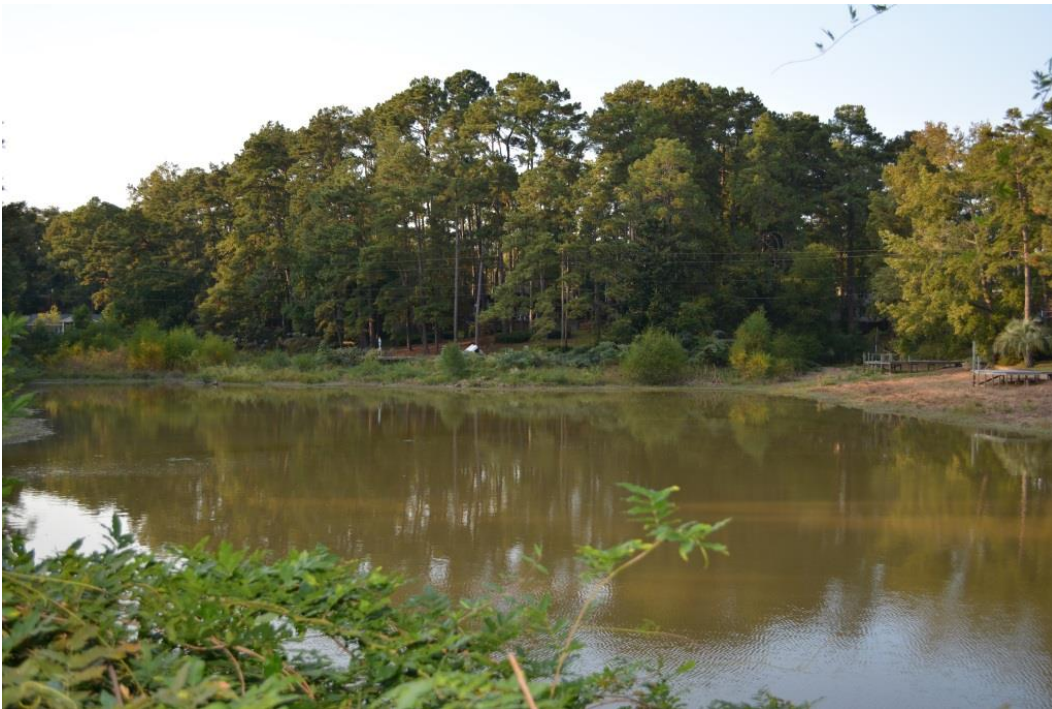
Photo 8: Reservoir
